**Quinte Source Protection RegionArea  
Updated Conditions Report**

**~~Updated~~ Quinte Source Protection Area Assessment Report**

April 25, 2021

Prepared by Mark Boone, P.Geo

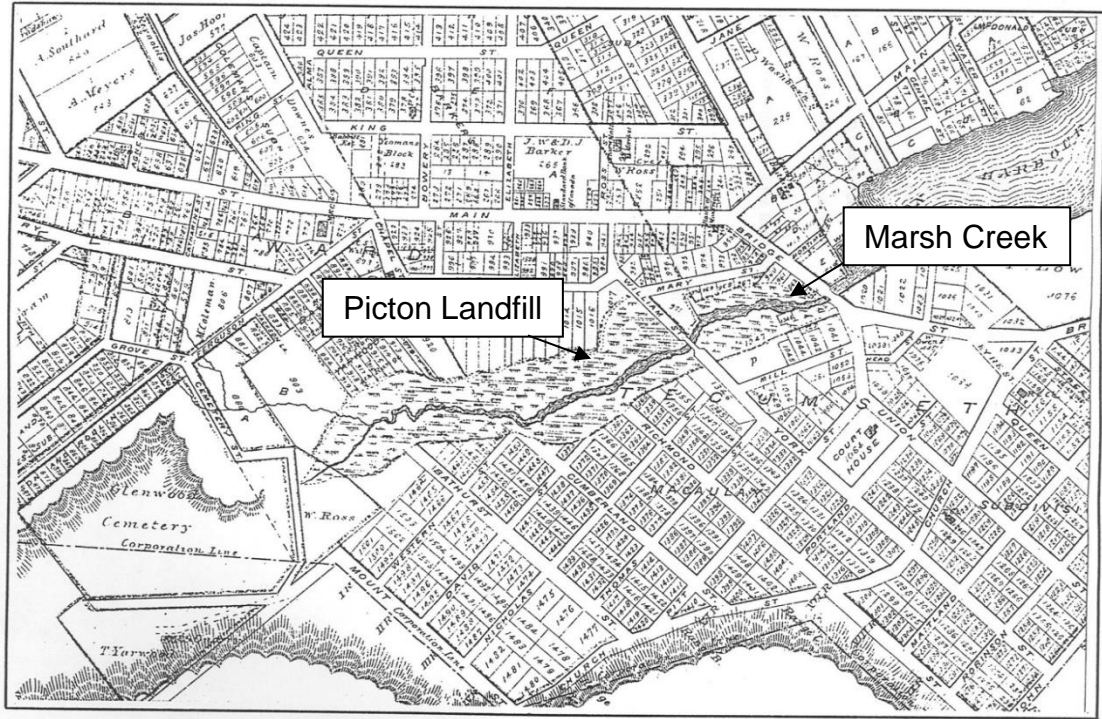
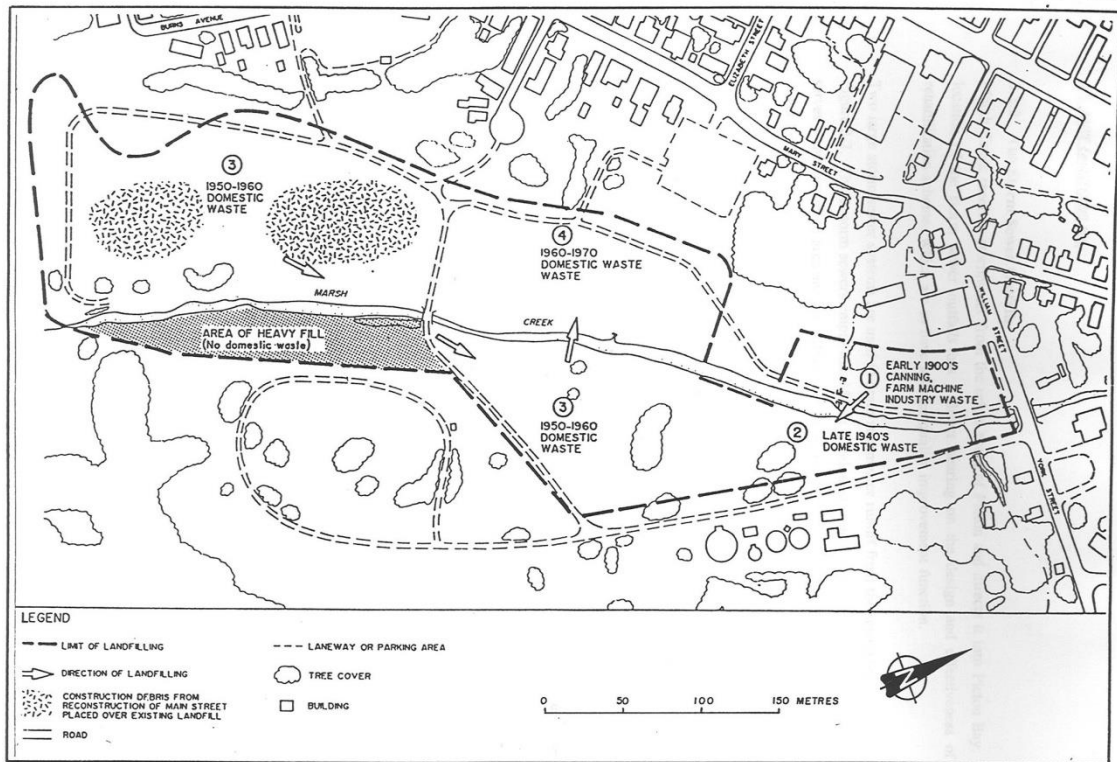
Figure 1: Town of Picton Landfill Site

It was reported that landfill operations was recommended to maintain a 30 metre separation from Marsh Creek. However this recommendation did not appear to be followed (Water & Earth Science Associates, 1989). Water quality monitoring of the creek by the Ministry of the Environment in 1971 and 1979 found the landfill to be impacting on the creek with some parameters identified at higher levels in 1977 than in 1971.

Based on the detection of these parameters above the standards the site is considered a condition within the Town of Picton IPZ. These parameters are organic and related to a group of chlorinated hydrocarbons. Sources of such chemicals may be from solvents, refrigerants, plastics, rubber, insecticides and

- 6.0 The former Town of Picton Dump was established in the early 1900's and closed in 1979. Hydrogeological assessment of the site was completed in 1988 and review of groundwater quality data for the site indicated that some parameters meet the standard for classification as a condition. The calculated risk score classified this property as a significant drinking water threat. Given the date of the data it is recommended that updated data be obtained to confirm this assessment.

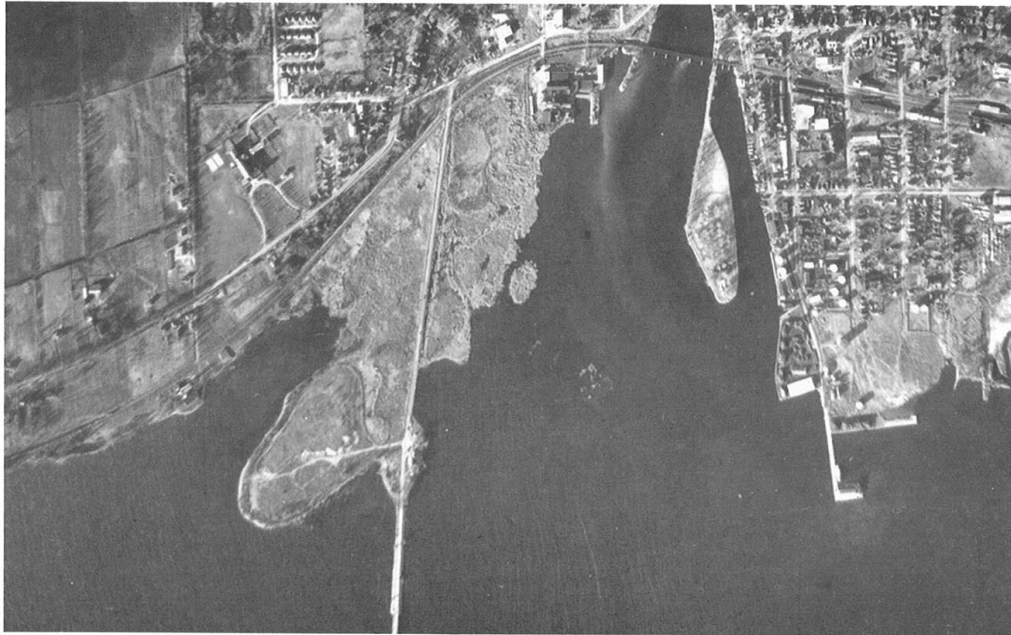
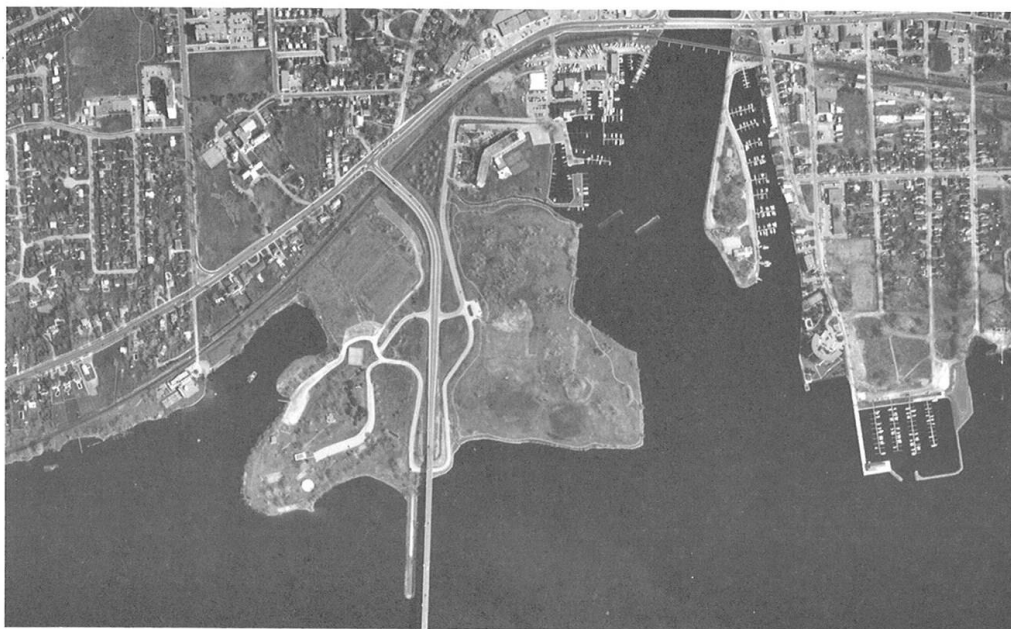
**Figure 2: Zwicks Island Landfill Before & After Filling**

parameters indicative of landfill leachate. As a result it was found that groundwater flows radially outward from the site towards the Bay of Quinte. Analysis of samples of groundwater found the site to be impacted by landfill leachate, however the overall strength of the leachate was thought to be low.

This low strength was attributed to how the waste was deposited (filling of the Bay) with significant flushing of contaminants and dilution. Parameters that were detected in the groundwater included Benzene, Toluene, Trichloroethane and some pesticides such as Aldrin. Analysis of surface water samples found discharge of leachate to ditches on the site, however the water quality in the Bay was found to not be significantly poorer than water farther off shore. Regardless it was reported that there is continual loading of relatively low strength landfill leachate to the Bay. Continued monitoring was recommended.

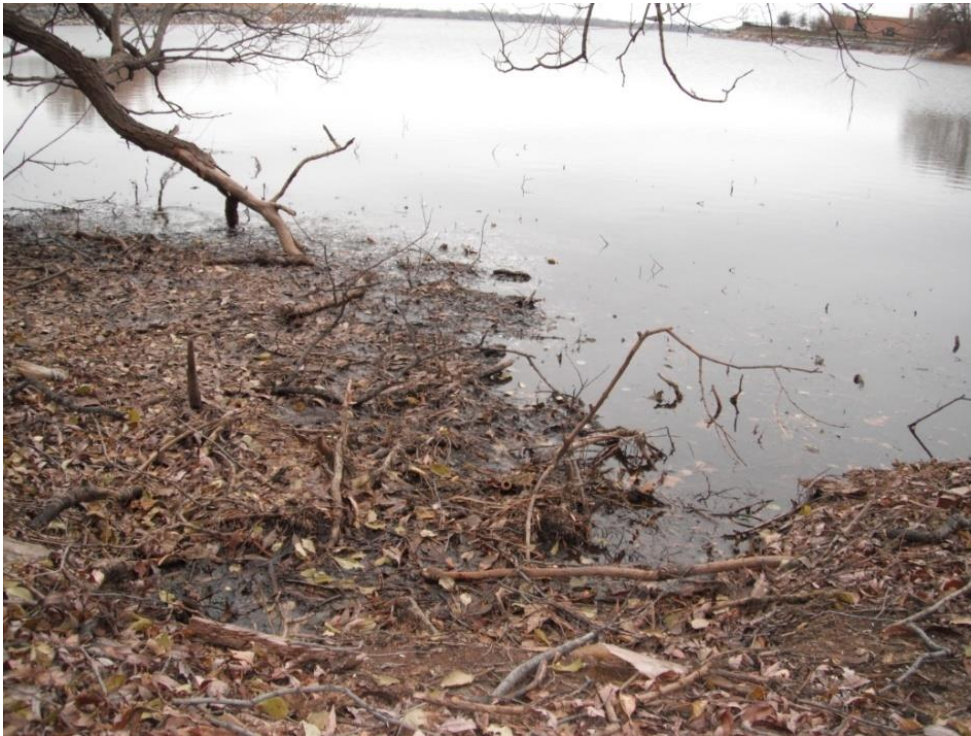
**Figure 3: Seep from Zwicks Island Landfill**

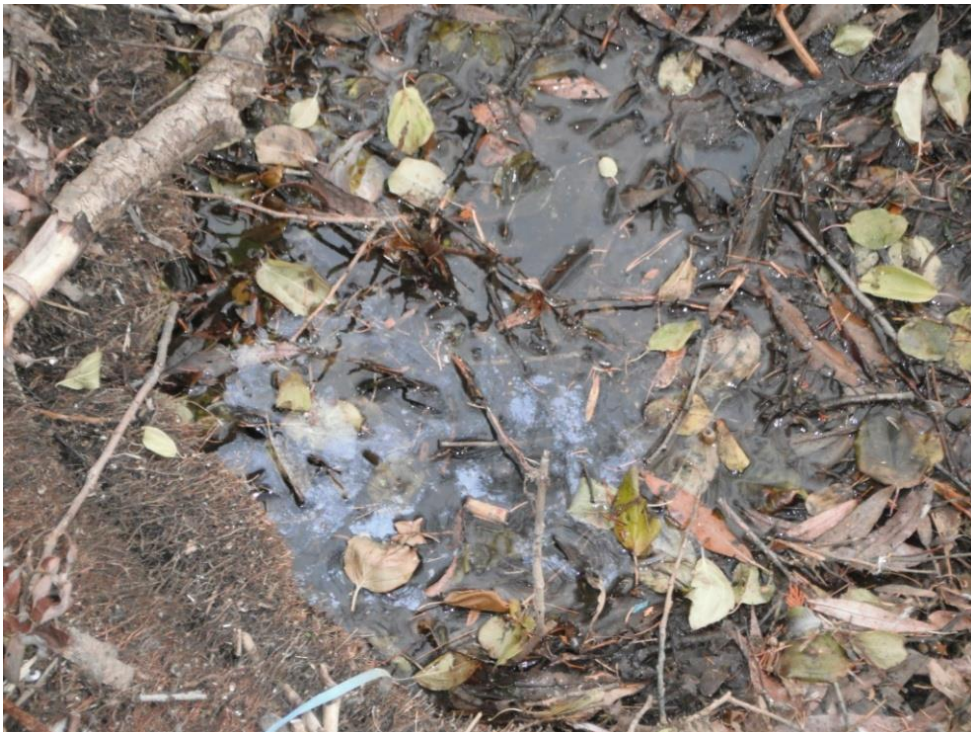
**Figure 4: Surface of Seep at Zwicks Island Landfill**
