Final Report

Bellrock Dam

Napanee Watershed

April 2004

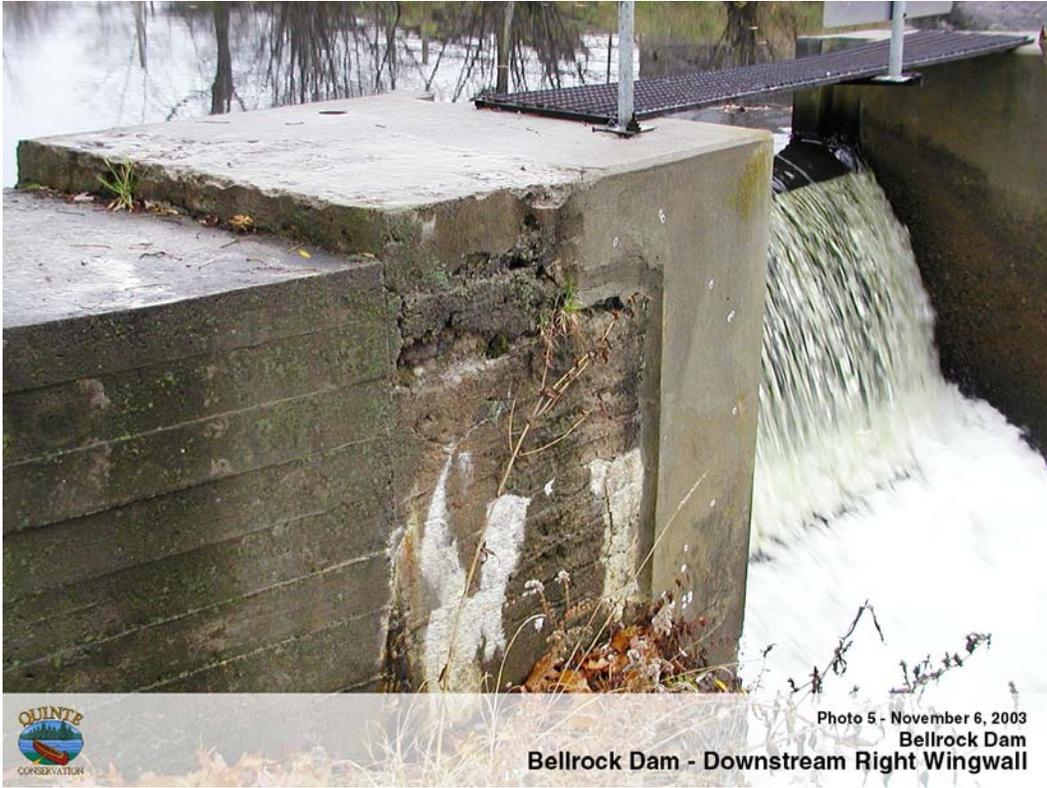
Photo 5 - November 6, 2003
Bellrock Dam
Bellrock Dam - Downstream Right Wingwall

- **Right Wingwall**
 - Some map cracking was noticed on the crest of the wall.
 - Light spalling was observed at the junction wall/pier with no sign of erosion at the waterline.
 - A major concrete deterioration was observed at the downstream face of the wall.

Leakage was detected at the right wingwall.

- Install a “No Trespassing” sign at the right and left sides of the structure.
 - Monitor leakage at the right wingwall and left abutment.
 - Perform stability assessment and recommend stabilizing measures.
 - The requirement for a log boom should be reviewed.
-

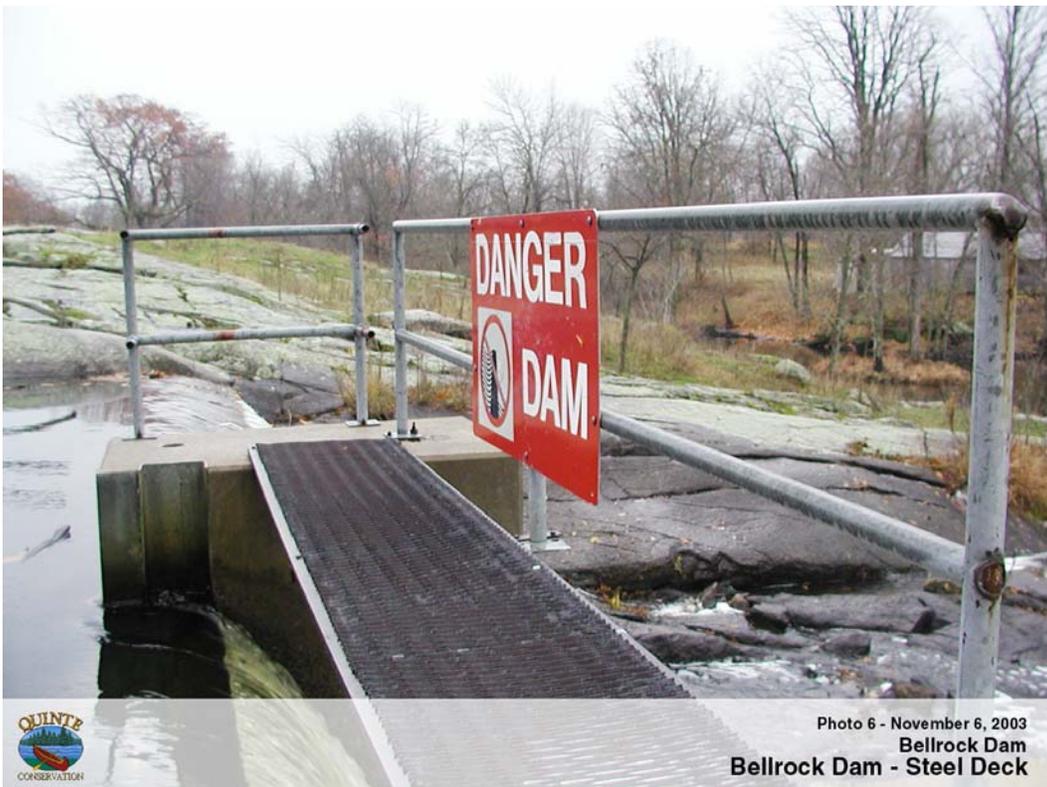
Photo 6 - November 6, 2003
Bellrock Dam
Bellrock Dam - Steel Deck

Deck allowing crossing from the right wingwall to the stop log guides is of steel grating. Guards are fabricated of steel pipe. Slot (gain) steel was not severely rusted above the waterline. The steel deck was in good condition and well-fixed to the concrete piers. The steel deck components need some painting.

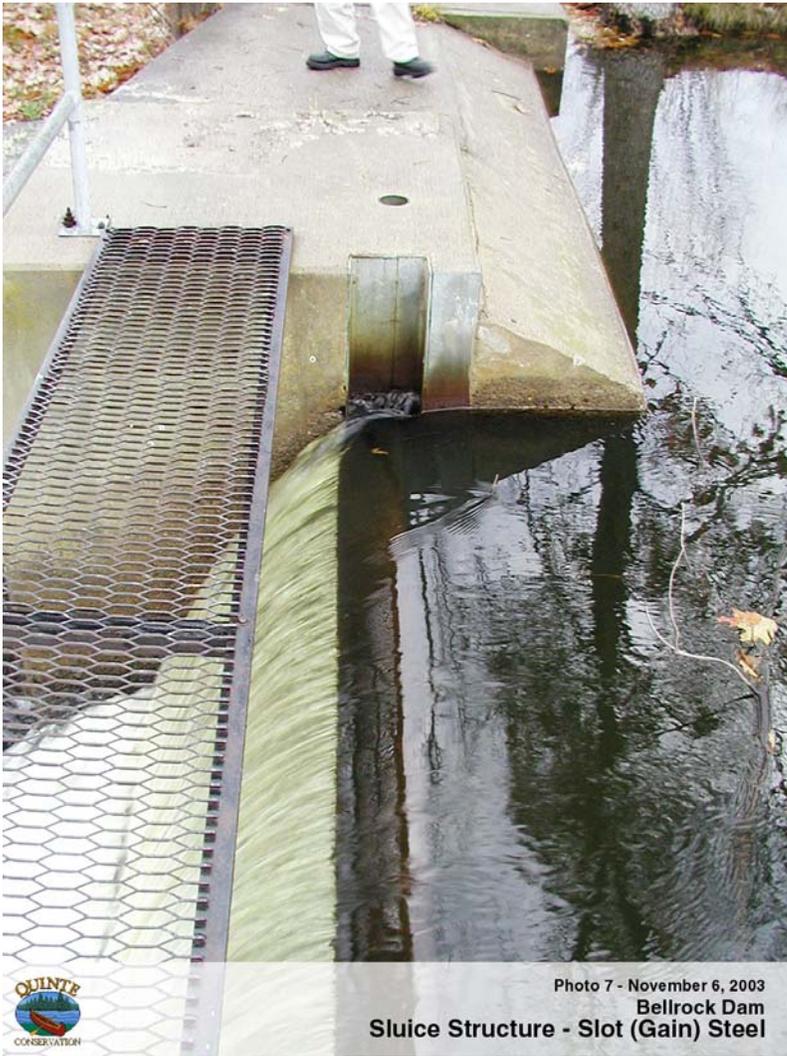
Photo 7 - November 6, 2003
Bellrock Dam
Sluice Structure - Slot (Gain) Steel

- **Stop Log Opening**
 - Rough concrete surfaces were noticed at the waterline inside the piers.
 - The topside of the concrete piers was showing some map cracking with spalling observed near the stop log gains.

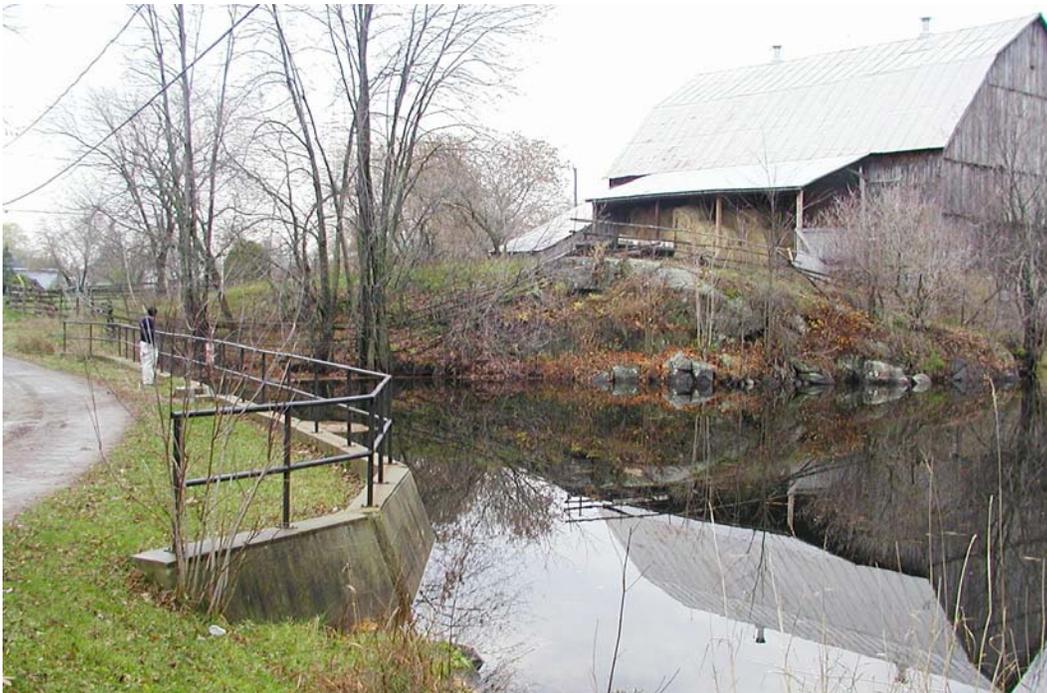
Photo 10 - November 6, 2003
Bellrock Dam
Mill Dam - Upstream View

The Mill dam is a retaining wall 32 m long (Photo 10) with a sluiceway that formerly provided water to an adjacent mill that is no longer in operation (Photo 11). The concrete was in good condition. A “Dam - Danger” sign was clearly visible on the sluiceway guard. The sign was generally in good condition (Photo 12).

The mill dam was in good condition.
