# Storm Outfall Monitoring

Bay of Quinte  
Remedial Action Plan

## Storm Outfall Site Inspection Form

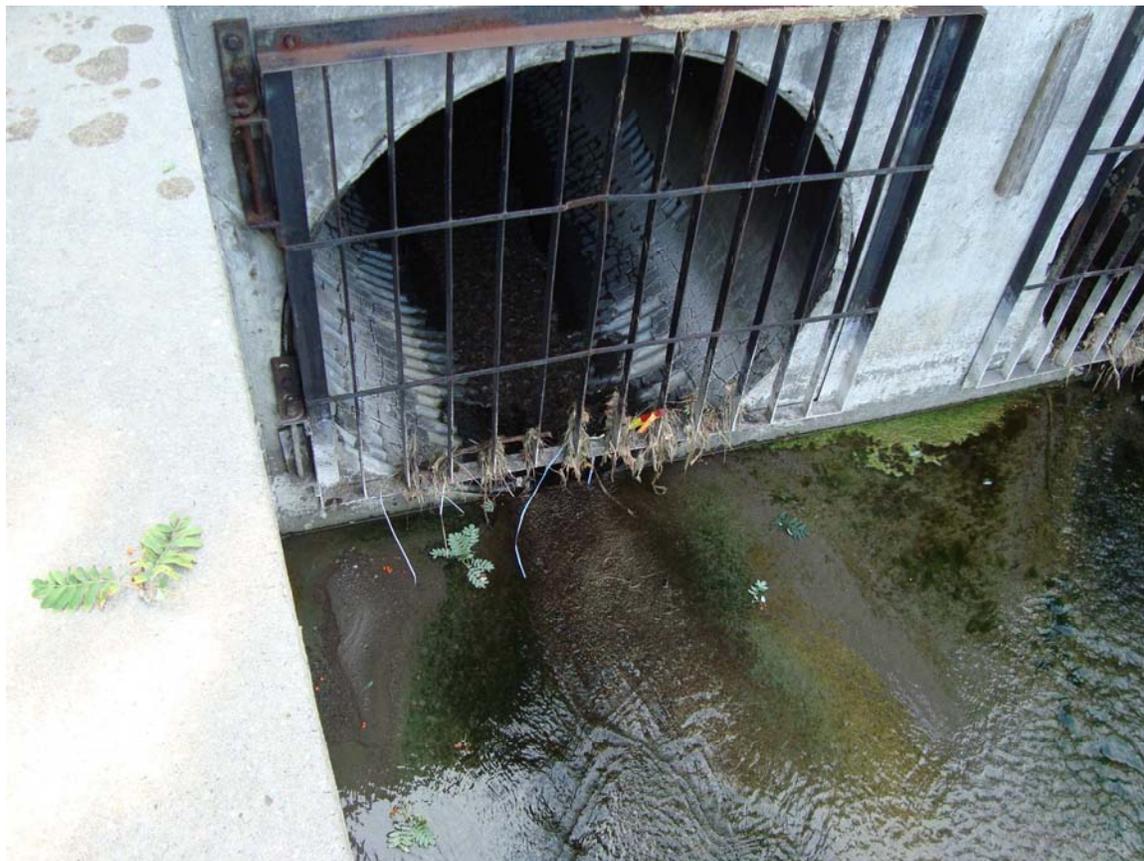
BE70 – August 22, 2008

Is there discharge from the outfall pipe? If yes, then please estimate flow depth in outfall pipe, or approximate % of pipe that is full	Approx. 1cm – could not get flow
Is the flow clear or cloudy or muddy?	Clear
Is there sediment or debris accumulation in the outfall pipe? If yes, then what approximate depth of pipe is filled by sediment or debris?	No
Is there any indication of oil and grease in the flow (for example, surface sheen)?	No
Is there any odour? If yes, please describe. Yes, smells like sewage	
Is there any evidence of sewage contamination? If yes, please describe. No	
Other observations or notes:
