Quinte Conservation Shoreline Management Plan

Quinte Conservation

June 21, 2022

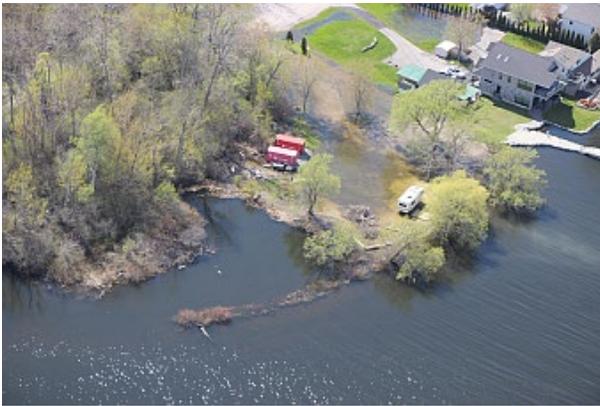
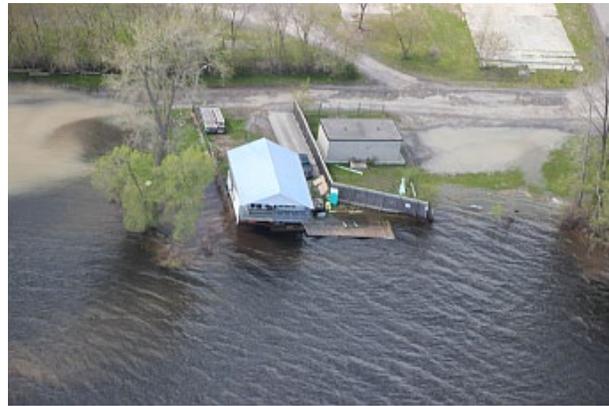
Figure 1.2 Bay of Quinte flooding in 2019

Examples of flooded properties in the Bay of Quinte are provided in Figure 1.2, where static lake levels inundated shoreline properties in numerous locations. Inundation of the lake shoreline also occurred in Prince Edward County, as did bank erosion along several roads (Figure 1.3).

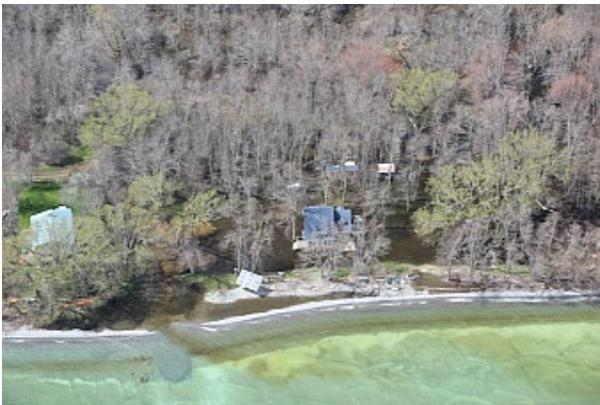
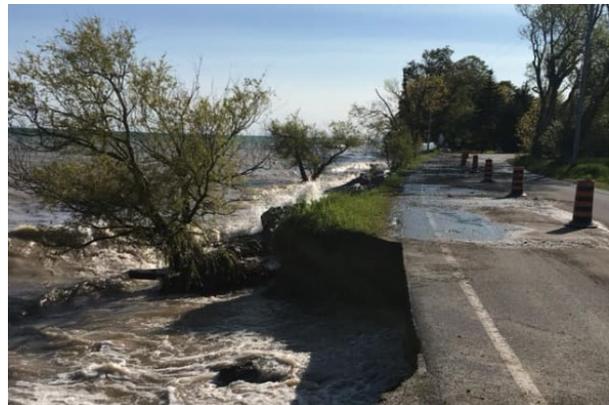
Figure 1.3 Lake Ontario flooding and bank erosion

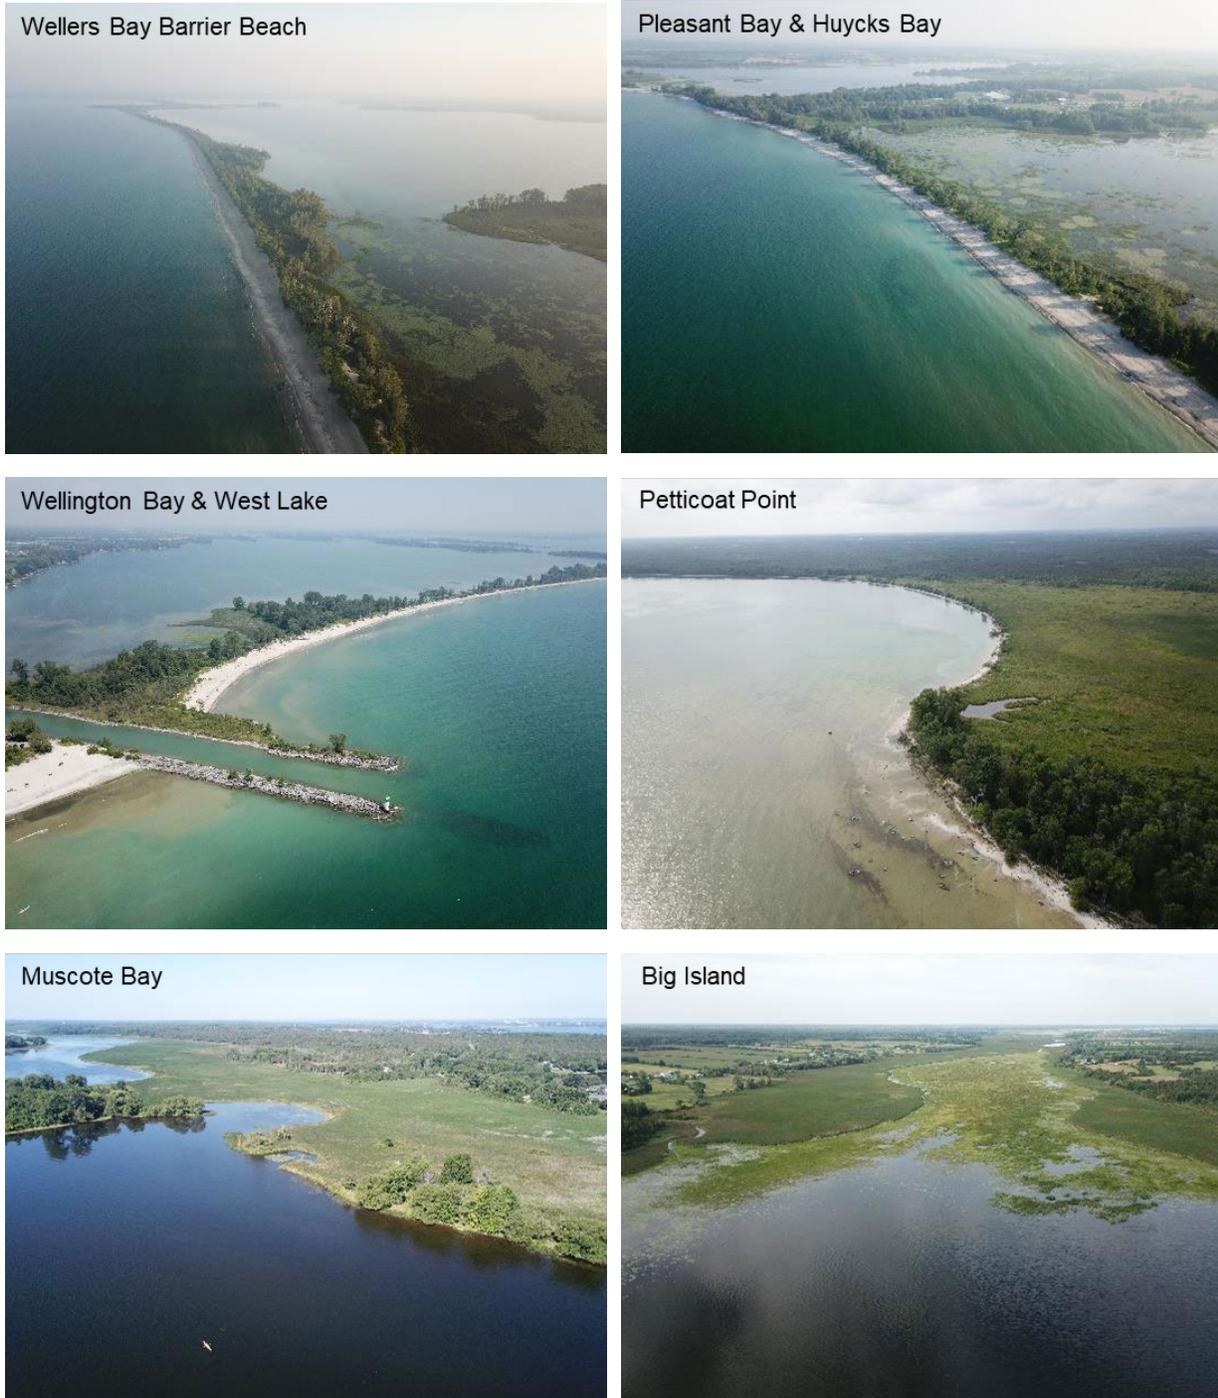
Figure 3.2 Examples of beach and wetland shorelines from the aerial oblique photo database (photographed Aug/Sep 2021)

shoreline protection structures. Where appropriate, images were captured from a higher elevation to provide an increased range of view. This includes areas featuring large barrier beaches, coastal wetlands, or extended portions of shoreline with increased erosion or flooding risks. Sample photographs of the QC shoreline from the compiled photo database are provided in Figure 3.2 to Figure 3.5.

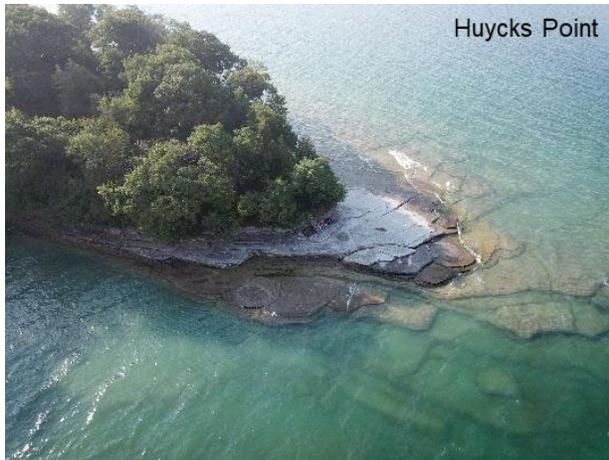
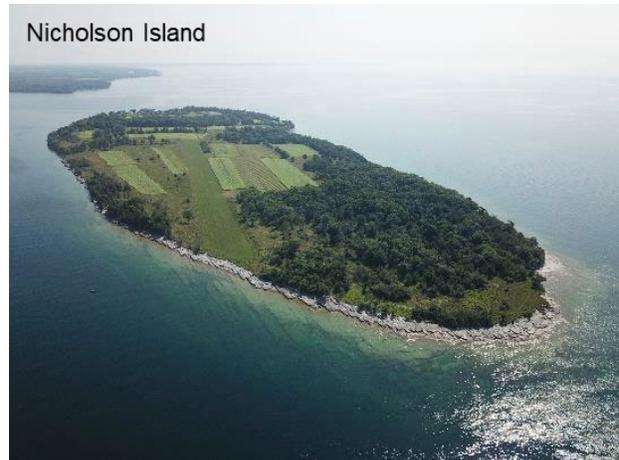
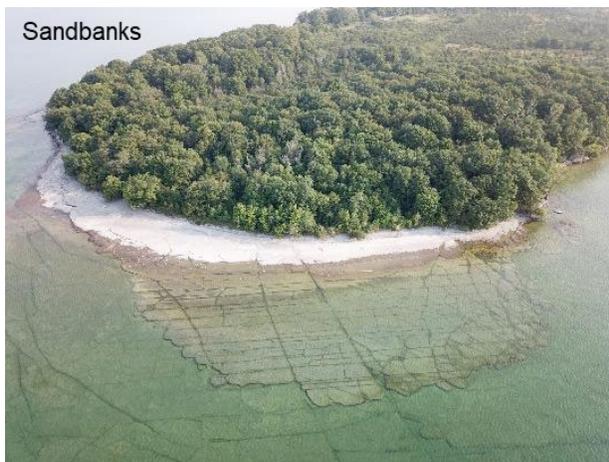
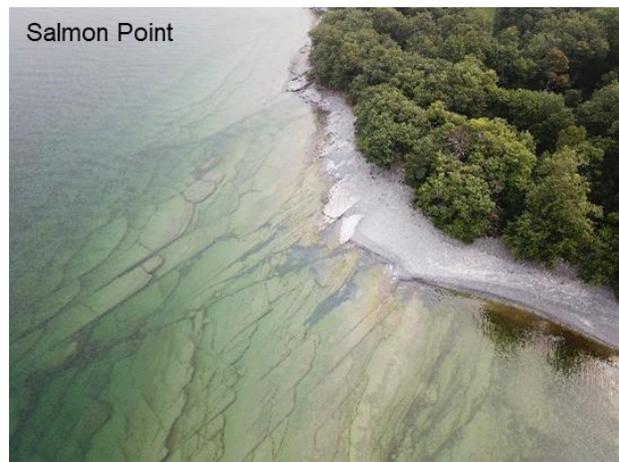
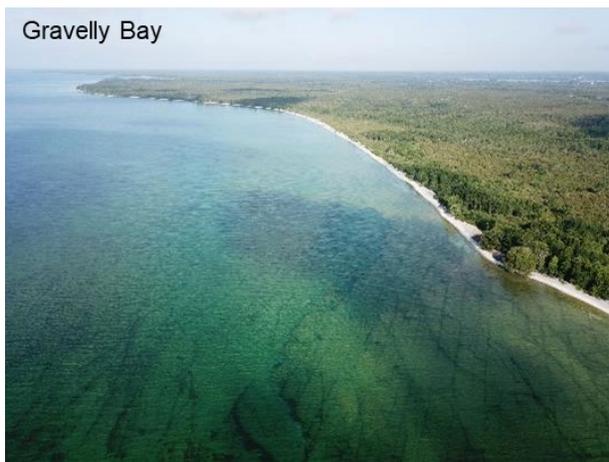
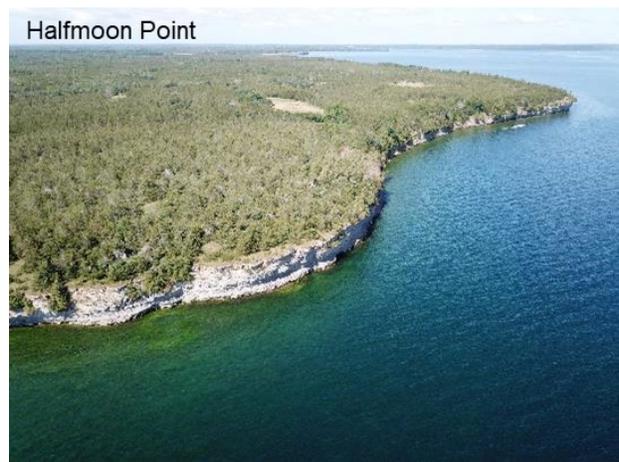
Figure 3.3 Examples of bedrock shorelines from the aerial oblique photo database (photographed Aug/Sep 2021)

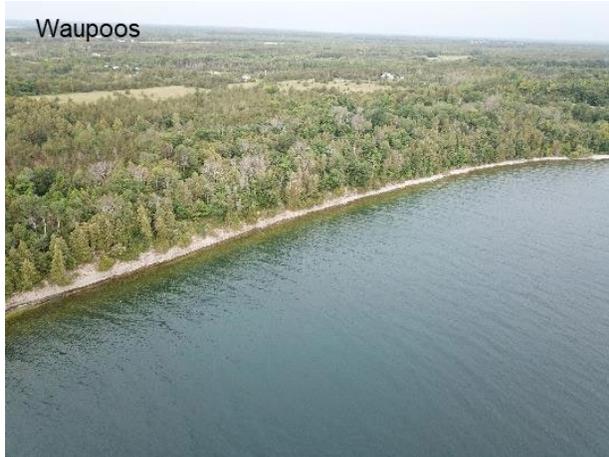
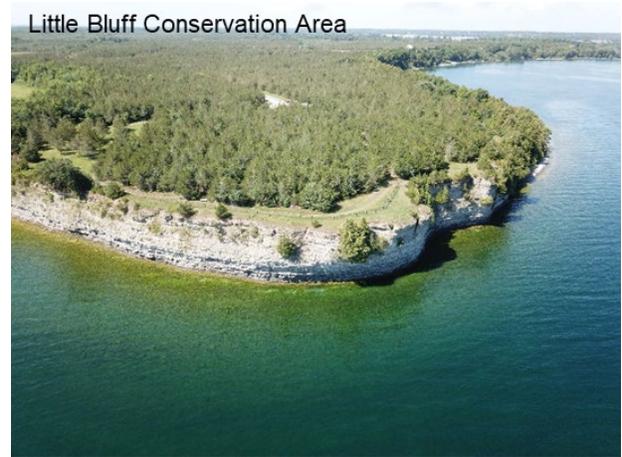
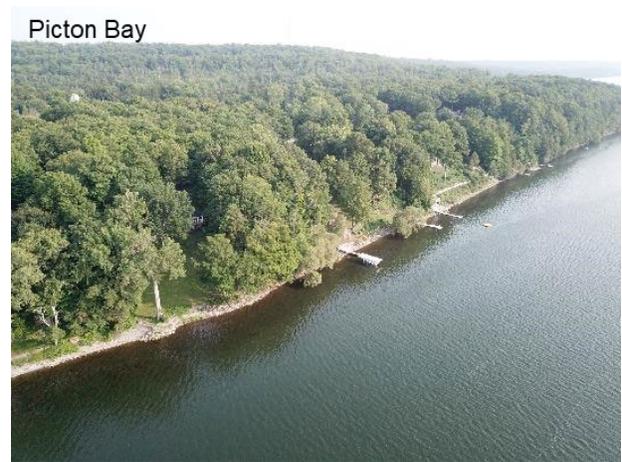
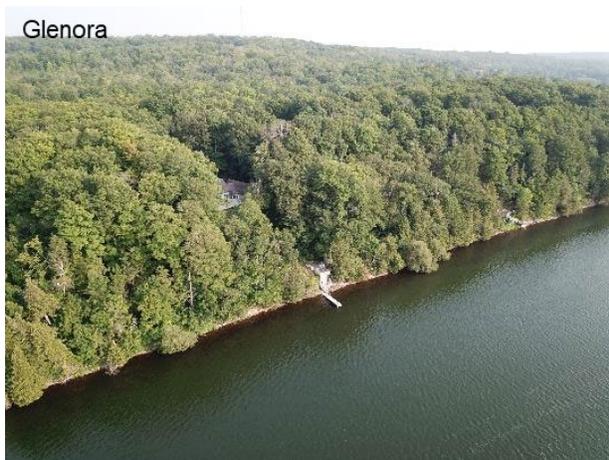
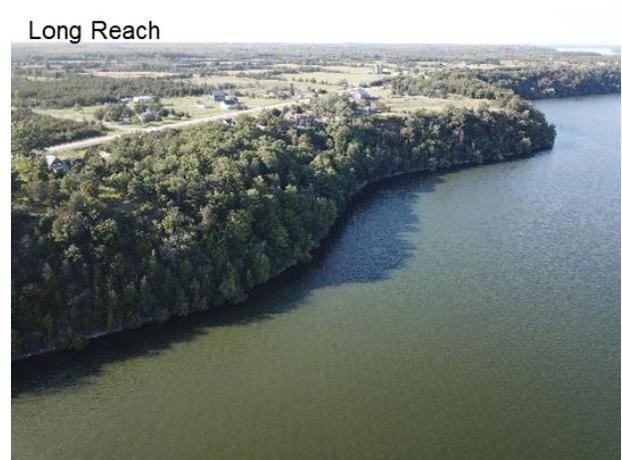
Figure 3.4 Examples of steep bank and cliff shorelines from the aerial oblique photo database (photographed Aug/Sep 2021)

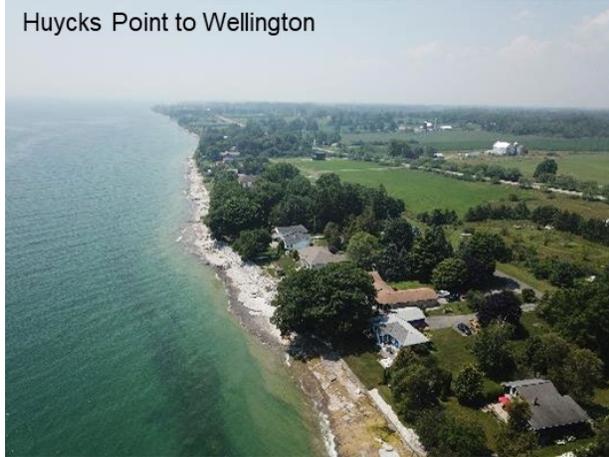
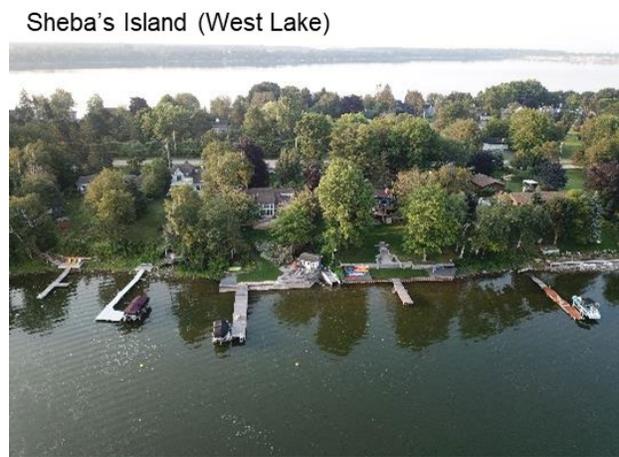
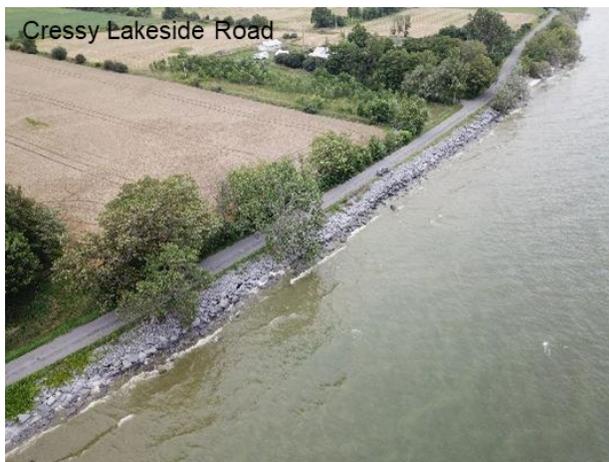
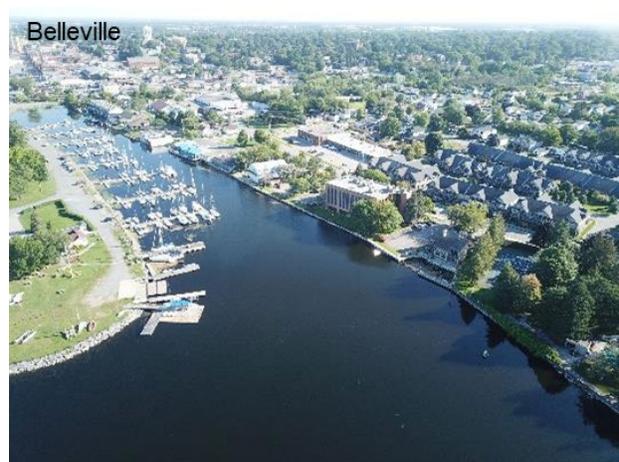
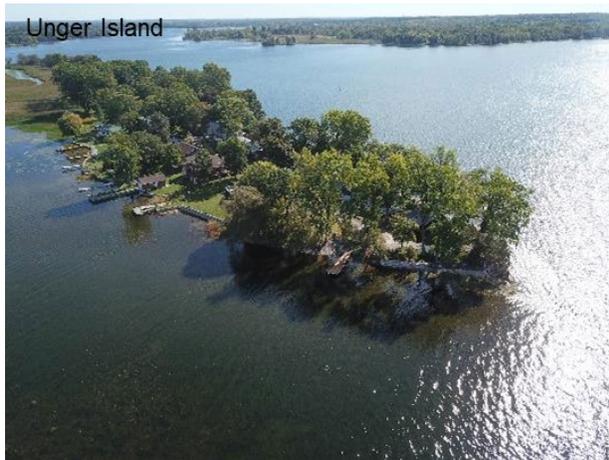
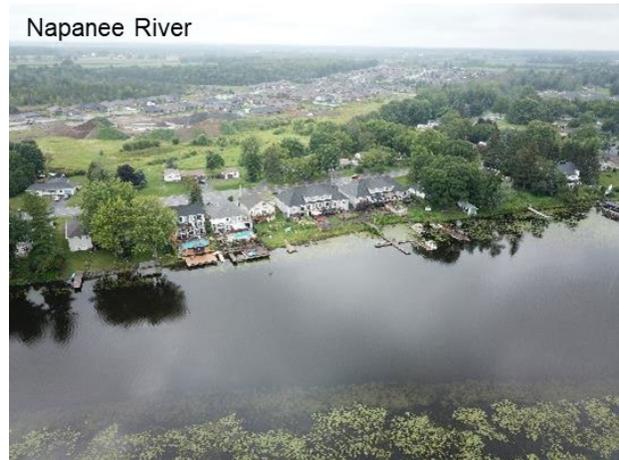
Figure 3.5 Examples of developed shorelines from the aerial oblique photo database (photographed Aug/Sep 2021)

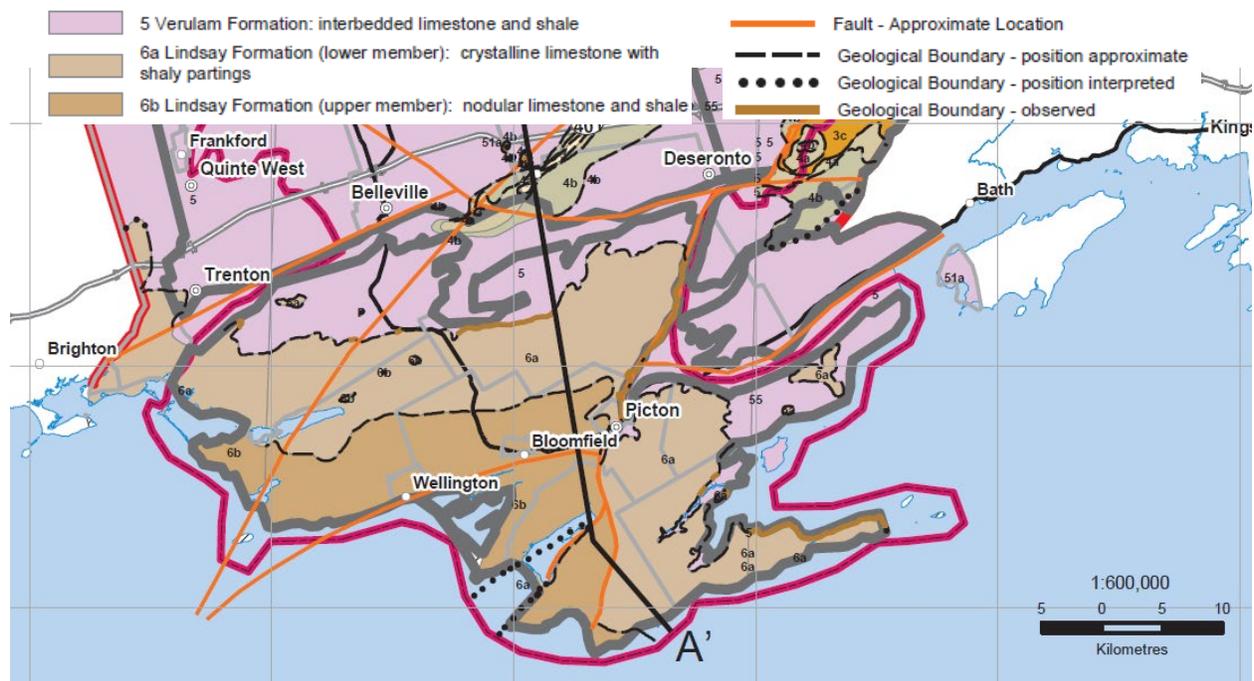
Figure 3.6 Bedrock geology of study area (source: Dillon)

Prince Edward County is a large bedrock peninsula that consists of three limestone units, including the Verulam Formation, lower Lindsay Formation, and the upper Lindsay Formation (see Figure 3.6 and Figure 3.7). While harder and more erosion resistant than glacial till or glacial outwash deposits found to the west, the interbedded limestone and shale does erode through a variety of physical and chemical weathering processes, such as wave attack at the bank toe, freeze-thaw cycles, and desiccation (wetting and drying).

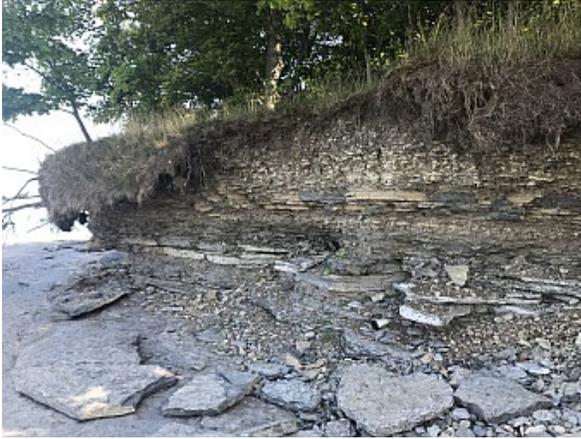
Eroding limestone bank

Figure 3.7 Eroding limestone bank and shelf in study area

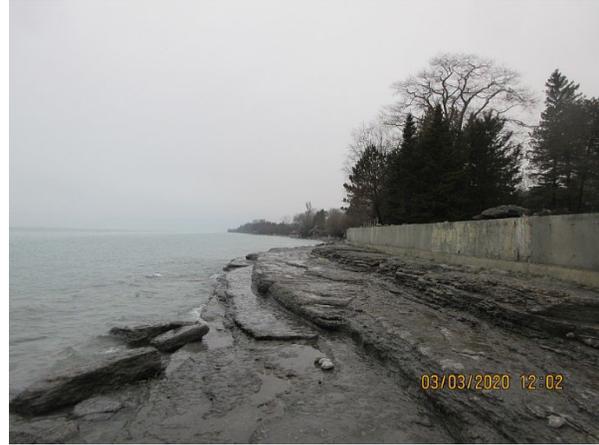
Limestone shelf at base of seawall

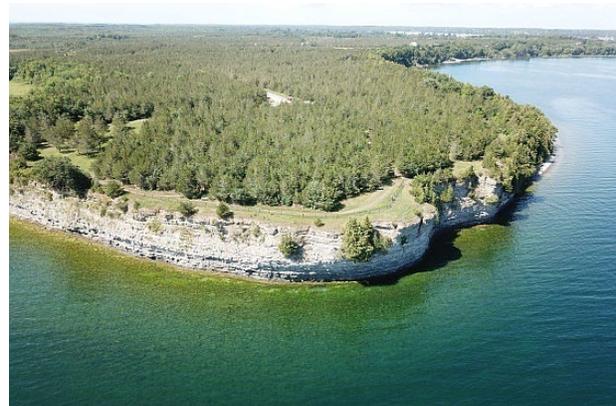
Figure 3.8 Conceptual diagram of a headland-embayment system (left) and headland at Little Bluff Conservation Area (right)

The study area shoreline, including the lake and bay, is characterized by prominent bedrock headlands and sheltered embayments, as seen in the conceptual diagram in Figure 3.8 (left). The bedrock headland associated with Little Bluff Conservation Area and beach is also presented in Figure 3.8 (right). The embayments typically feature beaches, barrier beaches, and/or expansive coastal wetlands.

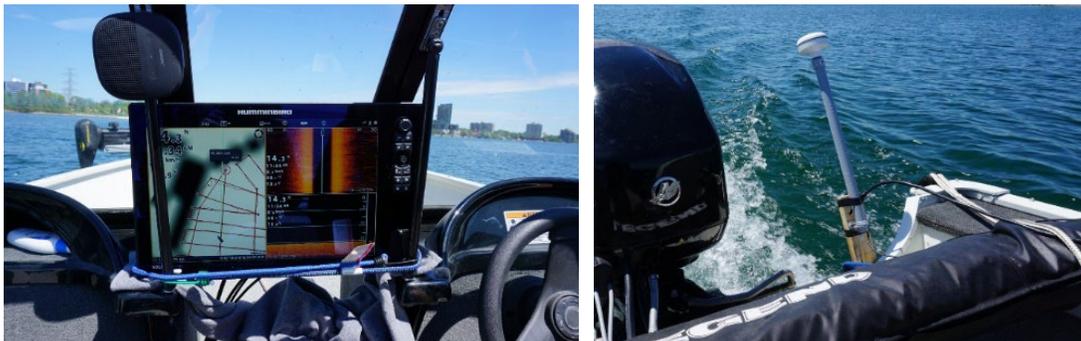
Figure 3.15 SOLIX data collection unit and transducer mount

Staff from Zuzek Inc. conducted a nearshore bathymetry survey from August 3-5, 2021. The raw data was collected with a SOLIX unit, a single-beam bathymetric and sonar system with built-in navigation and recording tools. The transducer was mounted at the back of the boat with a dedicated GPS antenna located directly above the unit. Refer to Figure 3.15. The unit auto-corrects for the depth of the transducer below the lake surface and the depths were recorded every second.

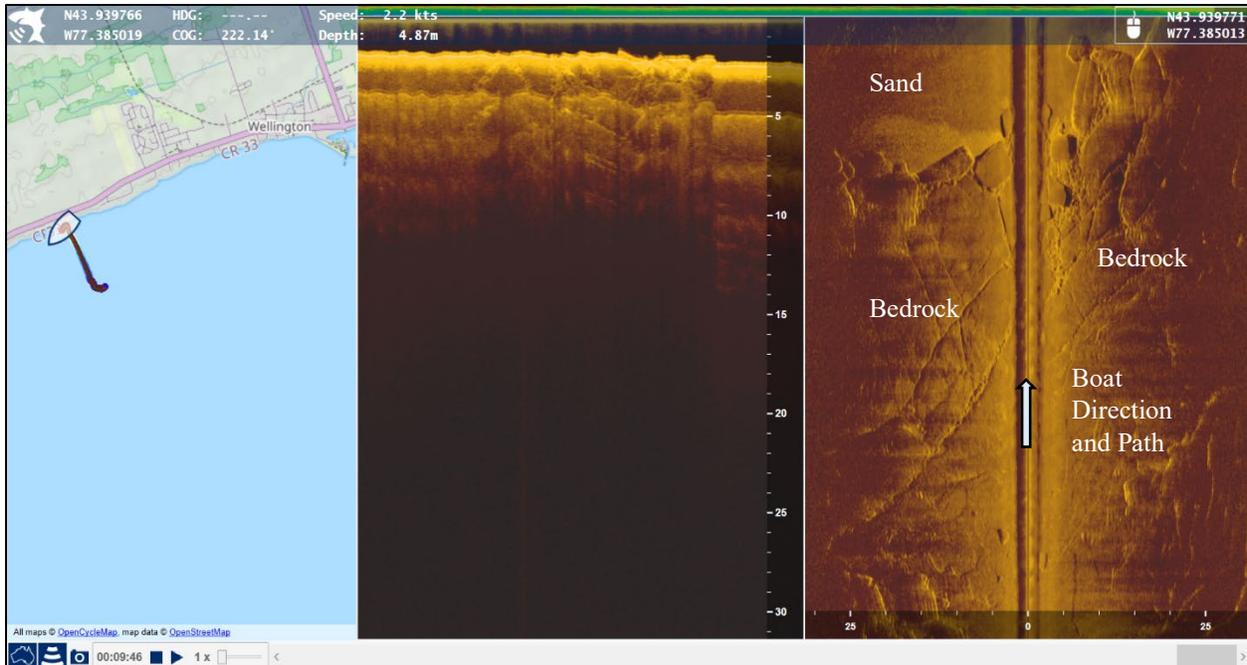
Figure 3.17 Sonar imaging of lake bottom near Wellington

The SOLIX also collects 2D sonar imaging in cross-section and bottom image formats. The sonar imaging provides continuous data to help characterize the lake bottom substrate. Refer to the sample output in Figure 3.17. In the downward imaging (right), bedrock is clearly visible transitioning to a sand bottom near the shoreline. The cross-section (middle) records a bedrock substrate and transition to sand. The boat location is noted in the left panel.

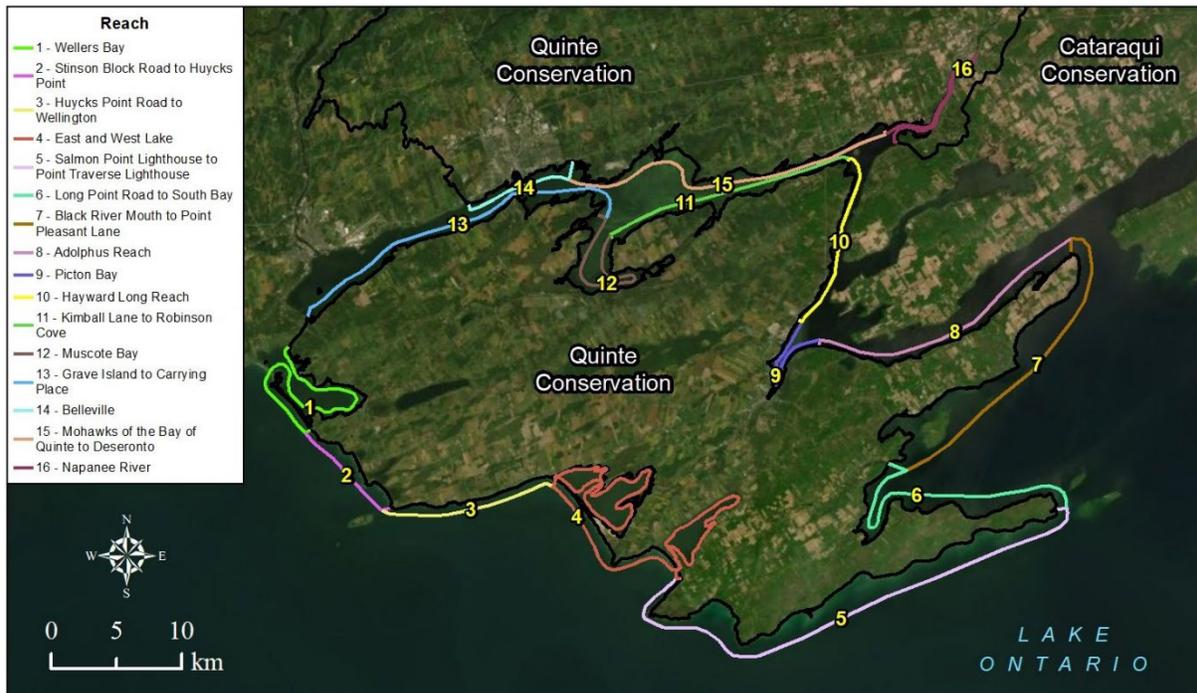
Figure 4.1 Reach boundaries for SMP

Sixteen shoreline reaches were defined for the Quinte Conservation shoreline following the field work in the Summer of 2021. See attached map in Figure 4.1. Boundaries were based on exposure to wave energy, shoreline and nearshore geology, shoreline morphology, physical processes such as erosion and sediment transport, development density, and sensitive ecological habitat.

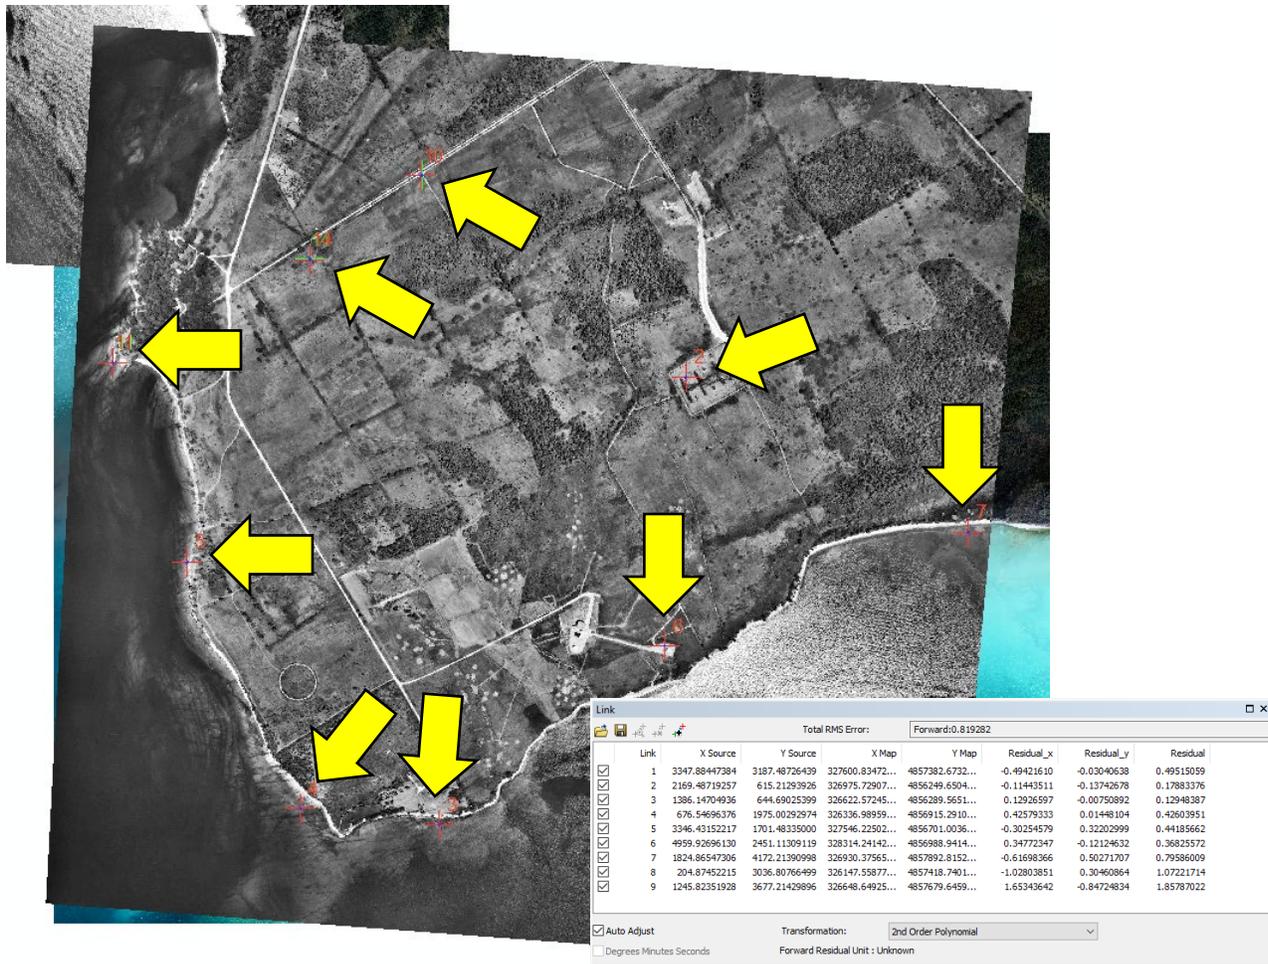
Figure 4.4 Ground control selection during photo registration

An example of a historical aerial photo during the registration process is illustrated in Figure 4.4. The yellow arrows point to the ground control used, which are the red Xs. Ground control represents features that are visible in both the historic aerial and the base imagery. To minimize horizontal positional errors in georeferenced imagery, ground control points were well distributed across the aerial, an appropriate transformation method was applied, and routine visual checks against base imagery were completed.

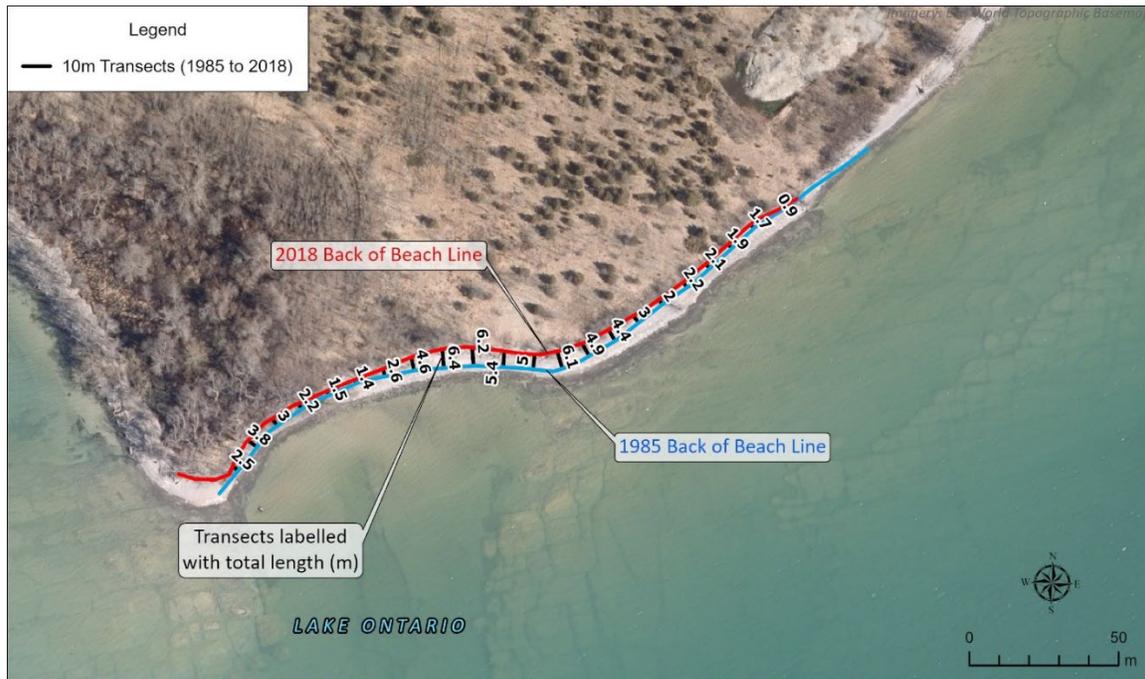
Figure 4.5 Transects between the 1985 and 2018 back of beach line

the transects (i.e., the variance), the standard deviation of the erosion transect AARRs was also calculated. The long-term recession rate for an area was based on the sum of the AARR and one annualized standard deviation. An example of erosion transects for a location of eroding bank in Reach 2 is presented in Figure 4.5. Here, the 22 transects featured an AARR of 0.10 m/yr and an annualized standard deviation of 0.05 m/yr. The long-term recession rates for mapping the erosion hazard was therefore 0.15 m/yr.

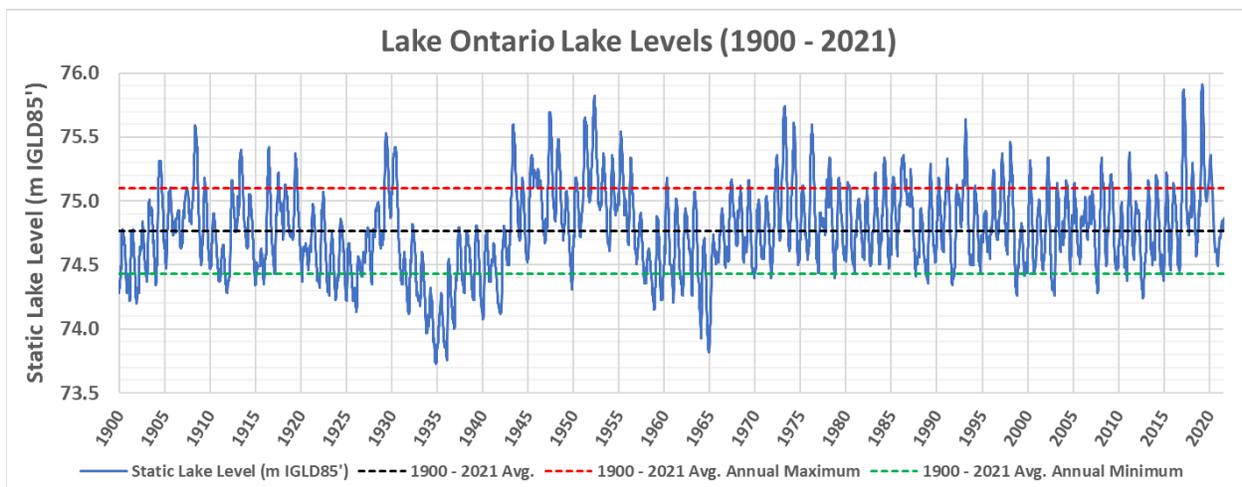
Figure 4.7 Monthly mean lake levels for Lake Ontario from 1900 – 2021, inclusive

Historically, 100-year flood levels for most Great Lakes shorelines were based on work completed by the Ministry of Natural Resources (now the Ministry of Northern Development, Mines, Natural Resources and Forestry – NDMNRF) in the 1980’s and published in a report titled “Great Lakes System Flood Levels and Water Related Hazards” (MNR, 1989). Since the MNR publication, more than 30 years of high-resolution water level data has been logged at numerous water level gauges around the Great Lakes. Measured monthly mean lake levels from a coordinated network of water level gauges around Lake Ontario are now available covering a period of more than 120 years. Figure 4.7 below presents monthly mean lake levels for Lake Ontario from 1900 to 2021, inclusive.

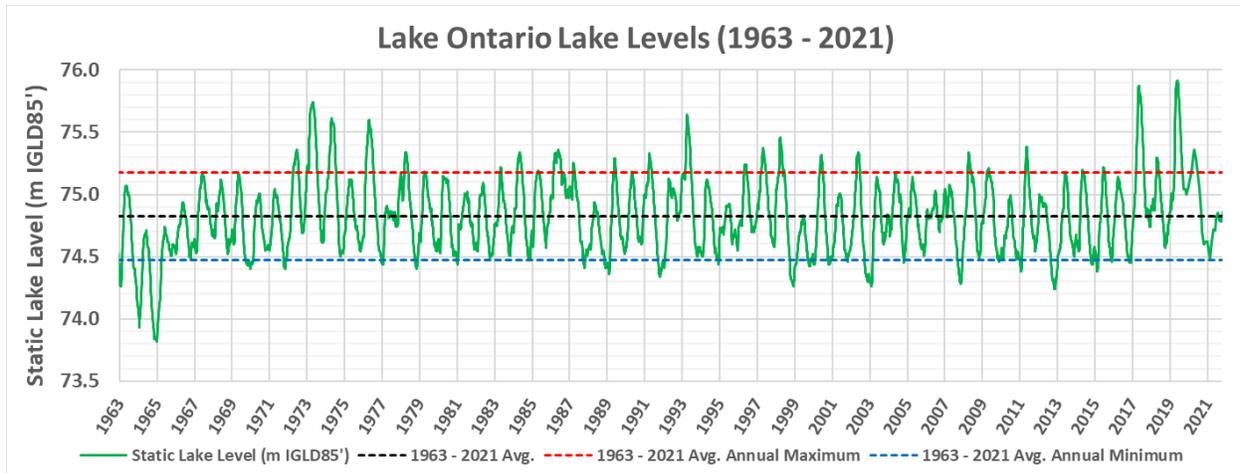
Figure 4.8 Monthly mean lake levels for Lake Ontario since the construction of the St. Lawrence Seaway and implementation of water level regulation policies, from 1963 – 2021, inclusive

Between 2000 and 2014 the IJC examined alternative regulation plans to better balance the various upstream and downstream interests and to update water level regulation practices in light of decades of shoreline development and fluctuations in water supply. Recognizing that Plan 1958-D had not considered the impacts of water levels on ecosystem health, the new plan, termed Plan 2014, considered impacts on coastal wetland environments and the protection of natural processes within the shoreline environment. Plan 2014 included guidance on releases at the dam that would occasionally allow for slightly higher highs during periods of high water supply, and lower lows during periods of drought. The new water level regulation plan was implemented in 2017. Inflow to Lake Ontario has historically been unregulated and remains so under the new plan, with no control structures in place between Lake Erie and Lake Ontario. Figure 4.8 shows monthly mean lake levels for Lake Ontario during the period of water level regulation only (post-1963), from which it can be seen that water level regulation has generally been effective in limiting lake levels to a narrower range than was observed historically (compared to Figure 4.7).

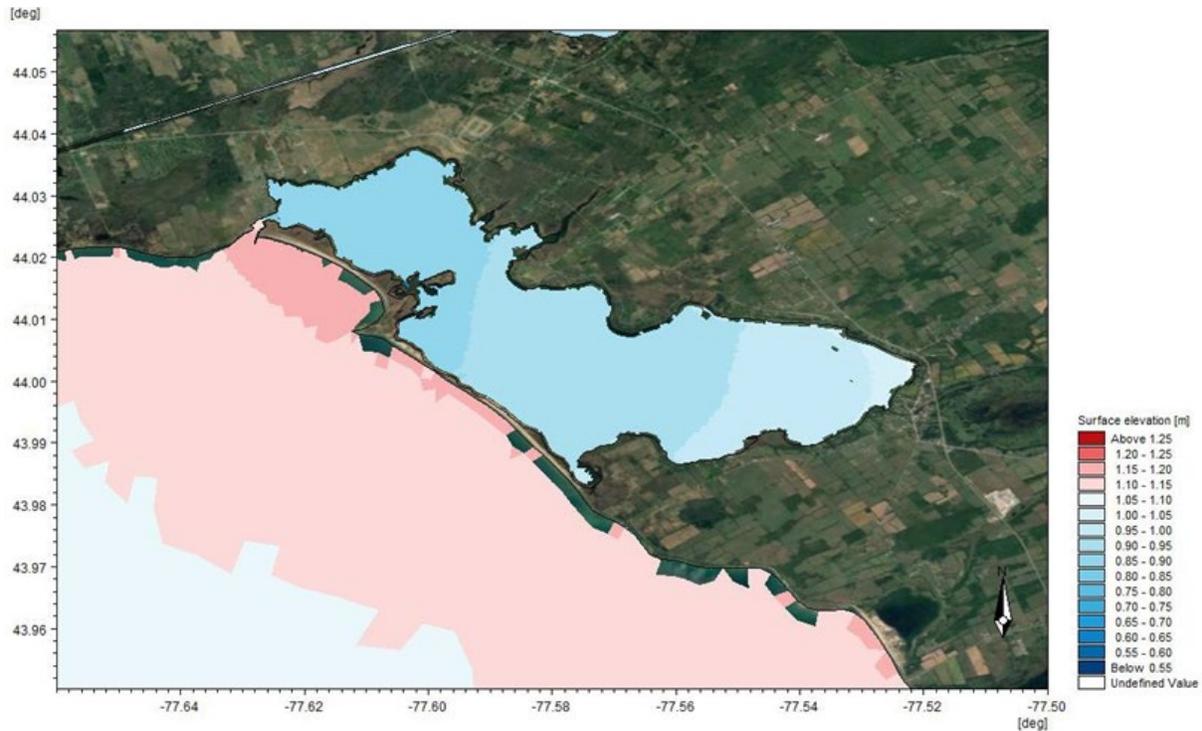
Figure 4.16 Simulated storm surge gradient within Wellers Bay during the April 6, 1979, storm event (in metres above Chart Datum)

The channel between Wellers Bay and Lake Ontario was resolved at a high resolution in the surge model (< 5.0 m). For this simplified investigation, the barrier beach between the Wellers Bay and Lake Ontario was assumed to be closed, with no exchange of water possible over the low-lying beach. The model results shown in Figure 4.16 indicate that only some storm surge penetration through the channel mouth would occur during the simulated events, resulting in a surge gradient from west to east within the embayment of no more than 20 cm. Local surge along the outer shoreline (i.e. lakeside) of the barrier beach is about 25 cm higher than the water level inside Wellers Bay during the April 6, 1979, storm. The elevation of the barrier beach should be taken into consideration in the event of future higher lake levels to determine whether the barrier beach would be overtopped and breached by a large surge event.

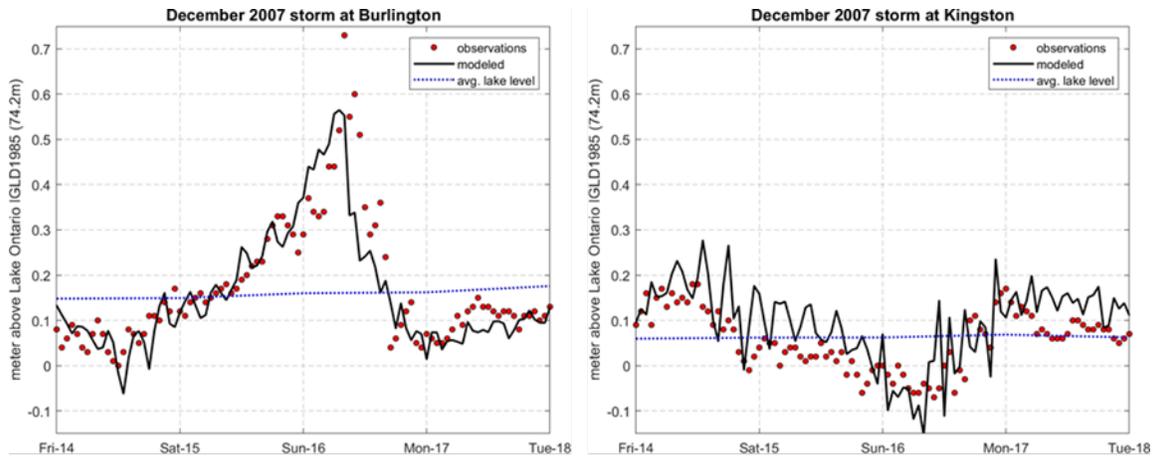
Figure 4.17 Model validation at Burlington (left) and Kingston (right) during the December 16, 2007, storm surge event (in metres above Chart Datum).

The model was used to simulate the December 16, 2007 event to investigate storm surge potential in the western extent of the Bay of Quinte during strong easterly winds. The storm surge event was validated at the Burlington water level gauge, and also compared to water levels observed at Kingston and Cobourg. A comparison of modelled and measured water levels during the surge event is provided in Figure 4.17 at Burlington (left) and Kingston (right). The observed discrepancy in the event peak at the Burlington gauge is likely due to the very short duration of the event itself, which is difficult to capture in the model. Importantly, the model is able to capture the water level draw-down at Kingston, attributed to a lake-wide seiching effect, where lake water accumulates at the western extent of the lake due to the surge effect, reducing water levels along the eastern extent of the lake. The ability of the model to capture lake-wide seiching and variable water levels at locations throughout Lake Ontario during the December 16, 2007, storm event validates the model's ability to replicate lake wide storm surge conditions.

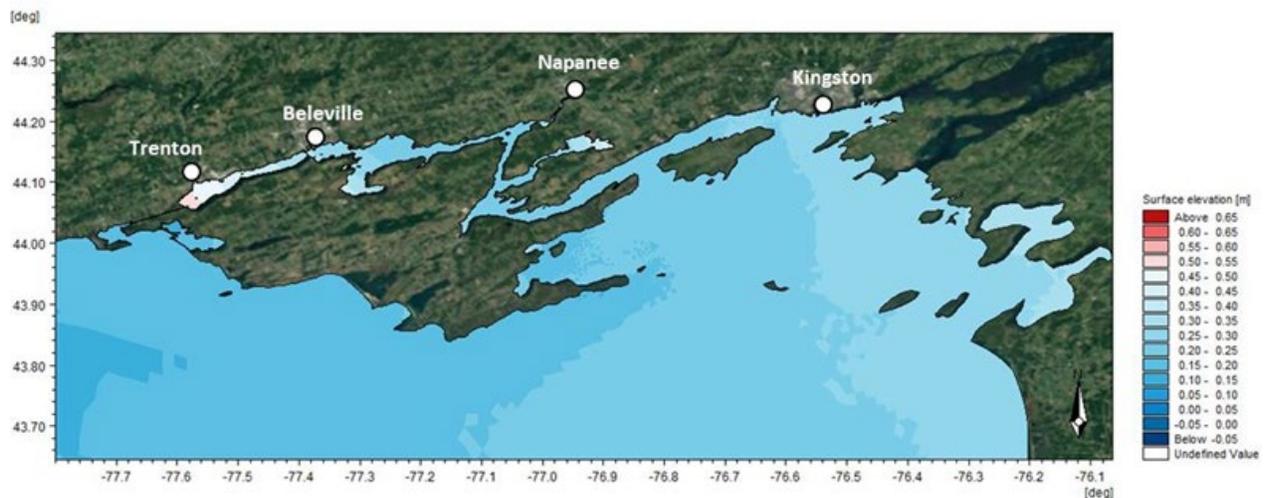
Figure 4.18 Maximum modelled storm surge within the project region during the December 16, 2007, storm surge event (in metres above Chart Datum)

The maximum water levels simulated within the Bay of Quinte during the December 2007 storm event are illustrated in Figure 4.18 below. The model results confirm that a surge gradient from east to west occurs within the Bay of Quinte during significant surge events on Lake Ontario associated with westerly winds, resulting in elevated water levels at the west end of the Bay (near Carrying Place and Trenton).

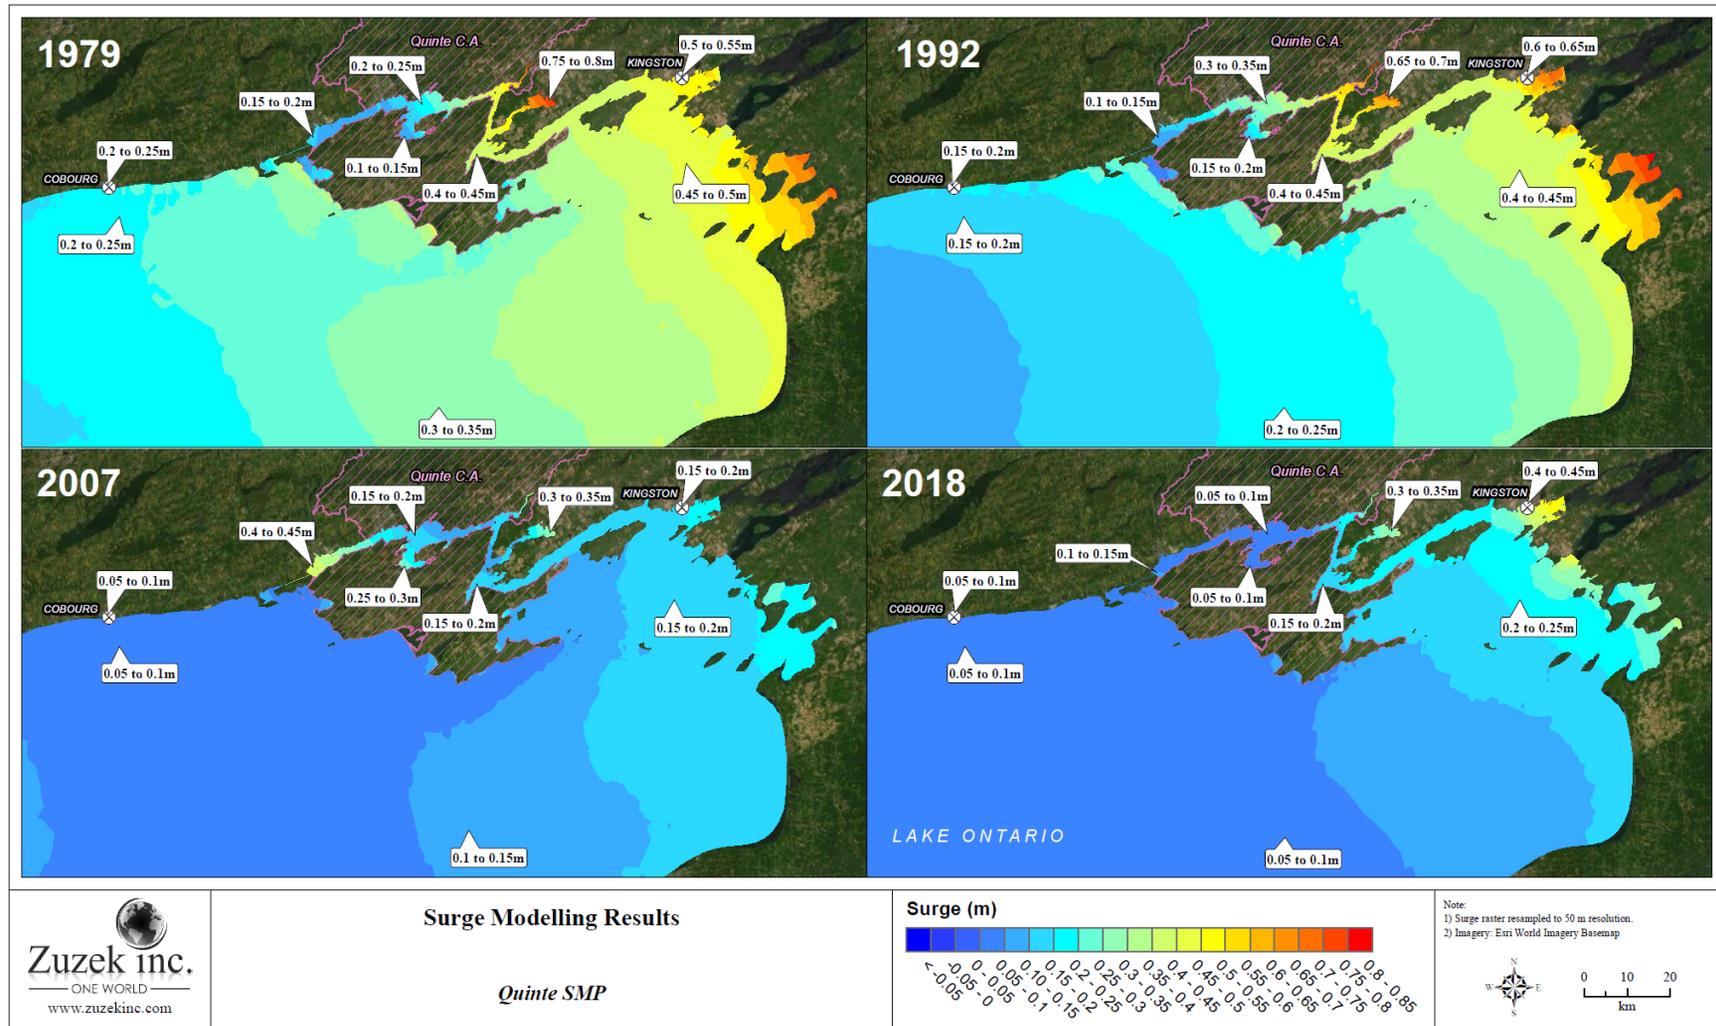
Figure 4.19 Maximum surge magnitude (in metres) experienced throughout the model domain during the four (4) simulated surge events

Modelled maximum storm surge levels throughout the entire project region and for all four (4) simulated storm events are summarized graphically in Figure 4.19 below. All model results were found to be within 10 cm of measured water levels at Cobourg and Kingston throughout the surge events. The contours (surge magnitudes) shown in Figure 4.19 are the maximum water level recorded at each model node over a 24-hour period surrounding the peak of the storm. The maps provided in Figure 4.19 therefore depict the primary storm surge gradient associated with the event peak, as well as secondary and tertiary surge gradients associated with rapidly shifting wind directions that can occur during extreme surge events.
