Quinte Conservation Shoreline Management Plan

Quinte Conservation

June 21, 2022

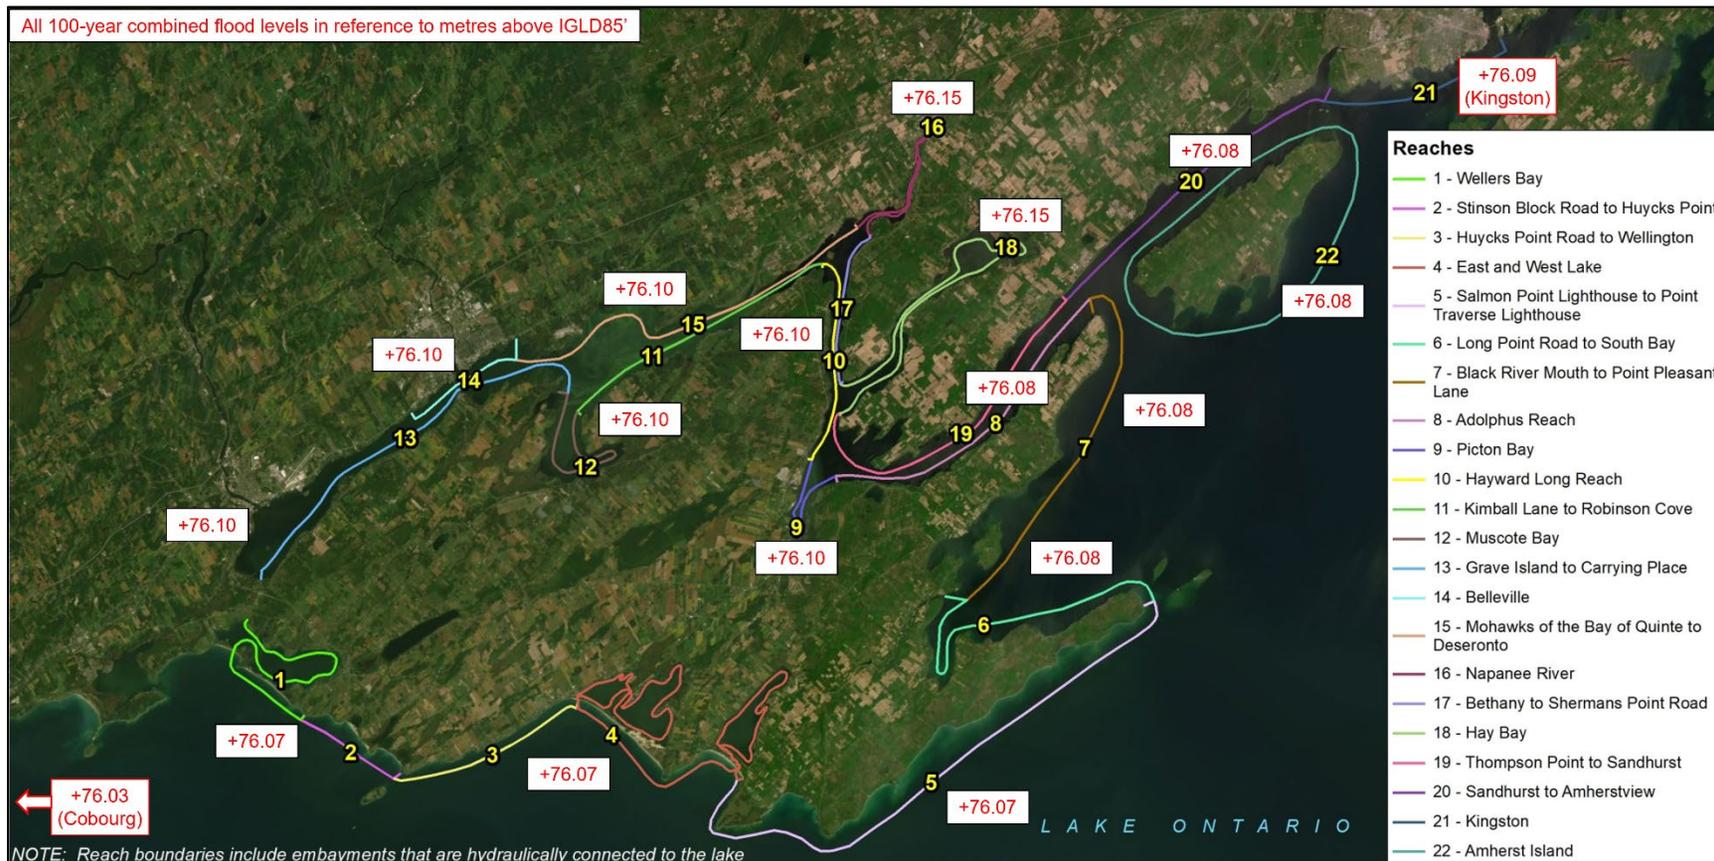
Figure 4.21 100-year flood levels for entire project geography based on updated joint probability analyses of measured static lake levels (1900 – 2021) and storm surge (1962 – 2021) at Cobourg and Kingston, scaled to other locations using DHI’s high-resolution storm surge model

The same methodology was followed to estimate the 100-year flood level at the west and east ends of the Bay of Quinte, where surges on the order of 45 cm and 80 cm were determined to be possible during significant easterly and westerly wind events, respectively (refer to Figure 4.19). At the east end of the Bay of Quinte for example (i.e. Napanee), surges of 75 cm to 80 cm were shown to be possible during surge events that produced surges of 60 cm to 65 cm at Kingston. The Kingston surge dataset was scaled accordingly, and the joint probability analysis repeated for the east end of the Bay of Quinte using the scaled surge data. The resulting 100-year flood level at Napanee and within Hay Bay (near Galt's Corner) was estimated at +76.15 m IGLD85'. A map illustrating recommended 100-year flood levels for the entire project geography within both Quinte Conservation and the Cataraqui Region Conservation Authority's jurisdictions is provided as Figure 4.21 below.

Once calibrated, each of the six (6) models was run for the 25-year and 100-year storm events, with the water level set at the 100-year flood level for the shoreline (+76.07 for Models A, B, and C, +76.08 for Models D and E, and +76.09 for Model F – refer to Figure 4.21). Wind-wave generation was included in the model, with the input wind speed and direction being commensurate with the average recurrence interval and direction of the wave event. 25-year and 100-year wind speeds were analysed for a variety of directional bins from measured wind data at the Trenton Air Base, as discussed further in Section 4.4.3 below.

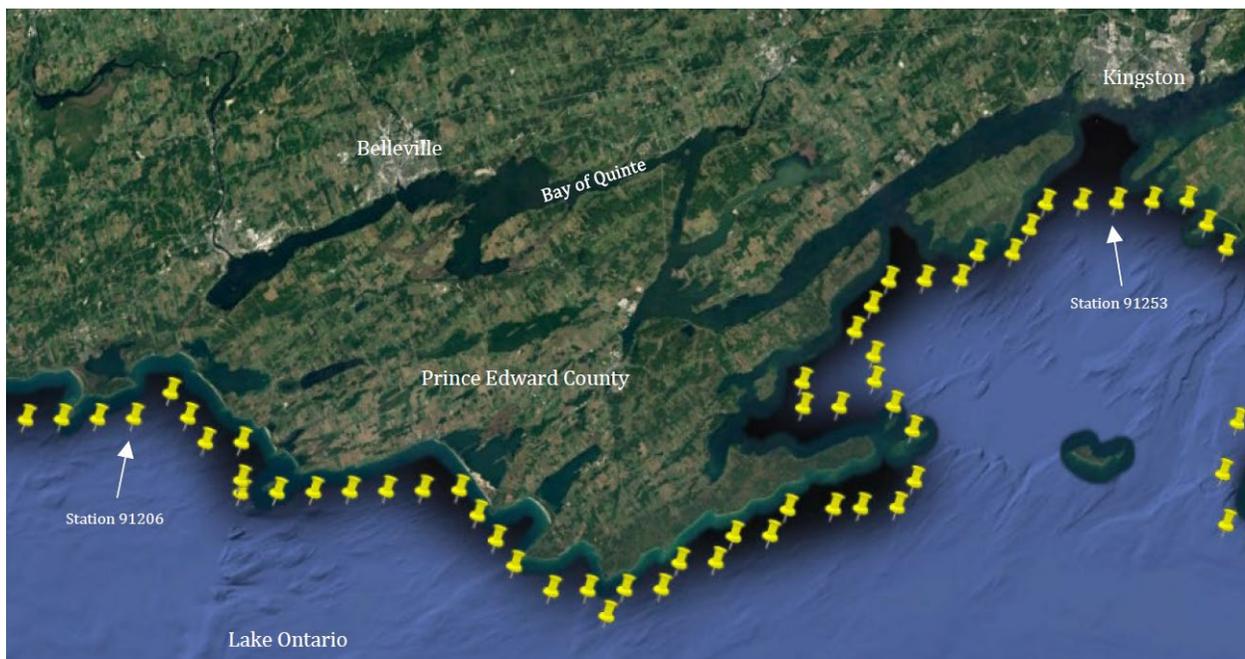
Figure 4.22 Wave output locations from the WIS study located within the project geography (USACE)

The WIS database includes wave data output at more than 50 locations offshore of the project shoreline, as illustrated in Figure 4.22. The output points are generally located a distance of 3 to 4 km offshore due to the limited spatial resolution of the hindcast model. Twelve (12) output points were selected for analysis, spaced out evenly around the project geography. Stations analysed for this study are listed in Table 4.10.

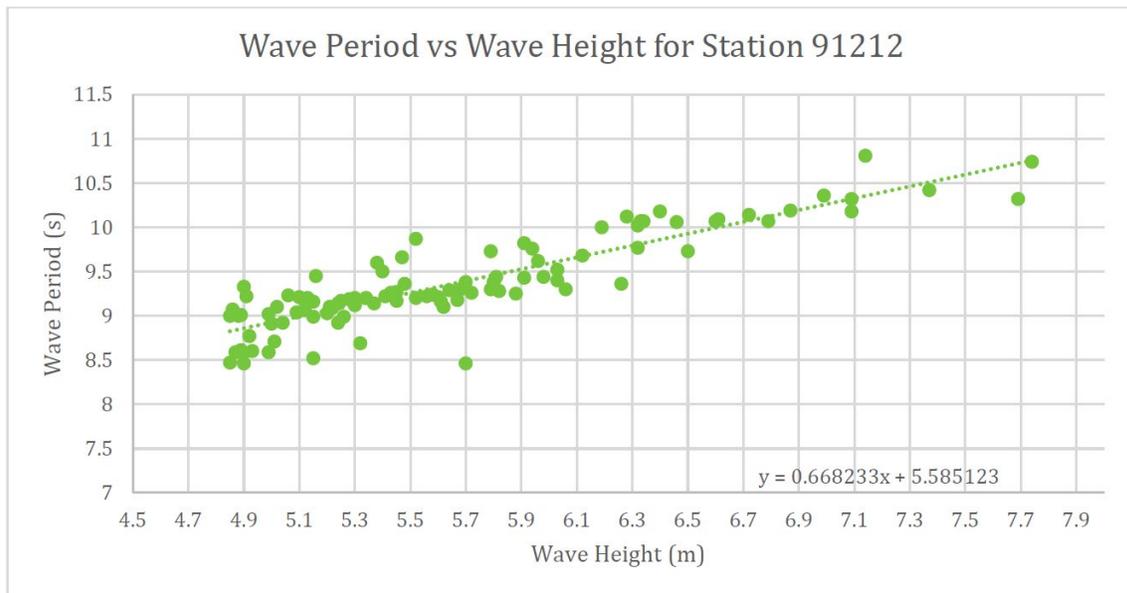
Figure 4.23 Relationship between significant wave height (Hs) and wave period (Tp) for top 100 storm events at WIS Station 91212

Plots of significant wave height versus wave period and wave direction were generated for all storm events within the storm lists to assess the maximum wave period and range in wave directions associated with each average recurrence interval event. Refer to Figure 4.23 which presents the relationship between wave height and wave period at Station 91212. Table 4.10 summarizes 25-year and 100-year wave conditions at each analysed WIS output location. The 25-year conditions were used in the determination of wave uprush which influences the regulatory flooding hazard. 100-year wave conditions are more commonly used in the design of coastal structures.

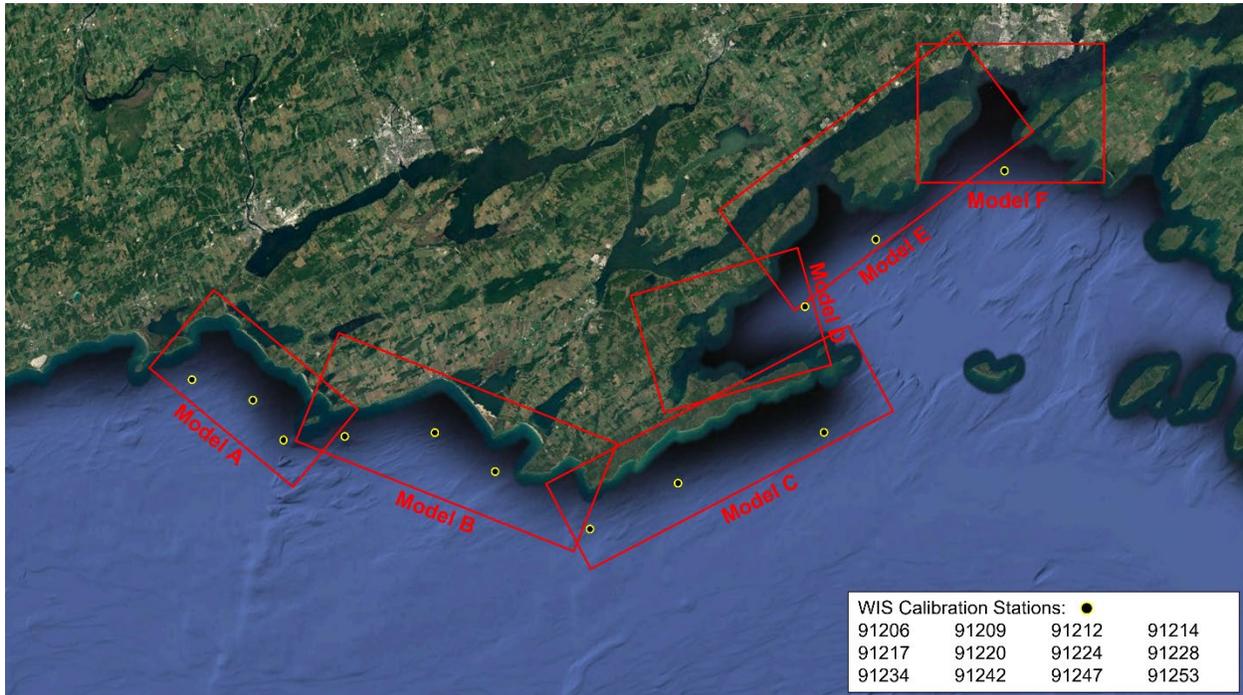
Figure 4.24 Location, size, and orientation of each of the six (6) numerical wave models used to transform 25-year and 100-year offshore waves to the project shoreline

wave conditions listed in Table 4.10. The general location, orientation, and size of the six CMS-Wave models is shown in Figure 4.24. Analyzed offshore wave locations (WIS output locations) are shown in the figure as yellow dots.

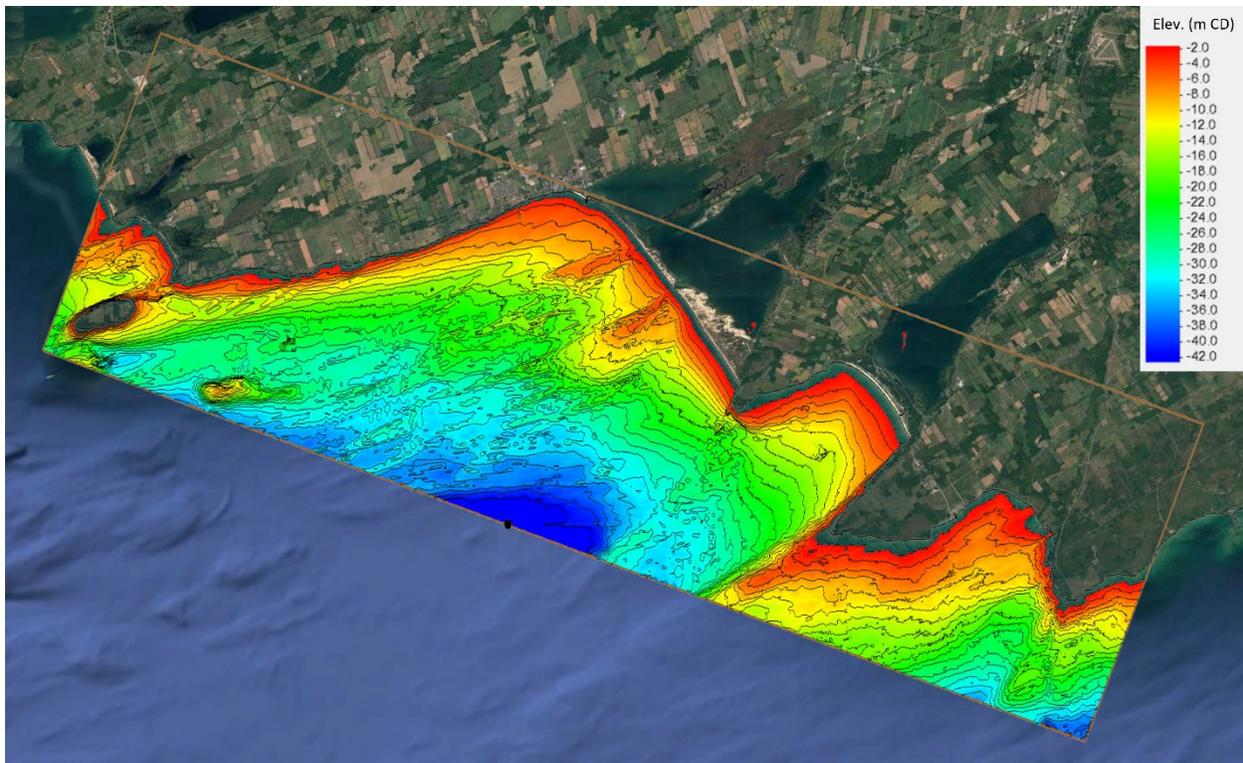
Figure 4.25 Nearshore wave model (CMS-Wave) domain and bathymetric contours for Model B, from Huyck's Point to Point Petre

Bathymetry used in the nearshore wave models was obtained from the CHS non-navigational (NONNA) bathymetric data portal and supplemented with single-beam bathymetric data collected by Zuzek Inc. in the fall of 2021 at areas of interest. This is the same bathymetric dataset that was used in the DHI storm surge modelling described in Section 4.3.5. Land boundaries used in the model were delineated manually from 2018 satellite imagery. The model domain and bathymetric contours for Model B are shown in Figure 4.25. Model B includes project Reaches 3, 4 and part of 5, including all Lake Ontario shoreline from Huyck’s Point to Point Petre.

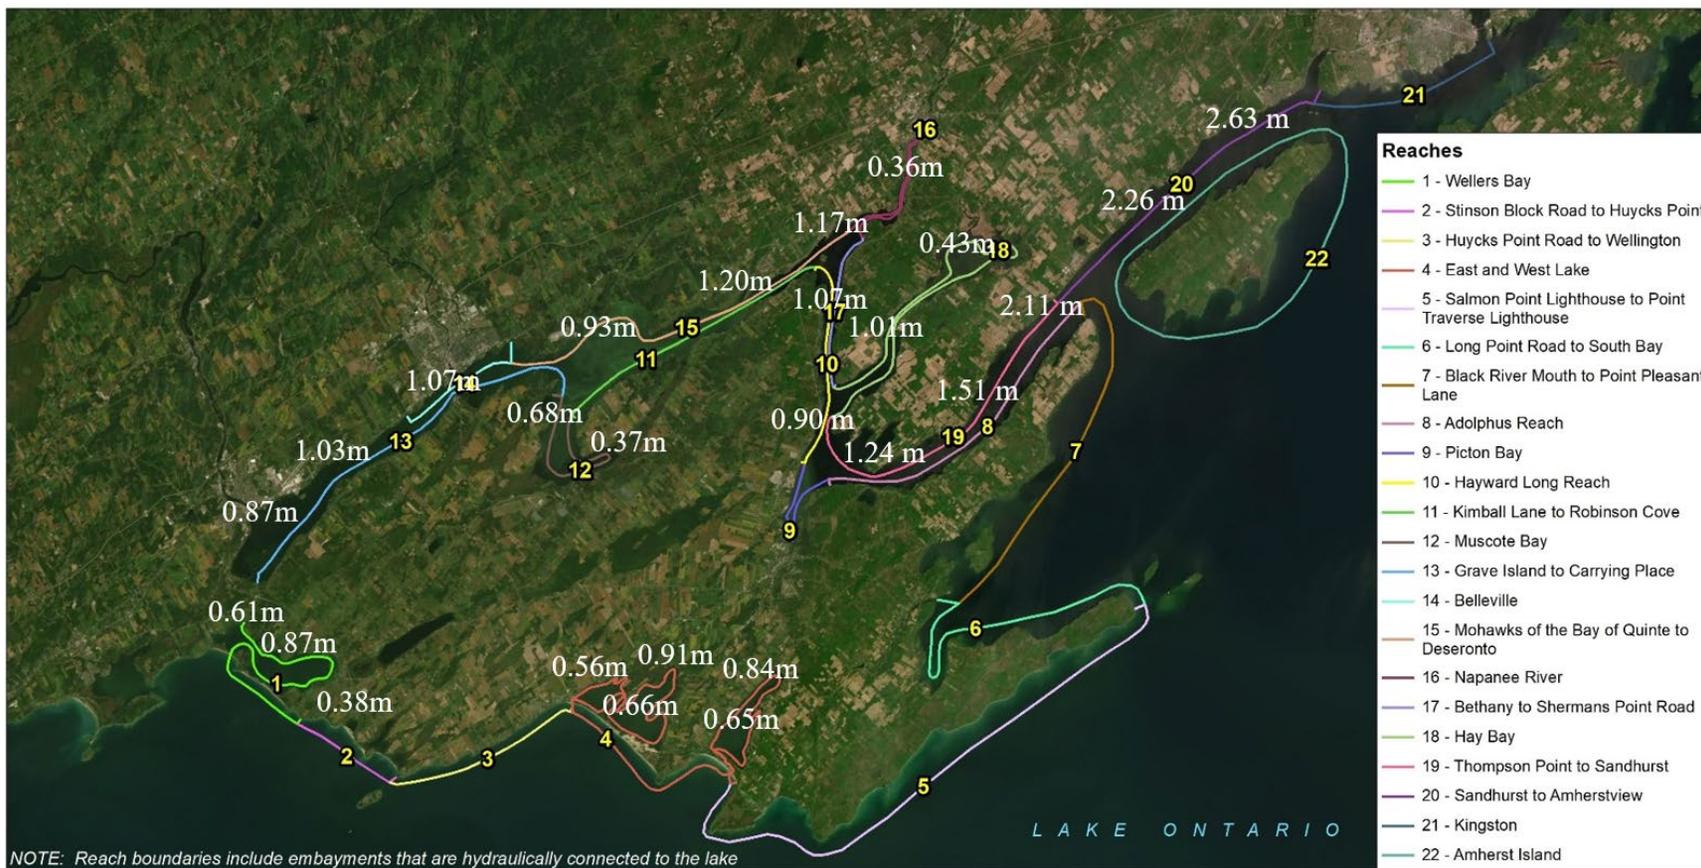
Figure 4.28 Estimated 25-year significant wave height (meters) throughout the Bay of Quinte and other sheltered embayments

It is noted that the analysis of wave growth potential presented herein is meant to be a conservative approach applied at a regional scale. For site specific wave conditions to be used in the assessment of lot-level shoreline hazards or the design of coastal infrastructure, a site-specific assessment of the design wave condition along the shoreline should be completed.

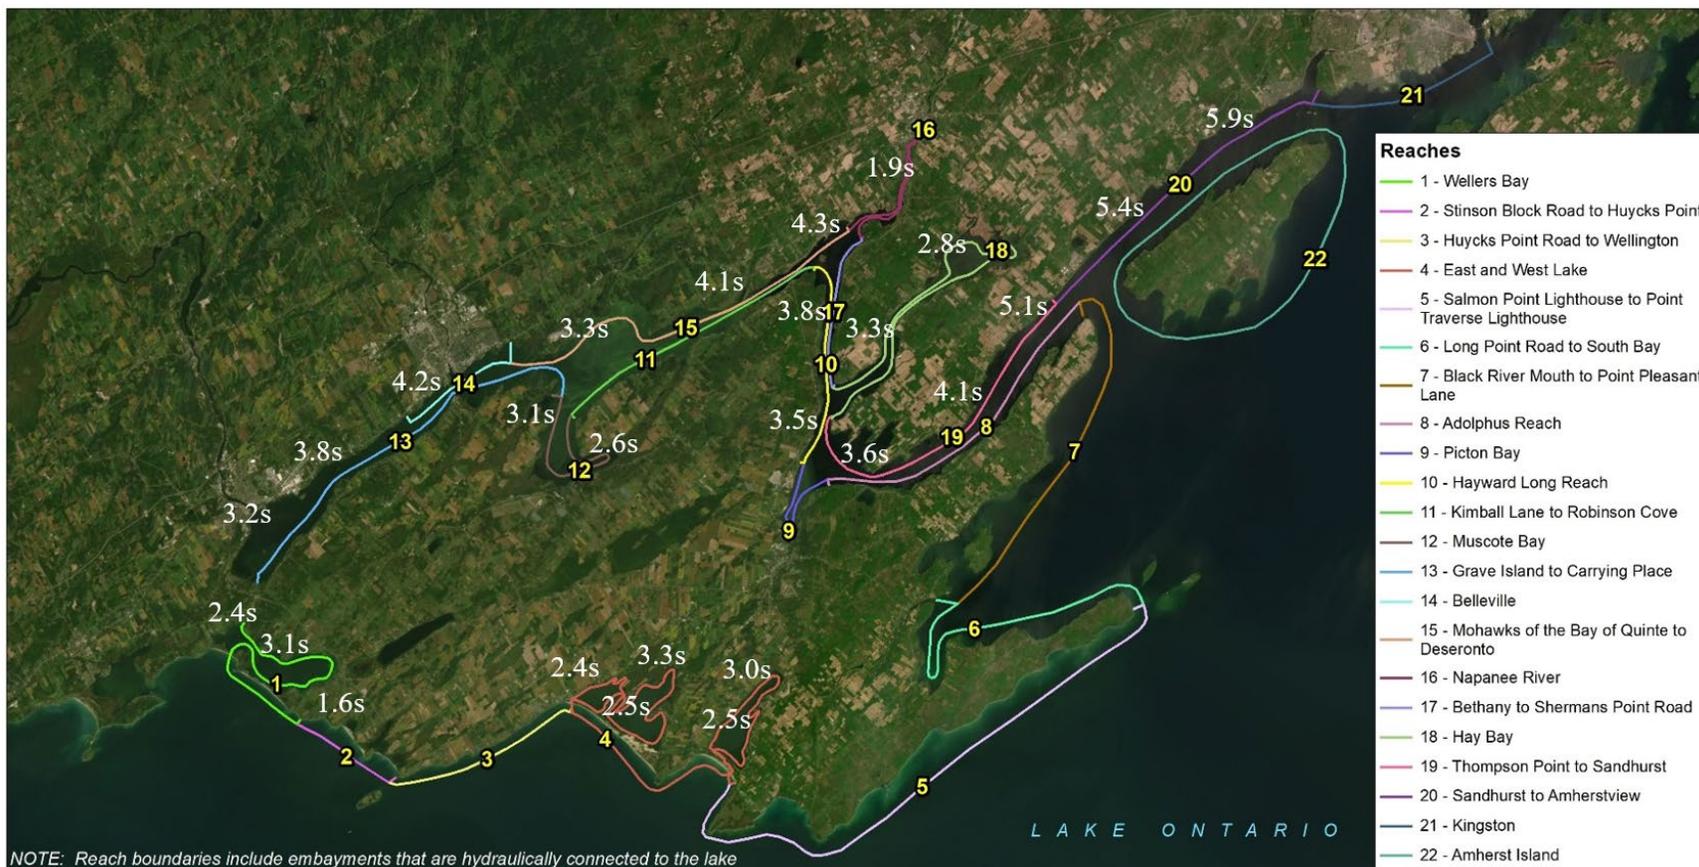
Figure 4.29 Estimated 25-year wave period (seconds) throughout the Bay of Quinte and other sheltered embayments

Governing significant wave heights and wave periods achieved within each analysed sub-reach during the 25-year wind event are summarized graphically as Figure 4.28 and Figure 4.29. The results were subsequently used in the estimation of wave uprush throughout the Bay of Quinte and other sheltered embayments, as discussed further in Section 4.4.4.

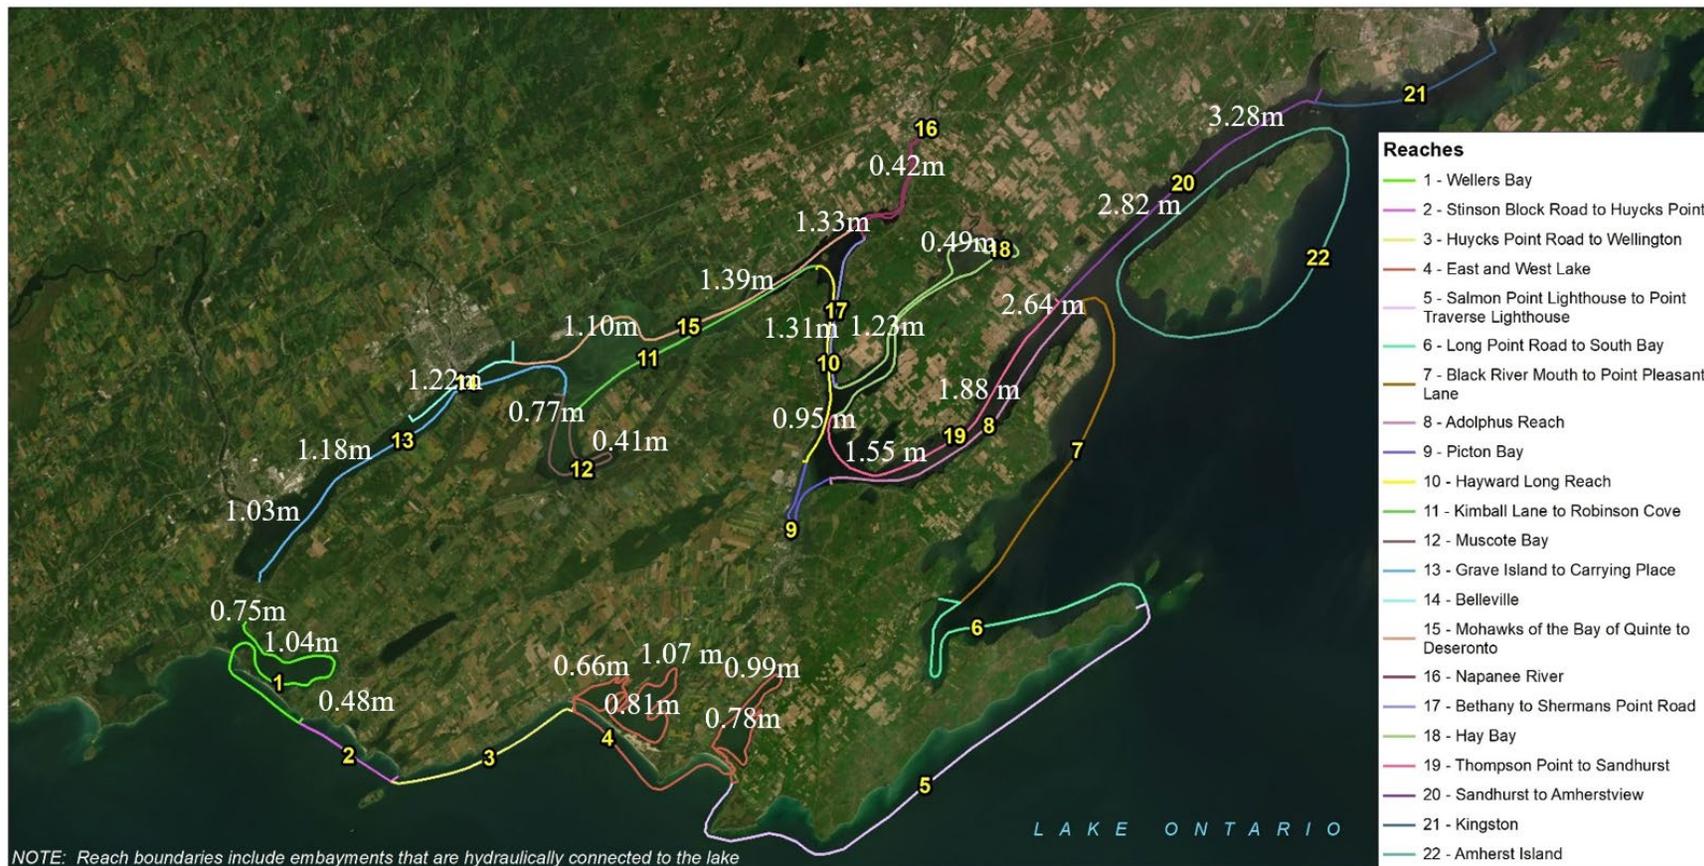
Figure 4.30 Estimated 100-year significant wave height (meters) throughout the Bay of Quinte and other sheltered embayments

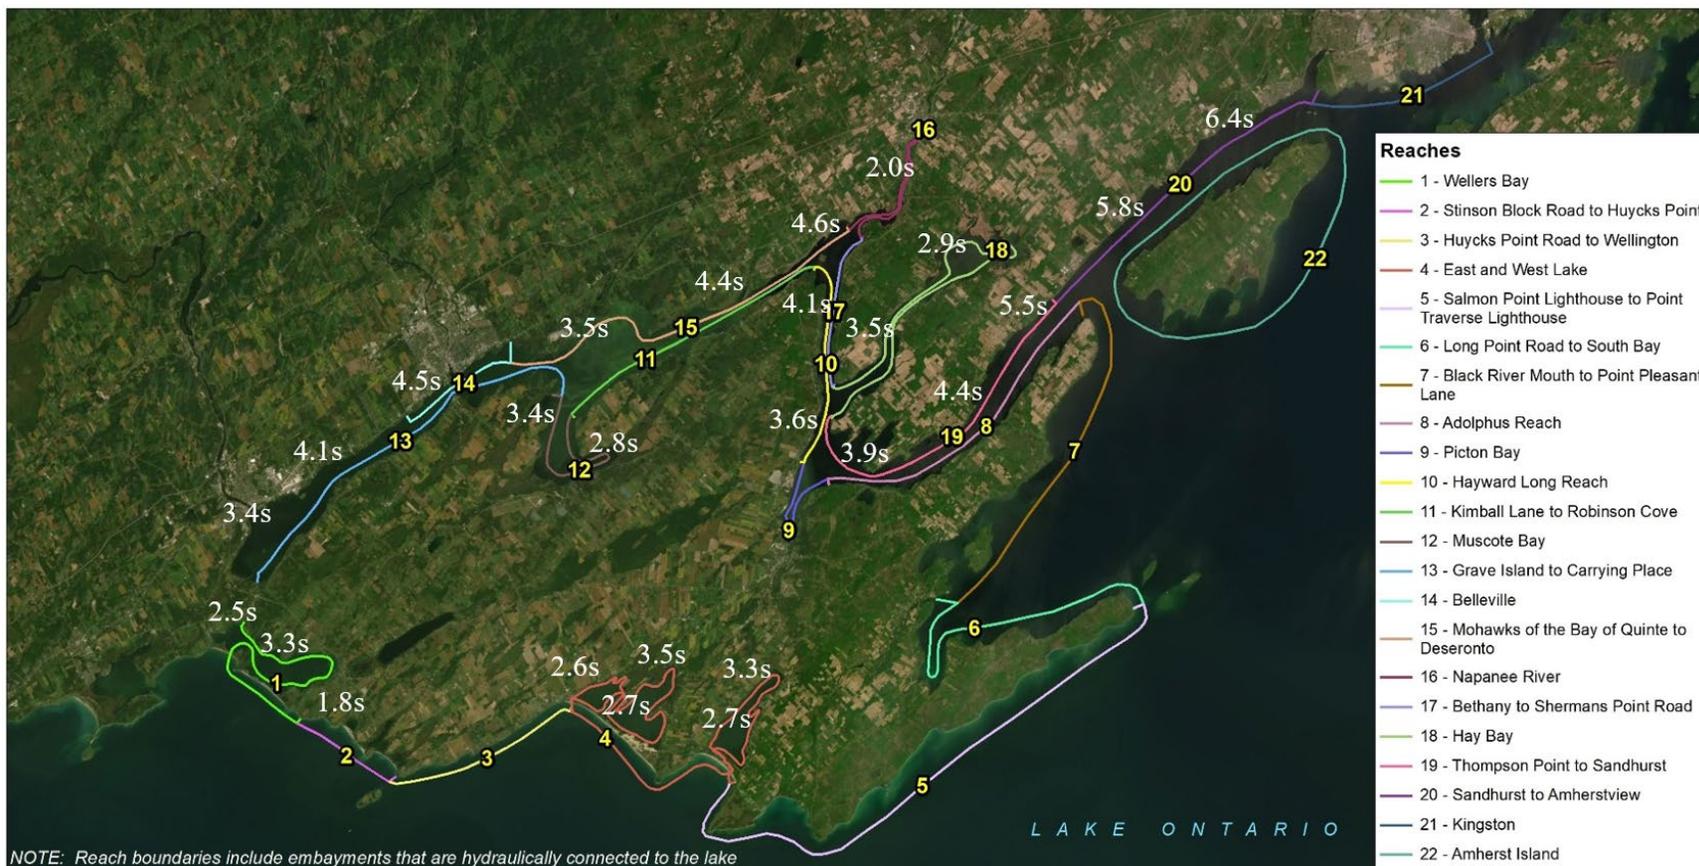
Figure 4.31 Estimated 100-year wave period (seconds) throughout the Bay of Quinte and other sheltered embayments

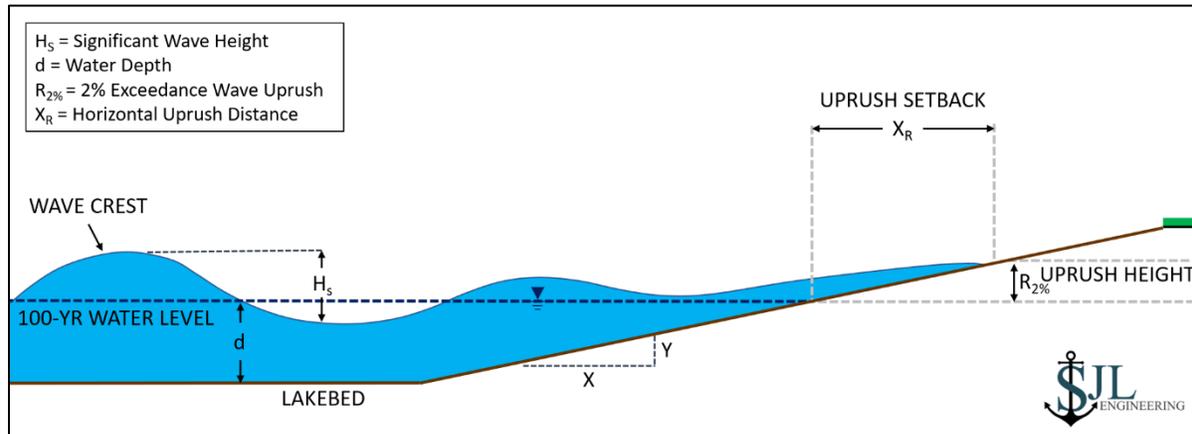
Figure 4.32 Wave uprush on a gentle sloping shoreline – definition sketch

As discussed in detail in Section 5.2, determining an appropriate horizontal distance landward from the waterline that may be impacted by wave action is a critical component of both the flooding hazard and dynamic beach hazard definitions. To address this, wave uprush was assessed at 77 locations along the QC and CRCA shorelines. Wave uprush describes the process by which waves break along a shoreline and surge up the shoreline to an elevation higher than the static water level. A definition sketch of wave uprush is provided in Figure 4.32 below.

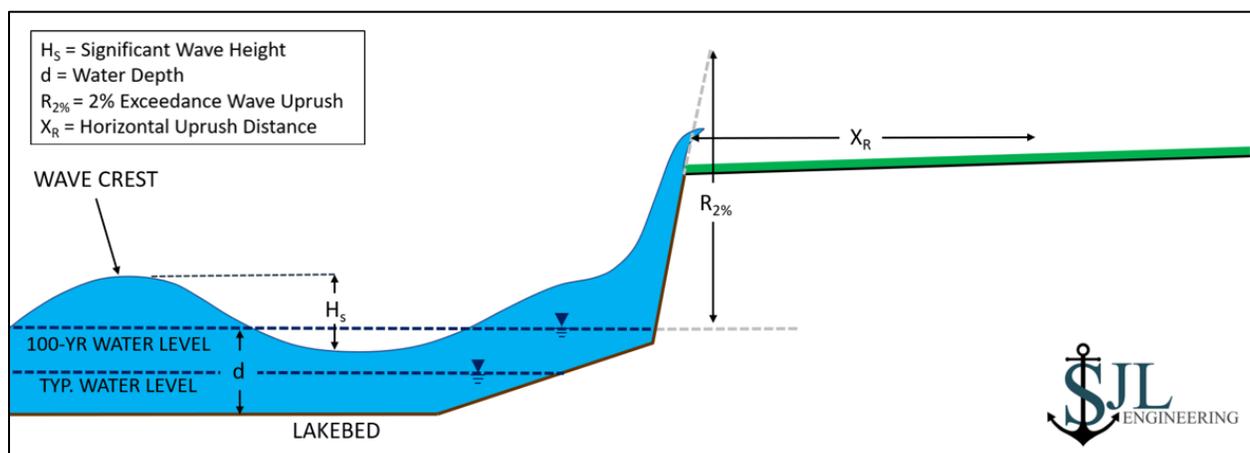
Figure 4.34 Wave uprush on a steep bank or cliff resulting in overtopping of the bank crest

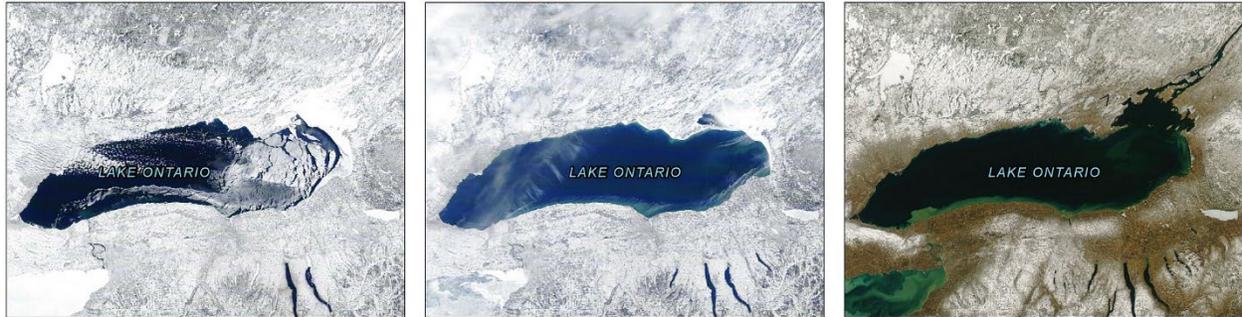
Figure 4.36 Schematic diagram of reduced Lake Ontario ice coverage

Ice cover in the Great Lakes has been decreasing since 1973 (Wang et al, 2012) with similar trends documented across the northern hemisphere (Sharma et al, 2019). The projected warming will continue to increase land and lake temperature, resulting in further reductions in ice cover in the future. Figure 4.36 provides a conceptual diagram of these potential changes for Lake Ontario with extensive ice cover in the eastern basin (left-hand panel), coverage limited to the Kingston Basin in the middle image, and no ice coverage in the open lake for the winter image in the right-hand panel.

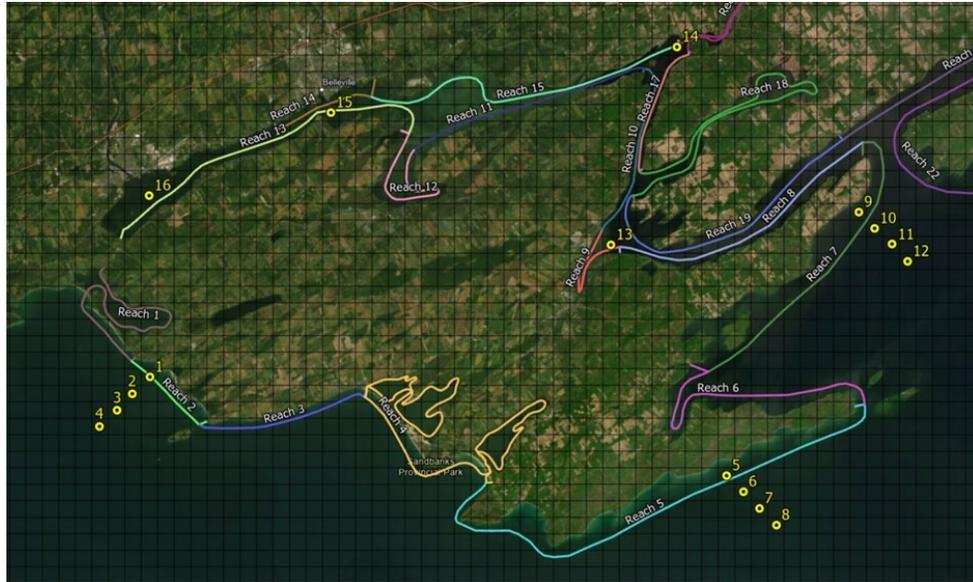
Figure 4.38 Locations of historical ice analysis for study area

The ice tool was applied to four locations throughout the study area, including the Lake Ontario shoreline with western, southern, and southeastern exposure, and four locations within the Bay of Quinte. Refer to Figure 4.38. For the lake shoreline locations, four grid cells were selected to evaluate changes in a cross-shore direction. Each cell is 1.8 by 1.8 km.

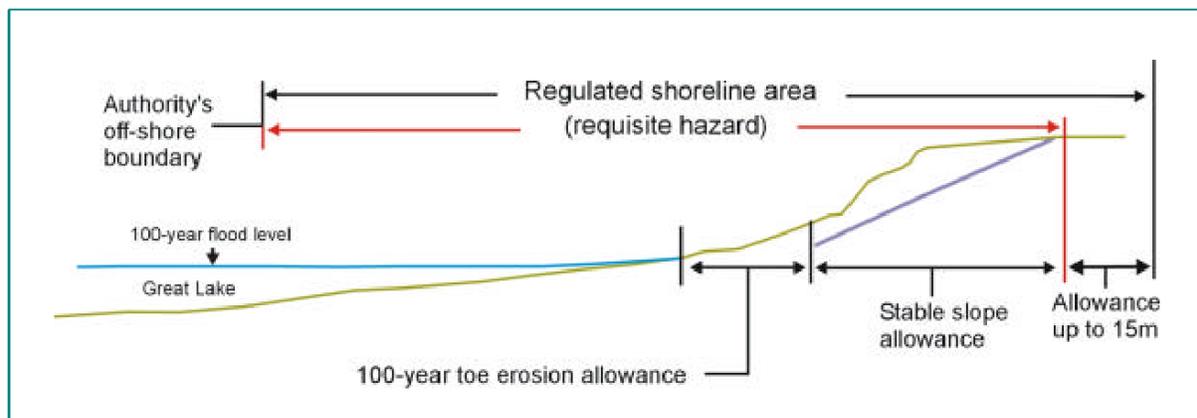
Figure 5.1 Erosion hazard setback approach

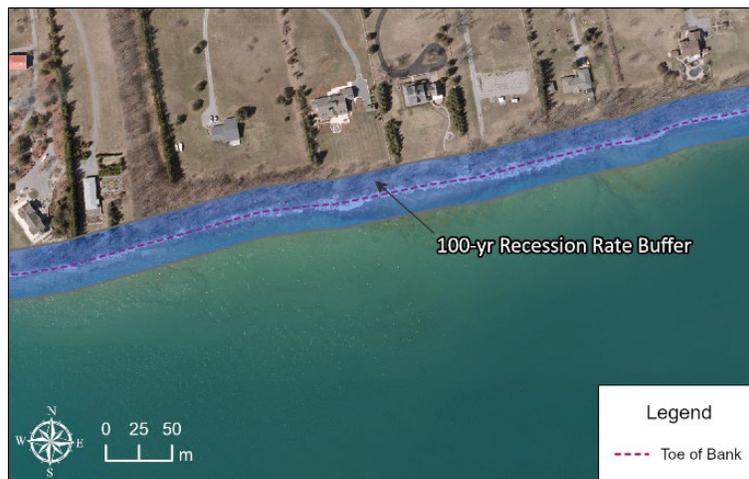
- Map 100-years of Future Recession: The 100-year recession rate was mapped by buffering the toe of slope line by a distance equal to 100 times the average annual recession rate outlined in Section 4.2.2.

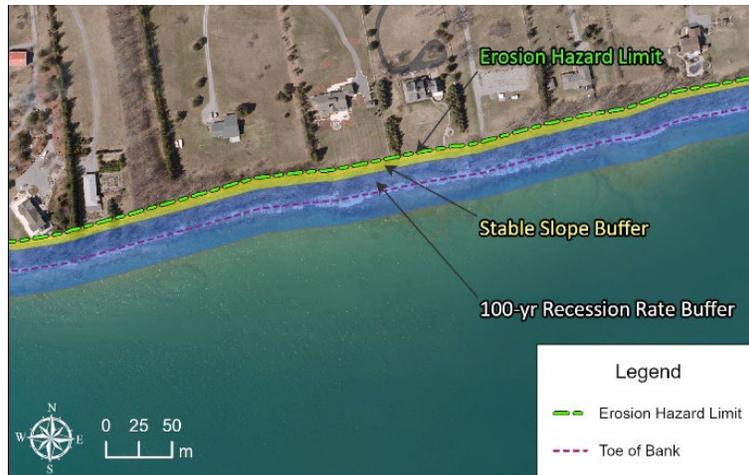
- Calculate the Stable Slope Setback: The recession rate buffer line was converted to a series of points spaced at 1 m increments. At each point, the toe elevation was compared to the land elevation from the DEM. When the height of the bank or bluff was greater than or equal to 2.0 m, the standard stable slope allowance of 1.75(H):1.0(V) (refer to Section 3.5) was calculated at each 1 m interval. The points were then joined to create a continuous polygon representing the Erosion Hazard Limit. See the graphic below (dashed green polyline).

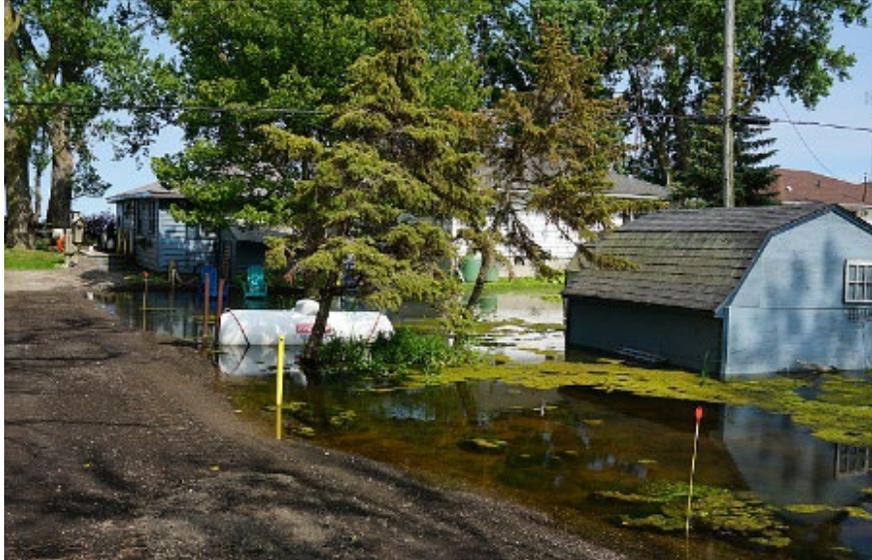
Figure 5.6 Sewage ponding from failed septic systems caused by flooding in 2019 in the Marentette community, Southeast Leamington, Lake Erie

- **Inundated septic systems:** septic systems are generally not functional when inundated and may fail outright resulting in significant environmental implications. Refer to Figure 5.6 below which shows a low-lying community on Lake Erie during the 2019 high water period where several septic systems failed contributing to multiple properties being flooded with contaminated sewage.

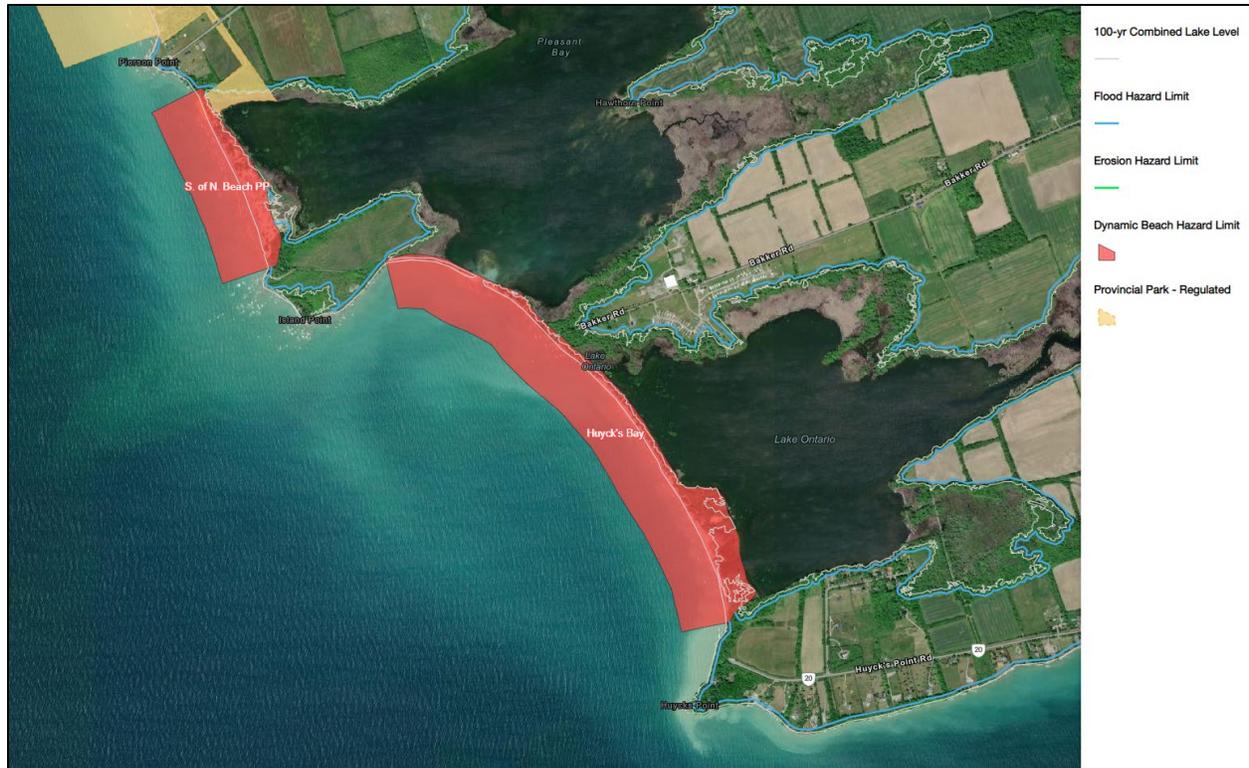
Figure 5.8 Sample of dynamic beach hazard mapping for the southwest Prince Edward County shoreline from North Beach Provincial Park to Huyck's Point (red polygon is the dynamic beach hazard, white line is the 100-year flood level and blue line is the flooding hazard including wave uprush)

Figure 5.8 provides an example of a mapped dynamic beach hazards for the portion of shoreline between North Beach Provincial Park and Huyck's Point on the southwest Prince Edward County shoreline (Reach 2).

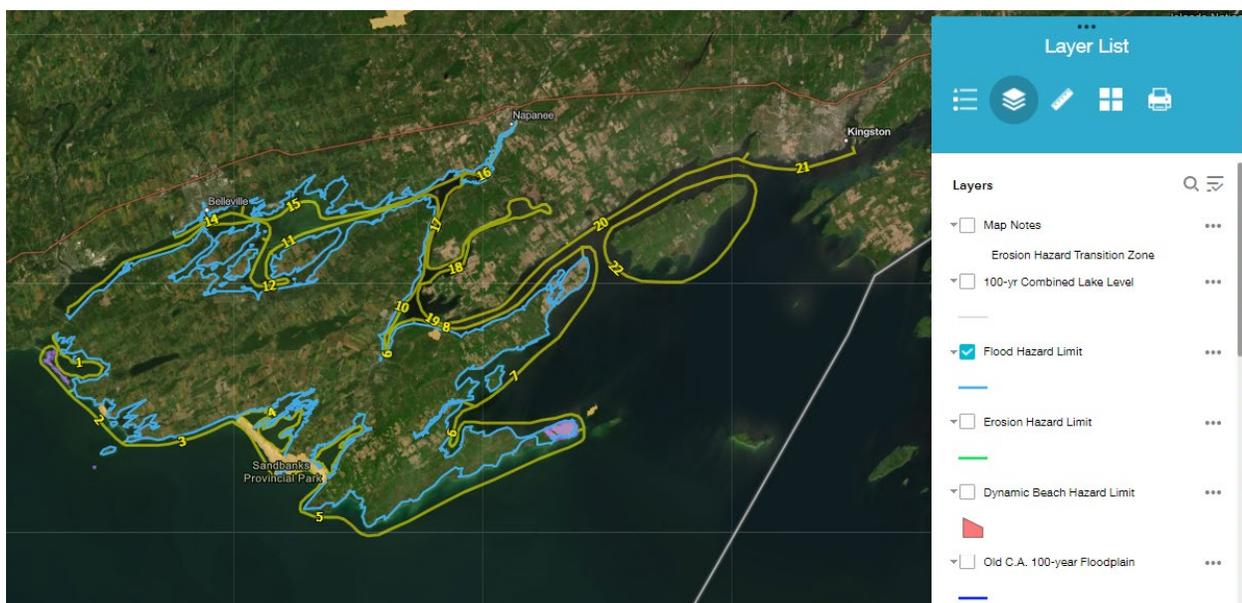
Figure 5.9 Online hazard mapping platform

The draft hazard limits were posted to a web mapping application to share with QC and other project partners during the internal review process. A view of the full study shoreline is provided in Figure 5.9 and a portion of Reach 2 is shown in Figure 5.10. Users can toggle layers on and off, produce a legend, measure distances and areas, change the background image, and print custom maps.

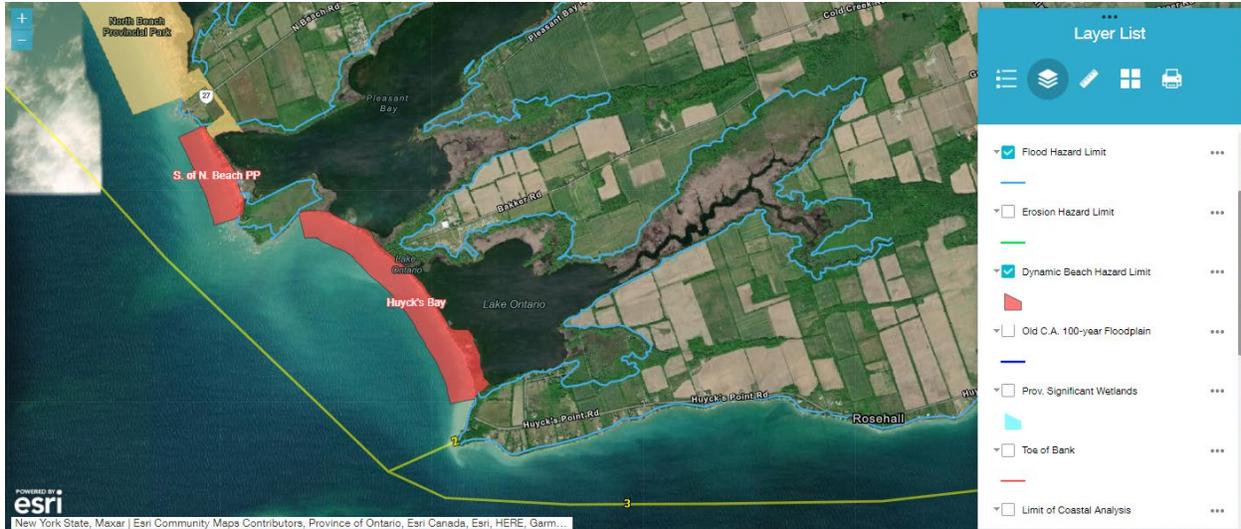
Figure 5.10 Flood hazard limit from North Beach Provincial Park to Huyck's Point

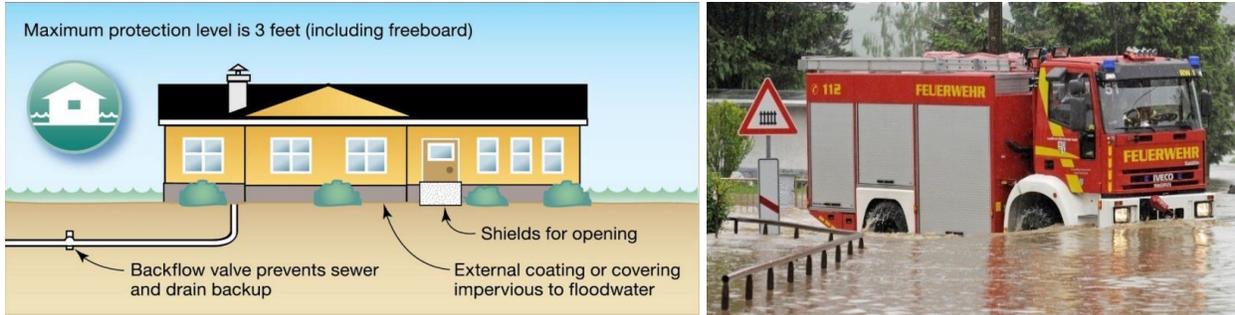
Figure 7.3 Examples of measures for floodproofing an existing building (left) and a specialized emergency vehicle with enhanced abilities to navigate through floodwaters (right)

The accommodate strategy leverages a wide range of adaptive approaches to reduce coastal risk and permit continued occupation of communities on hazardous lands. Examples of the Accommodate strategy include floodproofing existing buildings (e.g., flood gates, opening shields, backflow valves, and sump pumps), raising building foundations, raising road elevations to provide safe access during flooding events, relocating high-value assets to areas of highest elevation or furthest from the shoreline hazards within homes or properties, upgrading components of an urban stormwater management system, upgrading emergency plans and emergency vehicle fleets for first responders, and completing emergency preparedness planning. Figure 7.3 presents examples of how existing buildings can be floodproofed (left) and a specialized emergency access vehicle capable of accessing roads inundated by floodwaters (right).

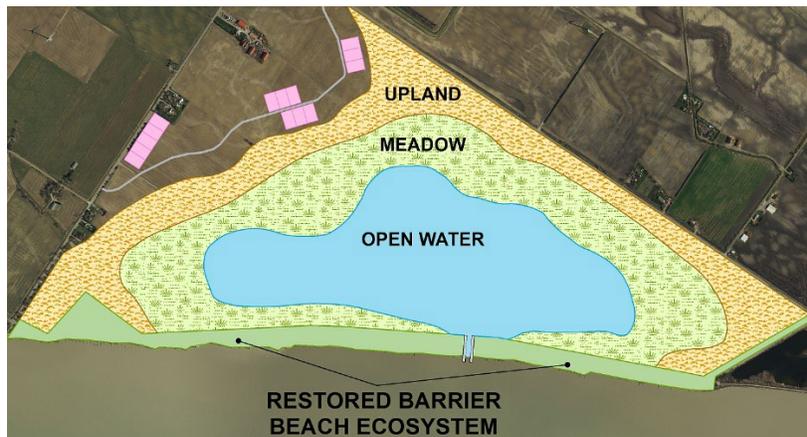
Figure 7.4 Diked agricultural land located below the lake level converted to a coastal wetland with a restored barrier beach

Retreat/ Re-align is a coastal risk mitigation category that encompasses strategic decisions to change land use and relocate public or private assets that are exposed to significant risk. Retreat / Re-align strategies are typically considered only when strategies under other PARA(P) categories are either not sufficient to mitigate the risk or cannot be reasonably implemented due to constructability, permitting constraints, negative environmental impacts or where the cost to mitigate the risk is greater than the assets under threat. Strategies within this category include relocating buildings away from the hazards on existing lots or to new lots further inland, re-aligning roads, or removing buildings, typically through a voluntary property disposition program implemented by municipalities on a willing seller/willing buyer basis. For this scenario, funding and fair compensation for landowners is also required. Once the at-risk infrastructure has been relocated or removed, the land use can be transformed to more resilient options, such as reinstating natural shoreline buffers or riparian vegetation and coastal wetlands that also create habitat and ecosystem benefits. Figure 7.4 presents a hypothetical example of flood prone diked agricultural lands converted to a natural coastal wetland and barrier beach system. Figure 7.5 presents an example of a proposed road and building realignment where the risk to homes, homeowners and implications to vehicular access were significant due to the likelihood of a large-scale bluff failure triggered by coastal erosion.

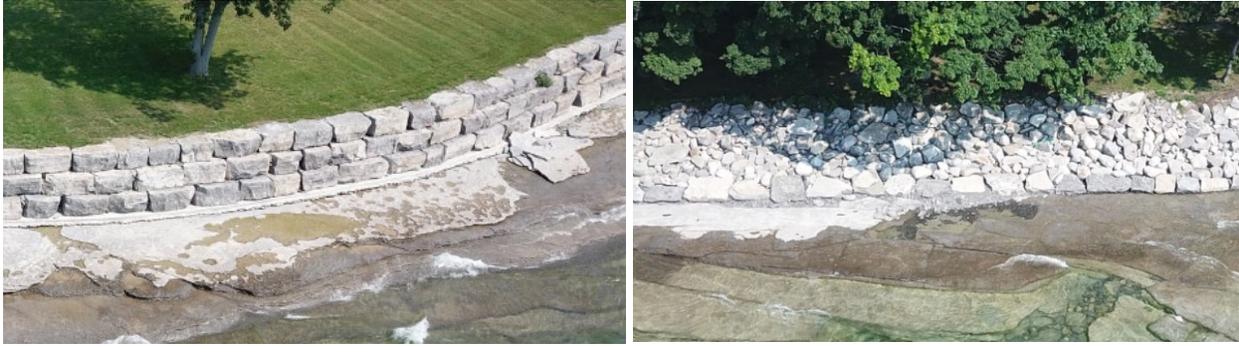
Figure 7.6 Example of conventional shoreline protection structures on bedrock shorelines; stacked armour stone seawall (left) and “keyed-in” armour stone revetment (right)

The protect category is focused on safeguarding people, property, and infrastructure from exposure to shoreline hazards, either through traditional engineering or nature-based solutions. Historically, protect has been the most common approach deployed to address coastal hazards in Ontario for existing shoreline development and at-risk infrastructure. There are many types of shoreline protection structures that can reduce flood or erosion risk, including conventional, shore-parallel shoreline protection structures such as revetments, seawalls, and breakwaters (refer to Figure 7.6). Beach nourishment and dune restoration strategies are examples of nature-based protection options (refer to Figure 7.7). For shorelines with relatively low wave exposure, hybrid grey-green protection structures can also be implemented, such as stone revetments fronted by vegetated buffers (refer to Figure 7.8). These hybrid approaches are most applicable in the Bay of Quinte and sheltered embayments throughout the study area. Specific guidance on shoreline protection structures that can be designed to mitigate coastal risk for shorelines within the Quinte Conservation geography is provided in Section 7.3.

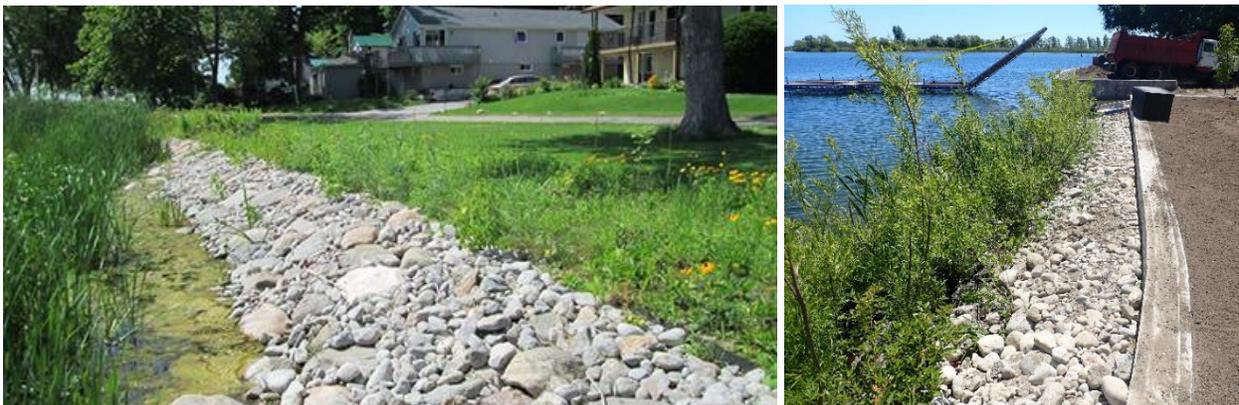
Figure 7.8 Hybrid grey-green shoreline protection structures featuring stone and/or concrete infrastructure fronted by vegetated natural buffers and natural riparian conditions

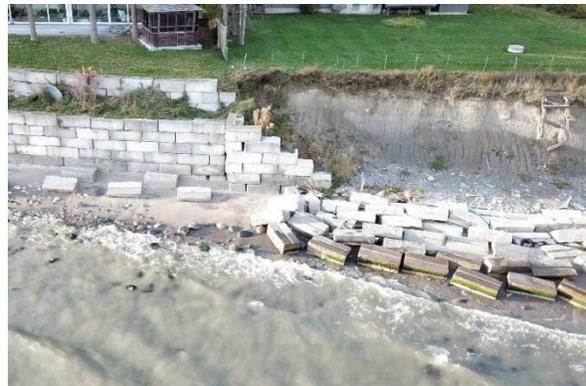
In general, for exposed, high-wave energy shorelines on the Great Lakes where erosion rates may be high, sloping shore protection structures such as revetments are preferred over vertical structures due to their superior ability to dissipate wave energy. Vertical structures tend to reflect more wave energy causing increased lakebed erosion directly in front of the structure. This can lead to failures if the structure toe is not designed properly. Sloping structures are also less likely to fail due to ground or hydrostatic pressures compared to their vertical counterparts. The adjacent image captured a vertical concrete block seawall failure on Lake Ontario during the high water period in 2017 and 2019.

A significant advantage to sloping structures is that they tend to have gradual failure mechanisms such as displacement of structure elements (typically stones) or settlement over relatively long periods of time. By contrast, vertical structures tend to fail abruptly and catastrophically during a major storm event. Sloping structures can be monitored and maintained more readily throughout their design life relative to their vertical protection.
