Quinte Conservation Shoreline Management Plan

Quinte Conservation

June 21, 2022

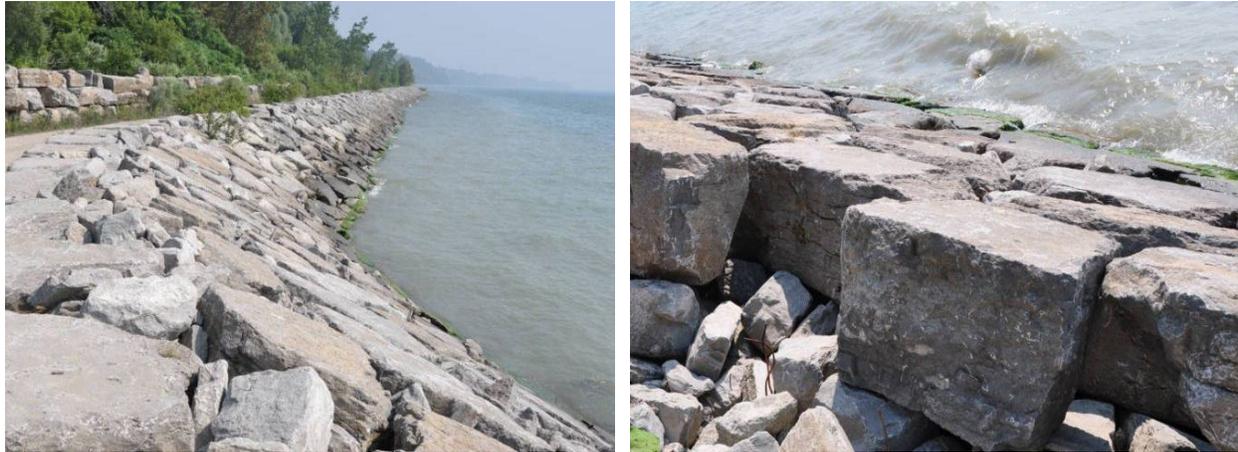
Figure 7.9 Examples of single-layer, blocky armour stone revetments on Lake Ontario

A typical design for a sloping stone revetment would include an outer ‘primary’ stone course, with underlaying courses of smaller ‘filter’ stone. The primary stone layer can be comprised of a single layer of very large, tightly packed, blocky armour stone (quarried stone), or multiple

layers of randomly placed irregular armour stone or field stone (natural boulders). Single-layer armour stone structures require a smaller volume of material; however, the cost of blocky armour stone is typically much higher per tonne than irregular armour stone or field stone. Ultimately the selection between the two types of revetments is based on the availability of materials and cost, as both structure types can be designed to effectively resist wave loading and mitigate erosion for Lake Ontario shorelines. Figure 7.9 presents examples of single-layer block armour stone revetments, while Figure 7.10 presents examples of randomly placed armour and field stone revetments.

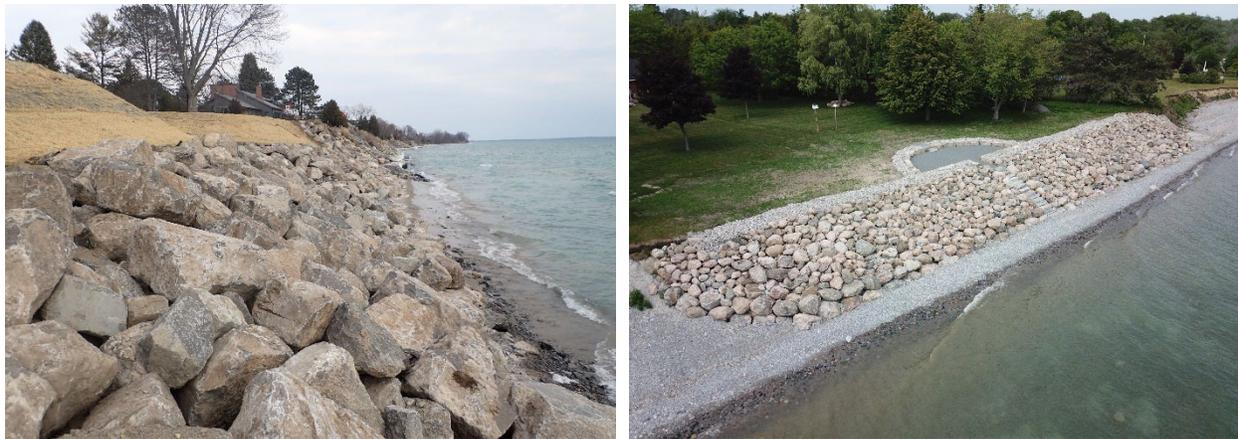
Figure 7.10 Examples of conventional, randomly placed armour stone (left) and field stone (right) revetments on Lake Ontario

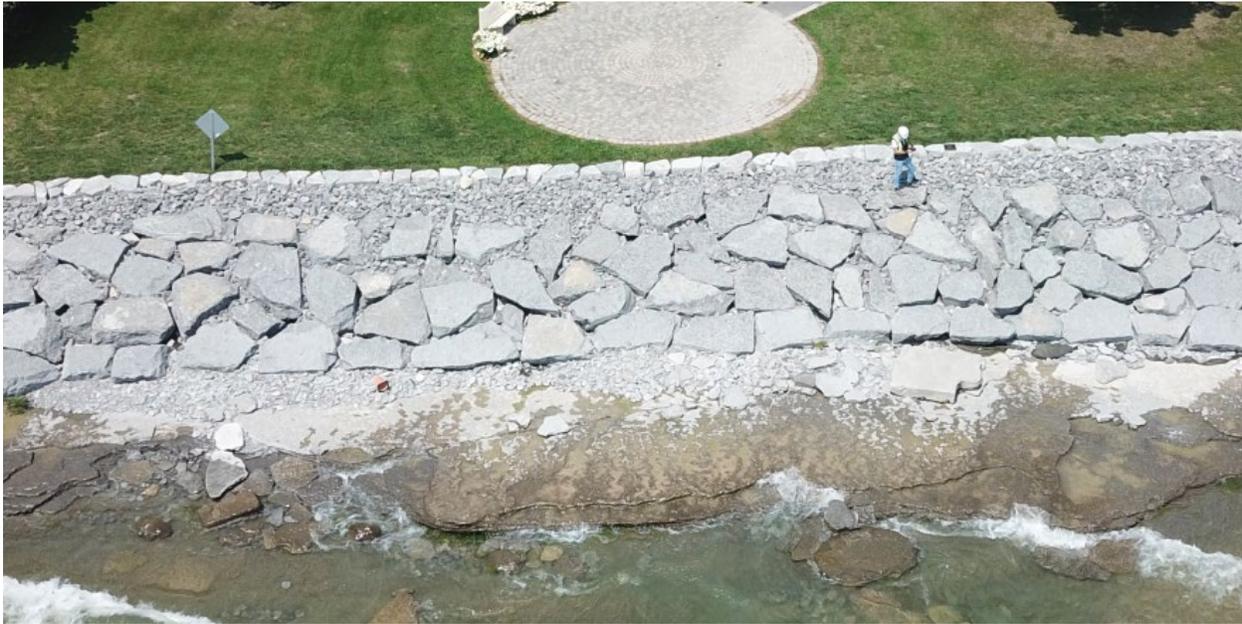
Figure 7.11 Single-layer blocky armour stone revetment with toe stones “keyed” into underlying bedrock shelf

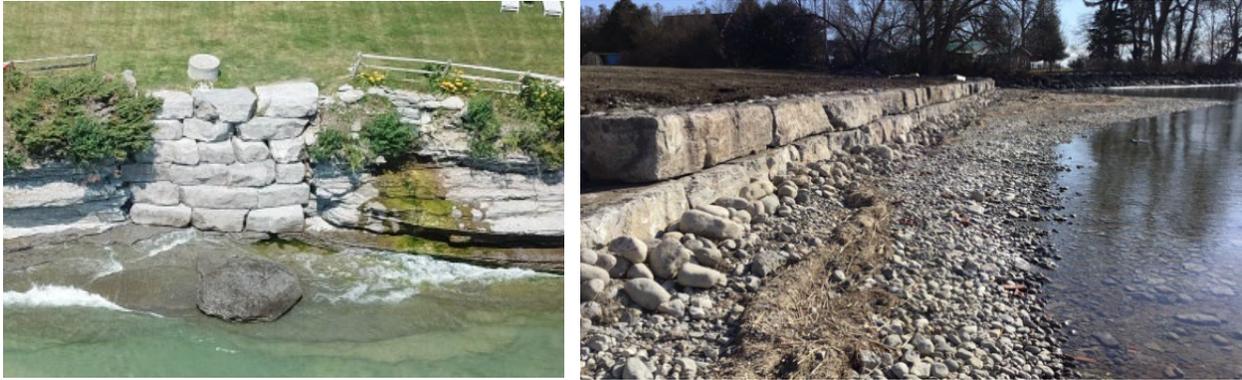
Figure 7.12 Stacked armour stone seawalls on Lake Ontario, “plugged” into an eroded section of bedrock cliff (left) and at the back of a cobble beach (right).

In some cases, due to space limitations or specific shoreline characteristics such as the presence of a flat bedrock shelf backed by a vertical eroding bedrock cliff, notwithstanding the above, vertical, or near-vertical structures may be warranted. In these cases, the preferred structure is a stacked, or stepped armour stone seawall. Armour stone seawalls are particularly well suited for shorelines with flat, shallow bedrock, such as those present along much of the exposed Prince Edward County shoreline. They are also preferred where erosion has compromised a small section of bedrock cliff, as they can be “plugged” into surrounding bedrock more readily than a sloping structure (refer to left portion of Figure 7.12). Finally, armour stone seawalls can be an effective shoreline treatment when placed at the back of a cobble or shingle beach or behind (landward) of emergent vegetation on a low-wave energy shoreline such as those encountered within many sheltered embayments (discussed further in Section 7.3.2 below).

Stacked armour stone seawalls are typically comprised of multiple rows of large, blocky armour stone, stacked vertically or near-vertically (i.e. each row setback back slightly from the previous row). These structures typically feature a coarse filter layer of rip rap or large gabion stone behind the outer armour stone, and require extremely tight packing of the outer stone layer to ensure that no filter stone is lost through voids in the structure. Where the structure is located on a cohesive or glacial till shoreline, the bottom row of stones should be fully or partially buried in the substrate. Where the structure is to be founded directly on bedrock, providing sufficient anchorage or friction with the underlying bedrock is critical to stability and longevity of the structure. The bedrock shelf should first be flattened through chipping away loose layers of shale and limestone, or conversely levelled through the use of a thin layer of concrete. An example of this technique is shown in Figure 7.13. Toe stones founded directly on the bedrock shelf should be oversized and may be pinned to the bedrock with steel rods. Typical, concept-level cross-sections of stacked armour stone seawalls for bedrock shorelines and cohesive or till shorelines are provided as Figure 7.20 and Figure 7.21. Design details including stone sizes, toe and crest elevations and anchorage should be evaluated by a professional engineer on a site-specific basis.

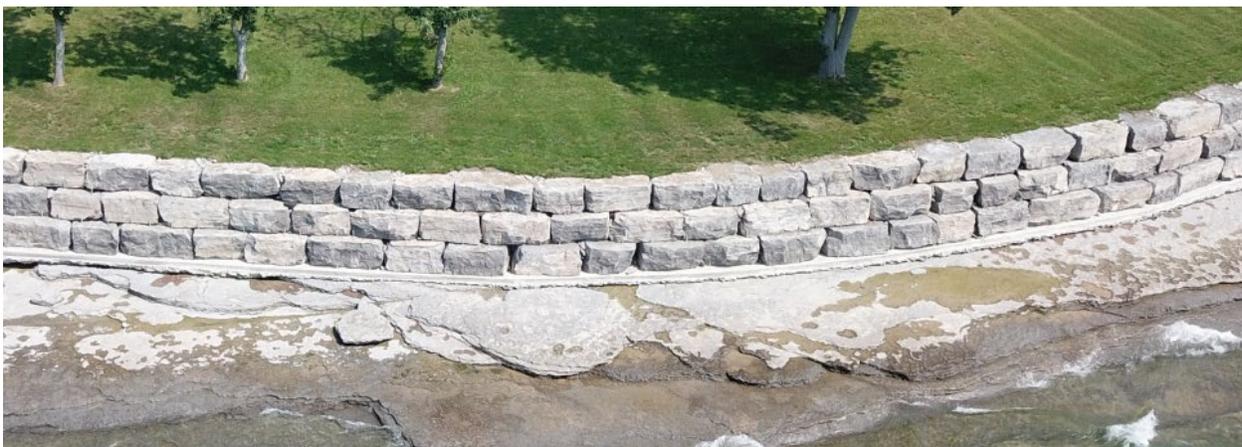
Figure 7.13 Stacked armour stone seawall founded on a thin concrete foundation over an irregular bedrock shelf

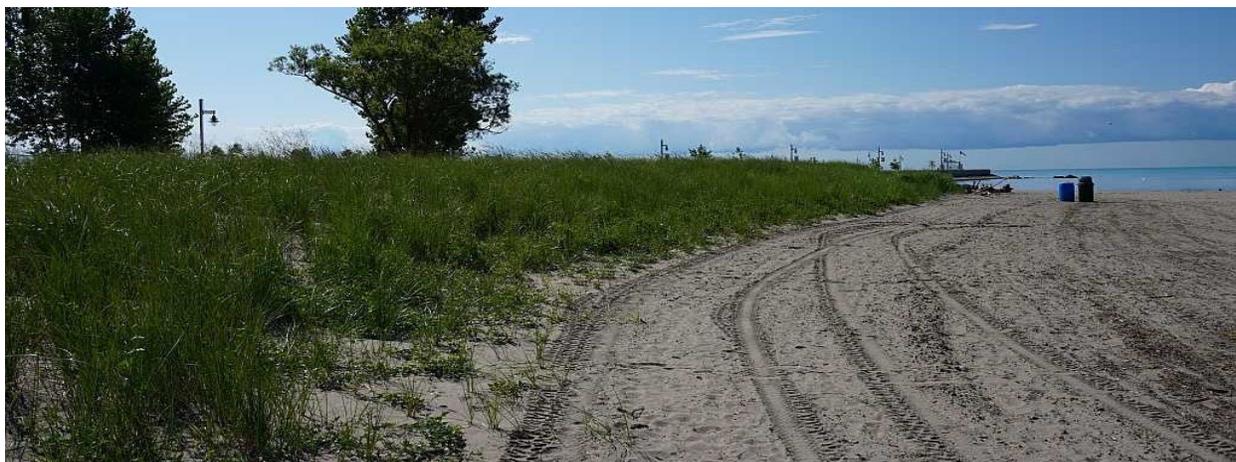
Figure 7.14 Example of successful dune restoration at Port Stanley, Lake Erie

For low-wave exposure shorelines such as those encountered within sheltered embayments and throughout the Bay of Quinte, preserving natural shoreline buffers and maintaining sloped, vegetated banks should generally be prioritized where erosion risks are low. Where shoreline protection is warranted, nature-based and hybrid grey(traditional)/green(nature-based) shoreline protection structures are preferred over traditional revetments and seawalls. Nature-based and hybrid grey/green infrastructure should be prioritized over traditional shoreline engineering wherever possible. Nature-based solutions may include such approaches as the establishment or preservation of shoreline vegetation with erosion-resistant root-structures, the placement of woody debris at the base of an eroding bank or bluff, vegetated flood berms, beach nourishment through the placement of dredged sediment, or supplementing a cobble or shingle beach shoreline with additional, oversized cobbles to improve stability and wave dissipation. Dune restoration is also an important form of nature-based shoreline protection for dynamic beach environments, whereby the beach-dune system is restored with native vegetation that traps sand and helps re-build eroded foredunes. Figure 7.14 presents an example of an artificial dune constructed on West Beach in Port Stanley on Lake Erie to reduce sand loss inland. For more information on Nature-based Solutions to shoreline erosion and flooding, please consult Bridges et al (2021) and CSA (2021).

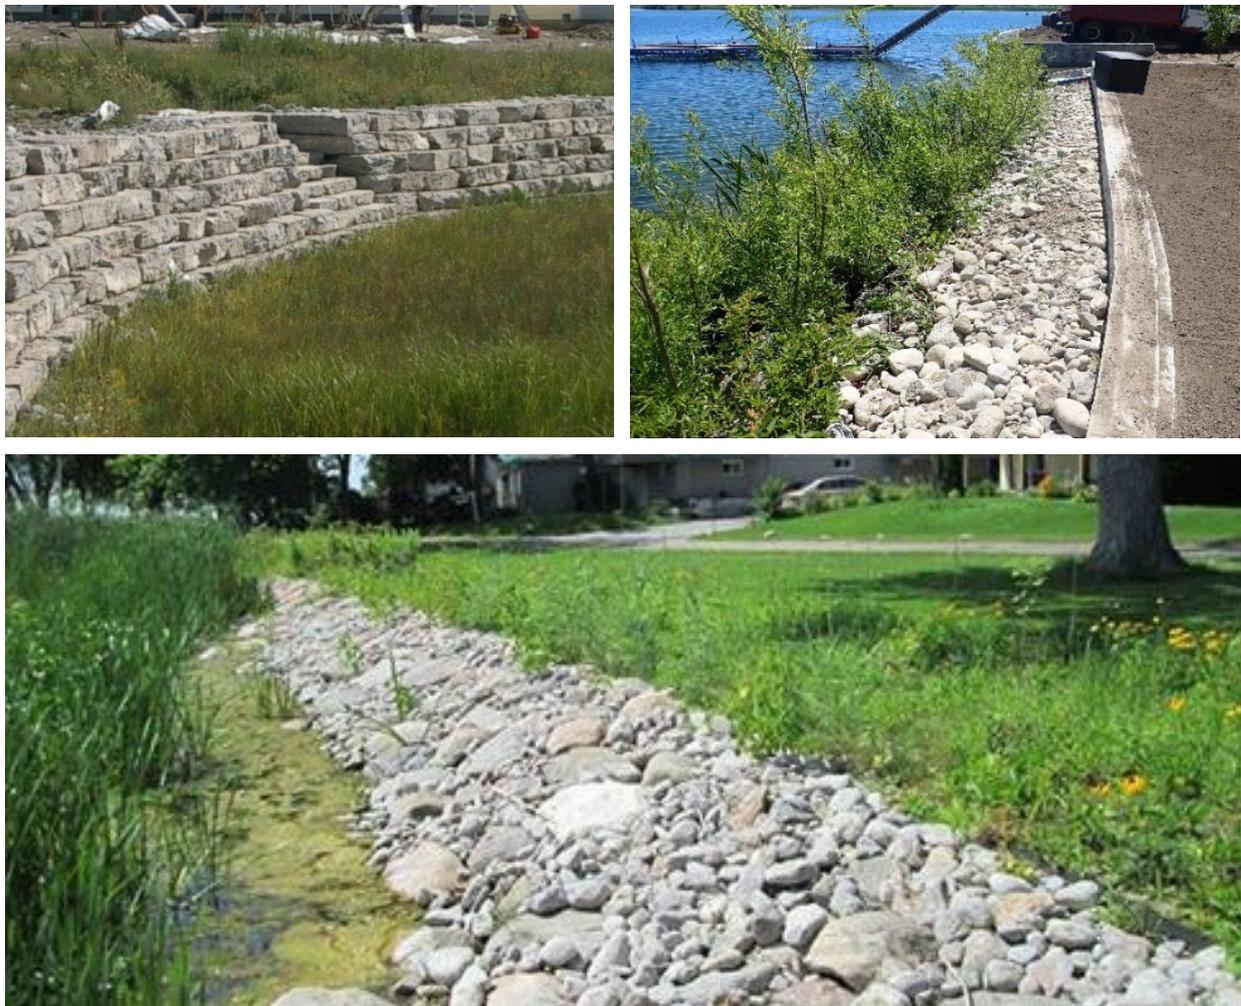
Figure 7.15 Examples of hybrid grey/green shoreline protection schemes suitable for low exposure, low-energy shoreline environments such as those present in sheltered embayments and the Bay of Quinte

Hybrid grey/green shoreline protection structures are a suitable option for most shorelines within sheltered embayments (Wellers Bay, West Lake, East Lake, etc.) or throughout the Bay of Quinte where erosion or flooding may occur during periods of high lake levels, but the wave exposure is low. Hybrid solutions generally involve the placement of stone materials to mitigate erosion or flooding such as a rip rap or cobble berm, revetment, or stacked armour stone wall, with the structure itself being vegetated or a natural vegetated buffer being included in front of the structure to better replicate natural riparian conditions. Many existing shoreline structures can be supplemented with nature-based elements to improve their overall stability, performance and longevity while restoring a more natural shoreline. For example, aging concrete seawalls on the Bay of Quinte can be supplemented with a vegetated cobble berm on their lakeside to provide stability and reduce erosion and flooding risks through improved wave dissipation. This concept and several other examples of hybrid grey-green shoreline protection schemes are provided in Figure 7.15 below. Concept level cross sections for two such approaches are provided in Figure 7.22 and Figure 7.23.

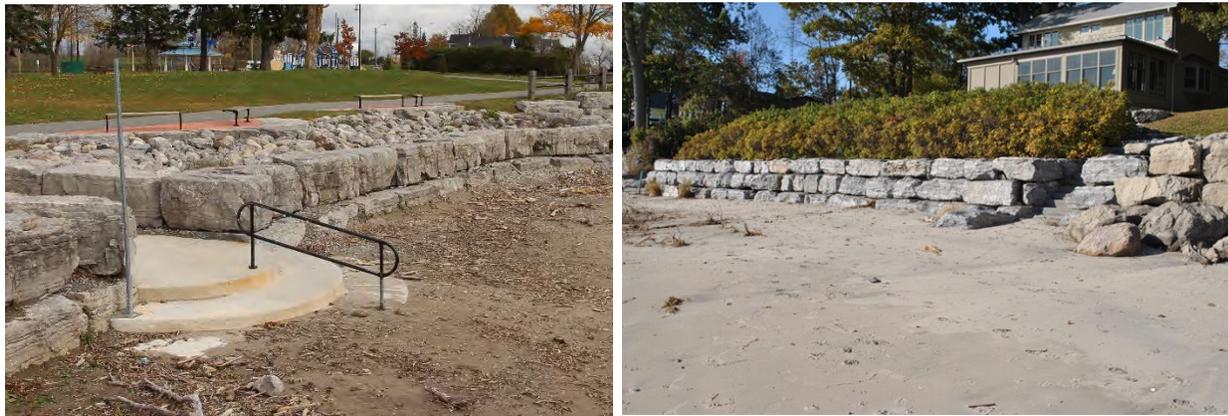
Figure 7.16 Examples of stacked armour stone beach curbs

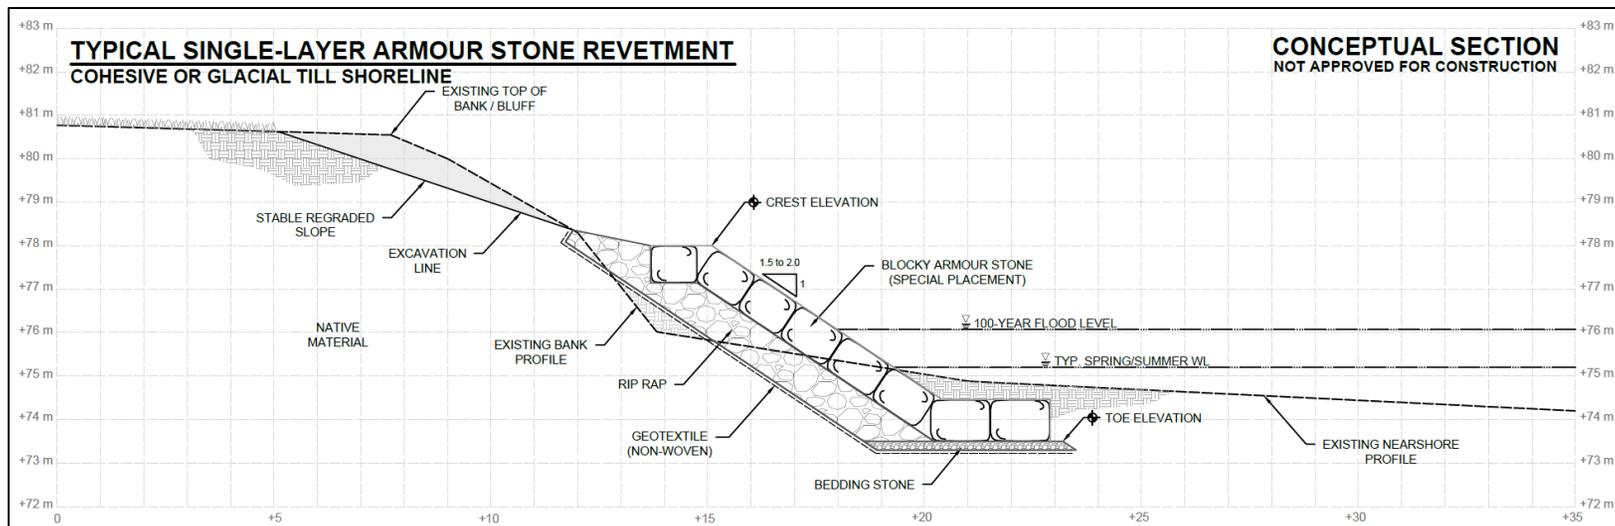
Figure 7.17 Typical single-layer armour stone revetment for a cohesive or glacial till shoreline (concept only)

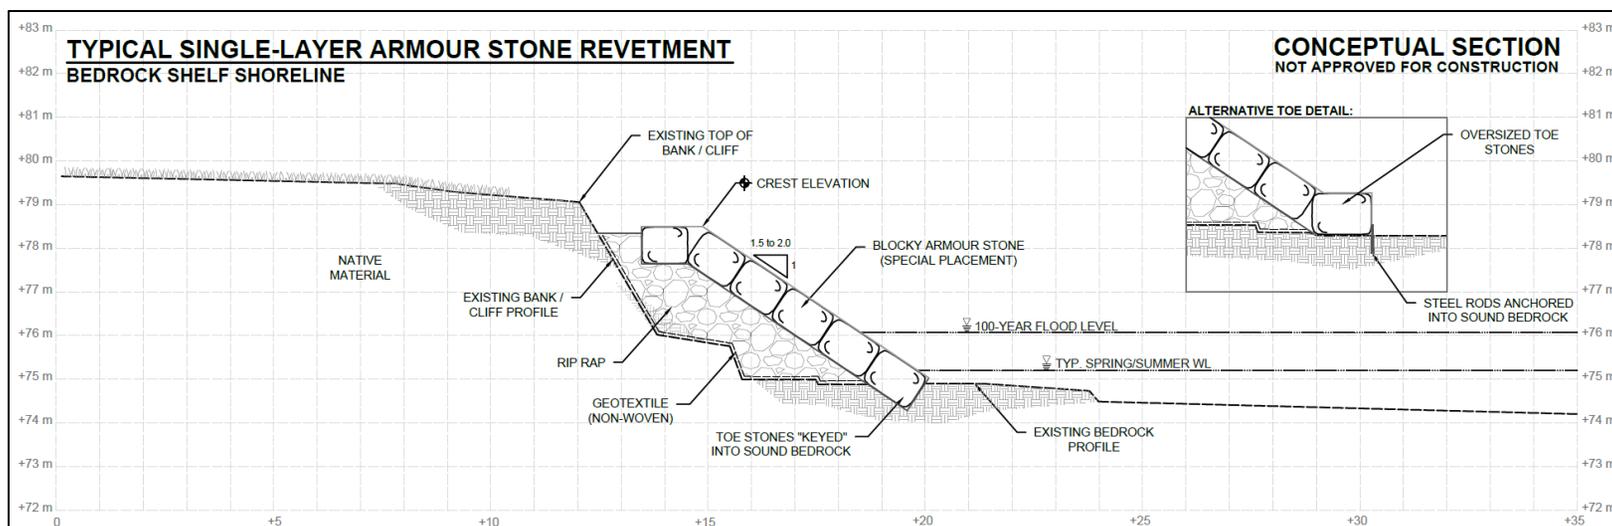
Figure 7.19 Typical single-layer armour stone revetment founded on a bedrock shelf (concept only)

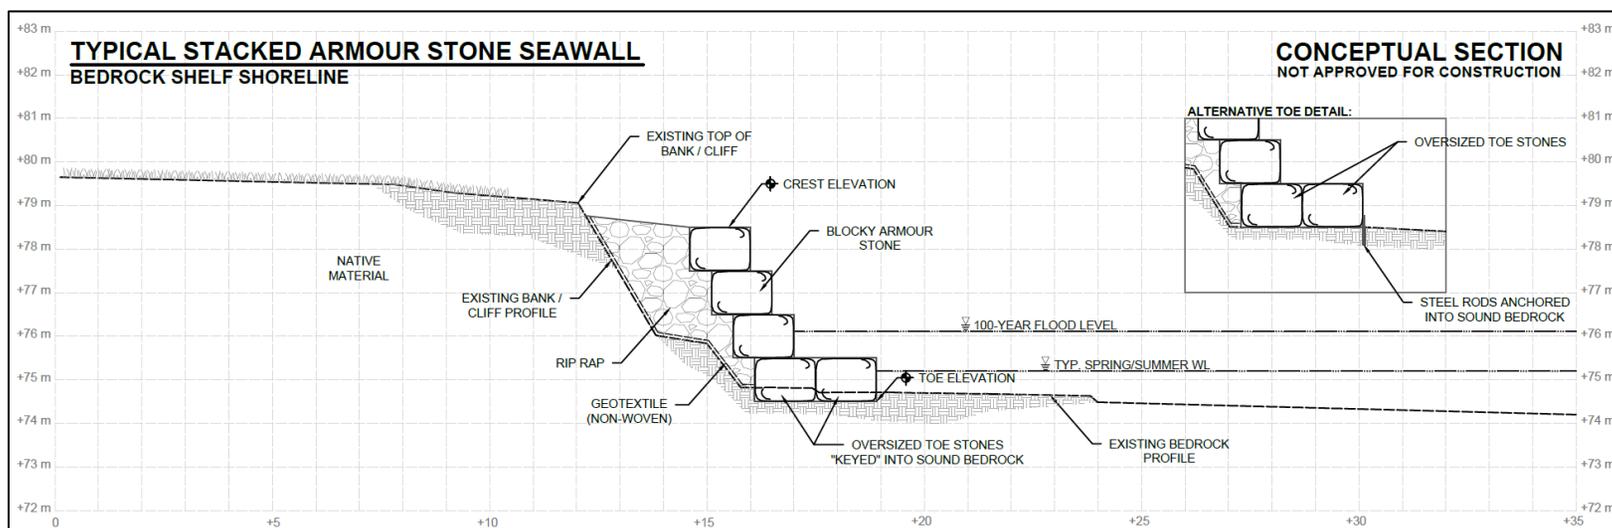
Figure 7.20 Typical stacked armour stone seawall founded on a bedrock shelf (concept only)

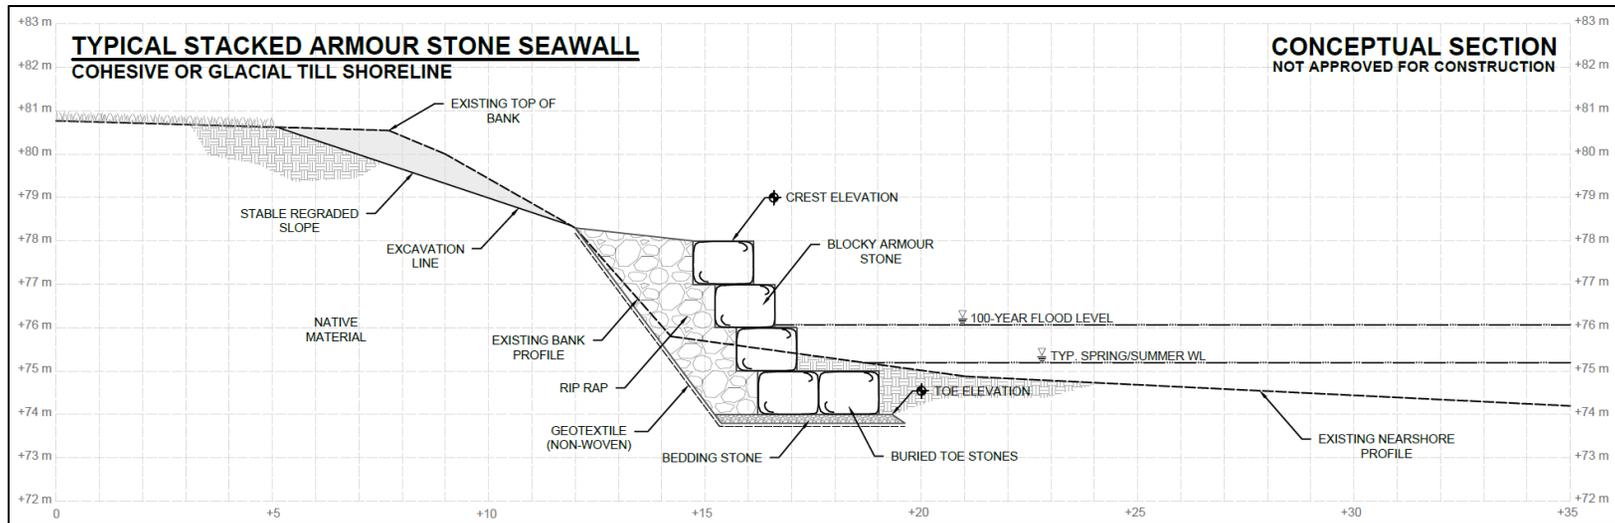
Figure 7.21 Typical stacked armour stone seawall for a cohesive or glacial till shoreline (concept only)

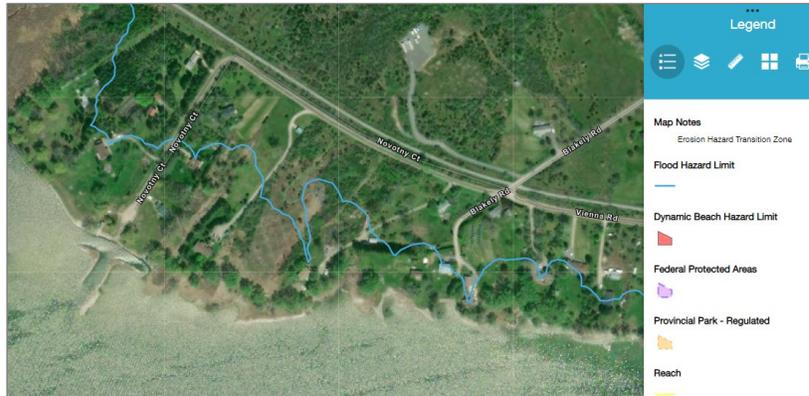
- Wellers Bay shoreline is low lying and many of the buildings and underground utilities (septic systems) are located within the Flooding Hazard Limit (see below).

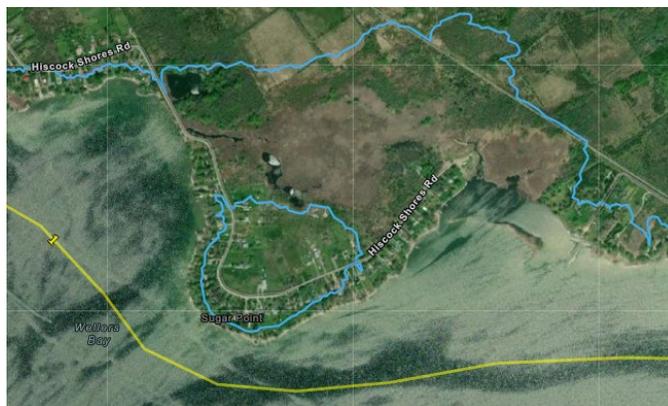
- Several communities feature flooded ingress/egress routes, which may prohibit evacuations during a flood or limit emergency responders from providing services. Affected roads include Harbard Lane, Hiscock Shores Road, and Sunset Lagoon Drive.

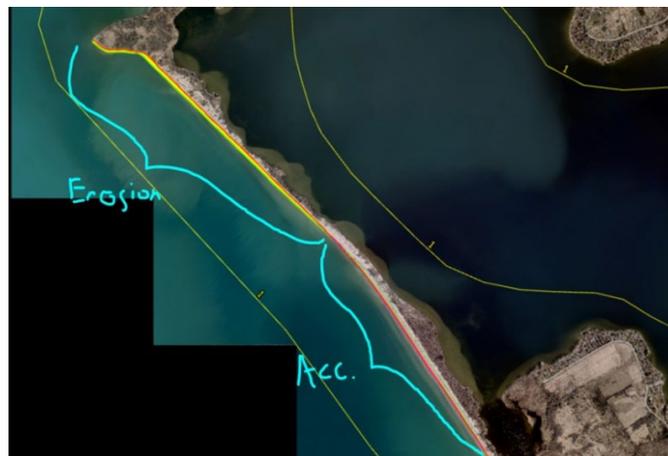
- The barrier beach that defines the Wellers Bay National Wildlife Area is very narrow and the northern half has been eroding at least since 1962. The barrier beach has breached in the past, and future breaches of the barrier are likely. This may increase the exposure to natural hazards within Wellers Bay in the future.

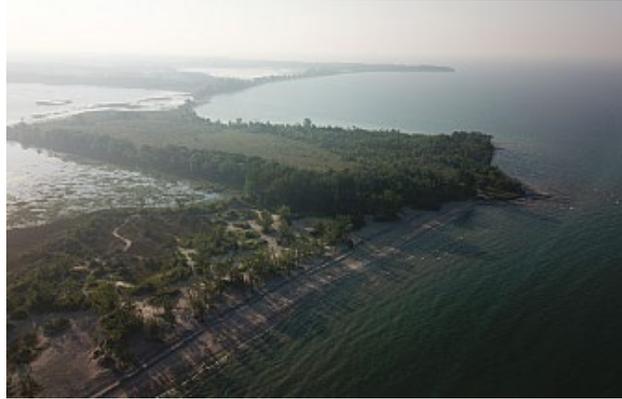
- Beach and dune ecosystems are vulnerable to erosion during period of high lake levels and development pressure. Development within the Dynamic Beach Hazard limit is prohibited under the Provincial Policy Statement and not recommended in the Great Lakes Technical Guide.

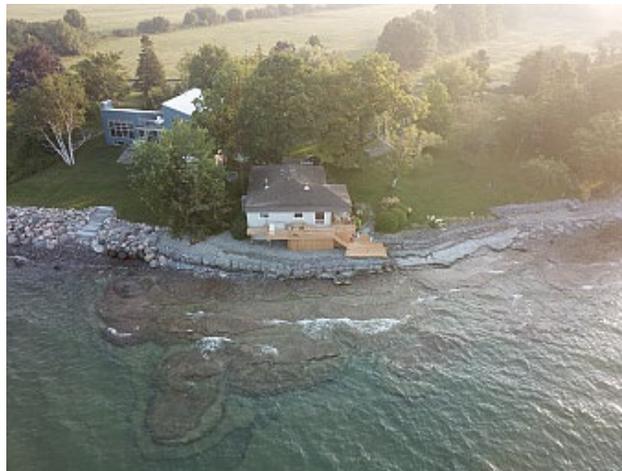
- Existing development located within the erosion hazard may require shoreline protection to save buildings. Permits will be required if shore protection is pursued.

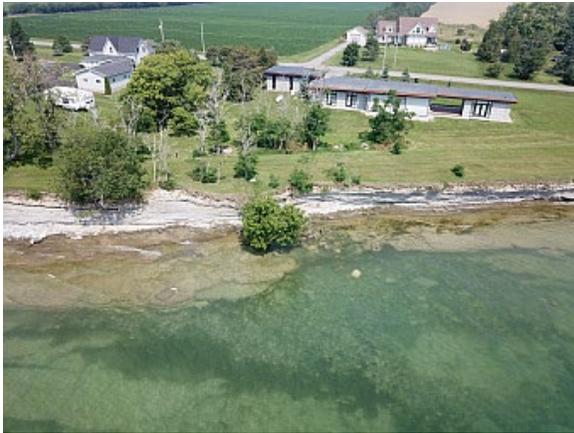
Eroding Bedrock Bank

- Reach Length = approximately 14 km.
- Most of Reach 3 features an eroding bedrock bank with a thin layer of glacial till overburden. The nearshore is dominated by flat bedrock shelves.
- The reach terminates at Wellington Beach, a filet beach anchored by armour stone jetties.
- Reach 3 is developed with estate residential lots in the west and denser settlement in Wellington.

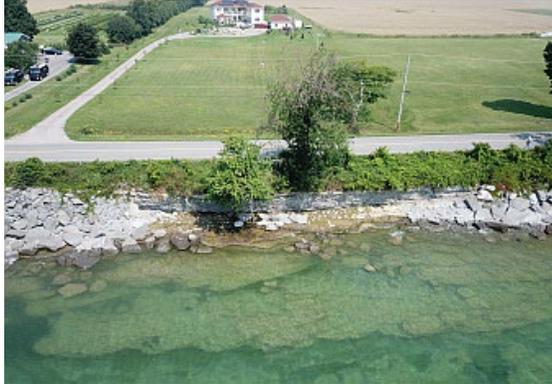
- Road infrastructure vulnerable to erosion (Huyck's Point Rd.).

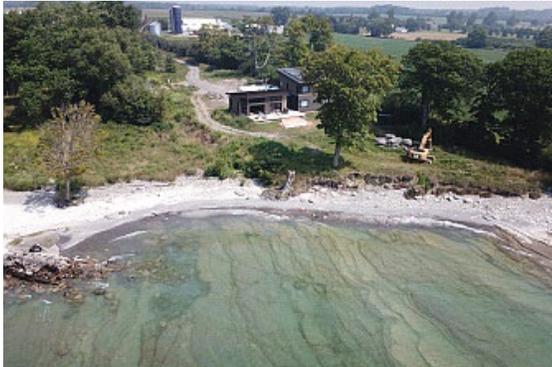
- Erosion will threaten new homes if not setback sufficiently from the eroding banks.

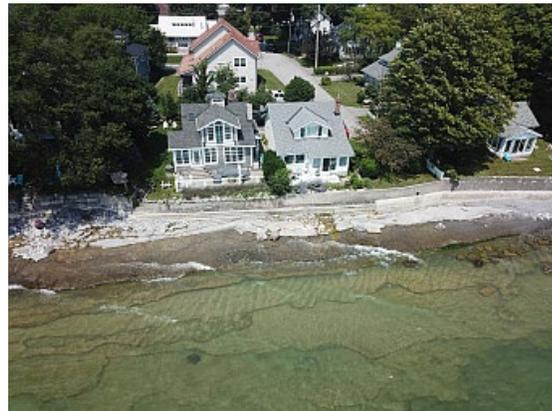
- Legacy development on hazardous lands in Wellington with old, failing shore protection.

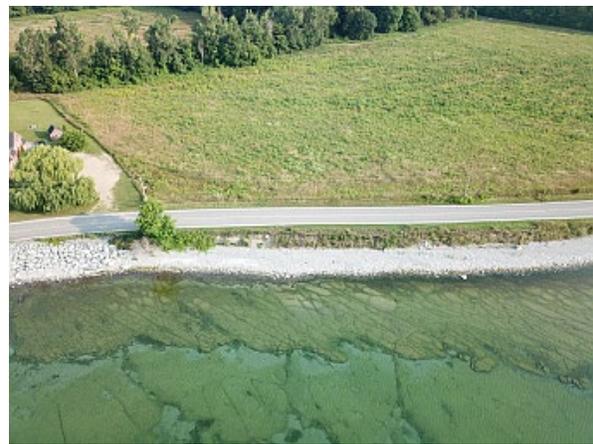
Eroding Bank along Highway 12

- West Point is a bedrock headland that anchors significant beaches on either side (part of Sandbanks Provincial Park).
- County Road 12 runs along the bank from West Point to Outlet Beach and was impacted by erosion in 2017 and 2019.

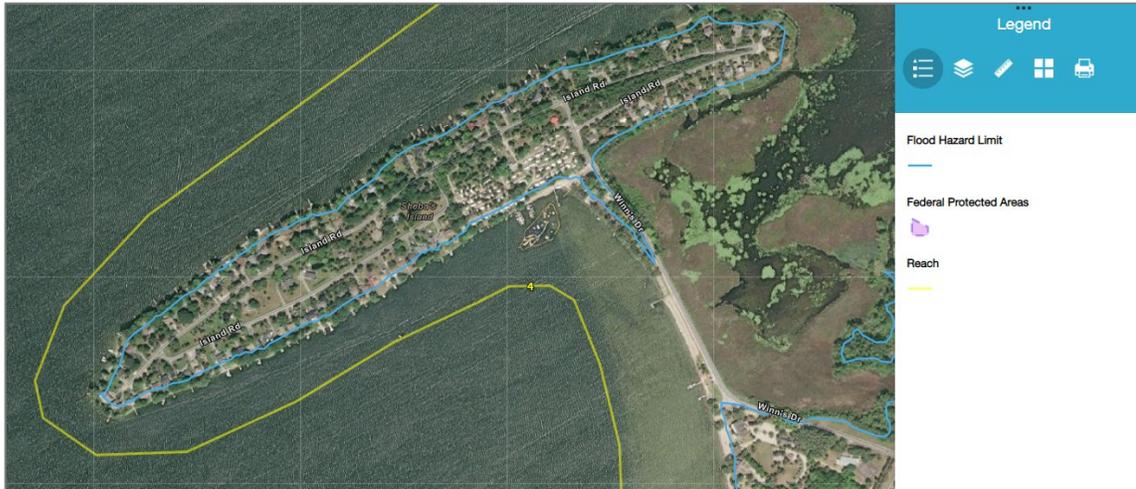
- Several of the shoreline developments in West and East Lakes have access challenges during major flooding events. These include Wesley Acres, Hideaway Trailer Park and Sheba's Island (pictured) on West Lake, and Cherry Beach, Copenhagen Lane, and Parr Island on East Lake.

- **Accommodate:** site specific investigations are required for communities with safe access challenges, as identified through the hazard mapping. Floodproof buildings, raise foundations, and upgrade septic systems on flood prone lands in East/West Lake. Emergency planning and preparedness for a major flooding event.

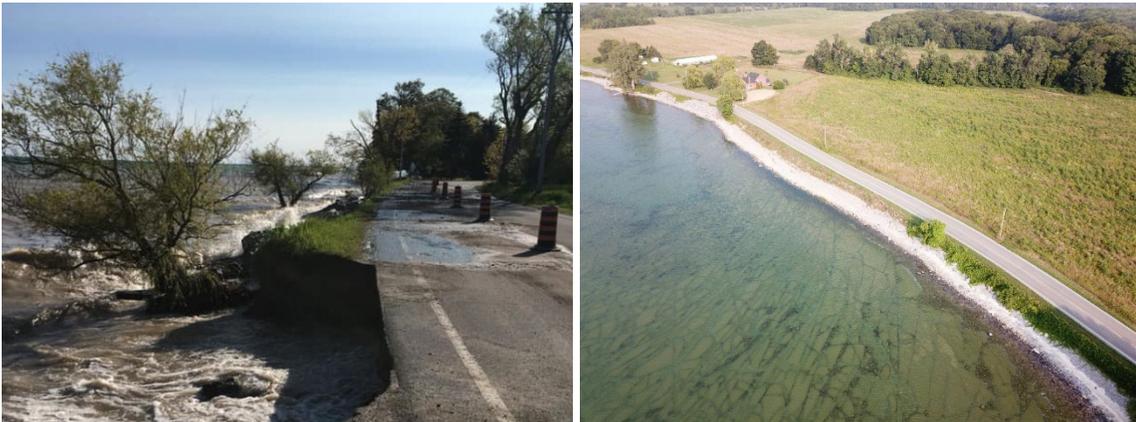
- Many residential buildings are within the flooding hazards of West Lake and East Lake.
- Sedimentation in the mouth of the Outlet River can lead to elevated water levels in East Lake after major rainfall events.
- Approximately 1 km of County Rd. 12 is threatened by erosion, with portions of it being impacted in the high water periods of 2017 and 2019 (refer to images below).

- **Protect:** hybrid grey/green erosion and flood protection schemes are recommended for properties on East/West Lake with erosion/flood risk, as discussed in Section 7.3.2 of the SMP. Investigate traditional shoreline protection structure for County Rd. 12 and compare to “re-align” cost.

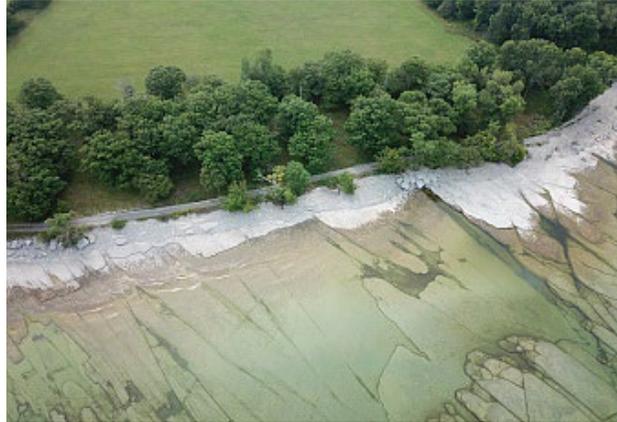
- Salmon Point Road is located at the edge of a low bank shoreline and has been damaged by erosion. Localized repairs have been completed but vulnerable sections remain.

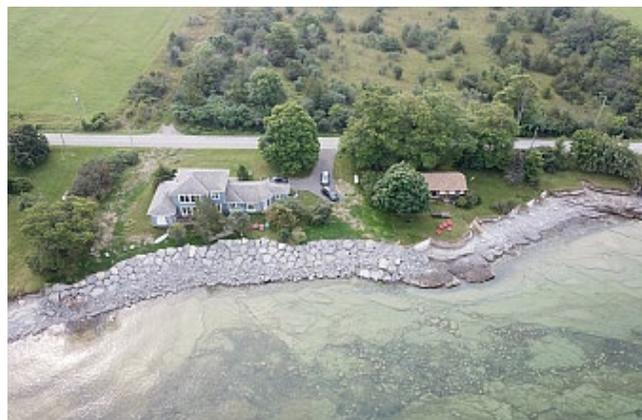
- Erosion of the bedrock banks threatens residential developments on Salmon Point Road where buildings are located too close to the top of bank. Shore protection must be well engineered to remain stable on the bedrock shoreline and withstand potential damage during severe storms.

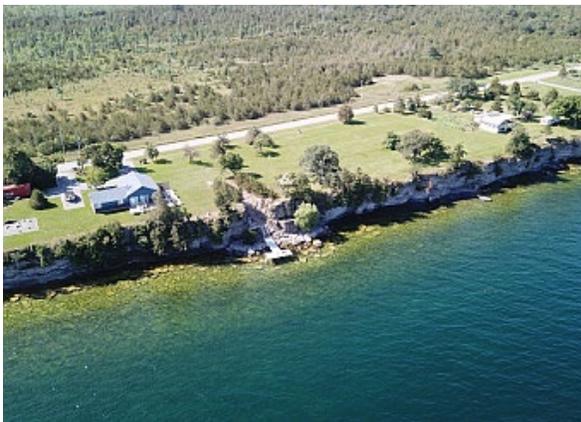
Eroding Bedrock Bluff and Steep/Deep Nearshore

- Reach Length = approximately 33 km.
- Prominent bedrock headlands are found at Flatt Point, Little Bluff, Halfmoon Point, and Point Traverse.
- The nearshore is steep and deep between Flatt Point and Point Traverse, allowing large waves to propagate close to shore and erode the bluff toe.
- South Bay is partially sheltered from the wave climate on Kingston Basin which makes floating or removable boat docks possible (pending approval from QC).
- The head of South Bay features extensive coastal wetlands with emergent/submergent vegetation.
- Dynamic Beaches were mapped at Little Bluff and north of Port Milford.

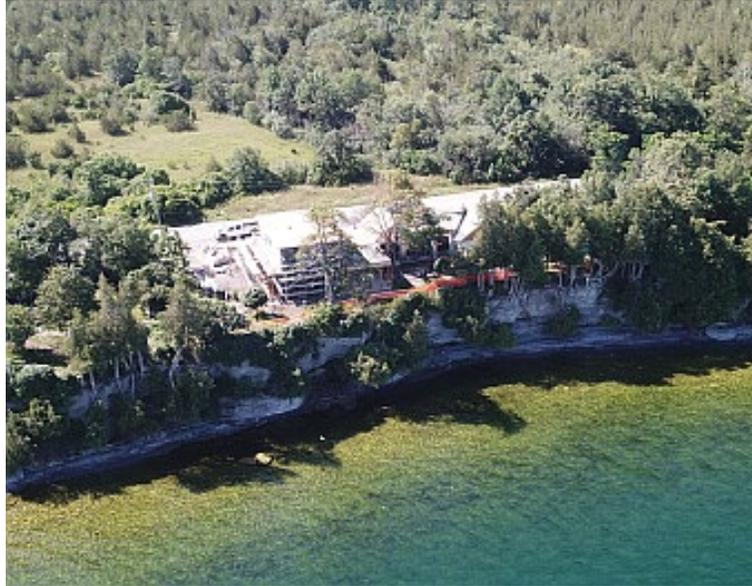
- Development pressure to build on the eroding bedrock bluffs.

- **Avoid:** ensure new development occurs outside of hazardous lands, and prohibit development/re-development of constrained lots affected by erosion.

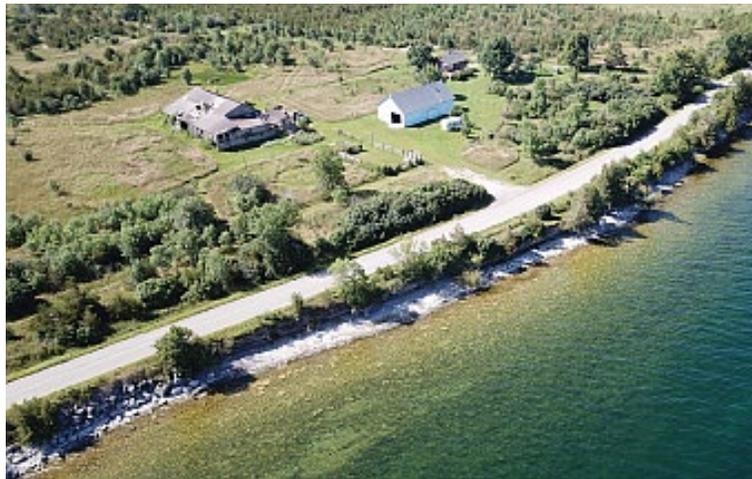
- Sections of Long Point Road are close to the eroding bedrock bank/cliff.

- **Accommodate:** Floodproof buildings, raise foundations, and upgrade septic systems in flood prone areas as per mapping.
- **Retreat and Realign:** Investigate re-alignment of portions of Long Point Rd. exposed to significant erosion risk, and compare to “protect” cost. Move homes away from hazards on deep lots, where possible.

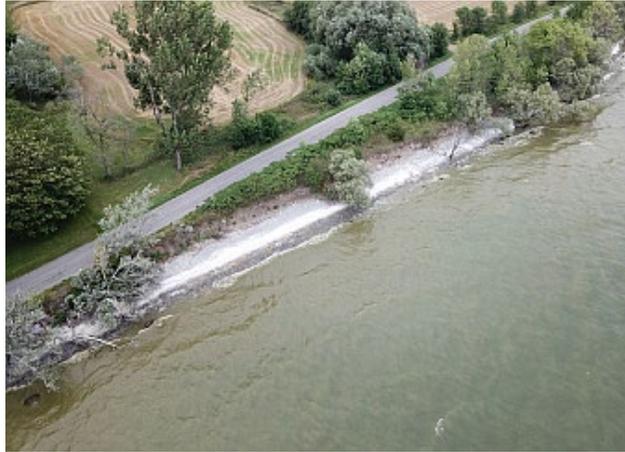
- The natural hazard challenges are relatively minor in Reach 7, with the exception of a few flood prone properties south of Cressy Marsh and Cressy Lakeside Road, and the eroding bedrock escarpment near Mary's Cove.
- Cressy Lakeside Road is located on the edge of an eroding low bank. It is the only ingress/egress route for properties in the area.

- **Accommodate:** Floodproof buildings, raise foundations, and upgrade septic systems in flood prone areas as per mapping.
- **Retreat and Realign:** Investigate re-alignment of portions of Cressy Lakeside Rd. exposed to significant erosion risk, and compare to “protect” cost. Move homes away from hazards on deep lots, where possible.

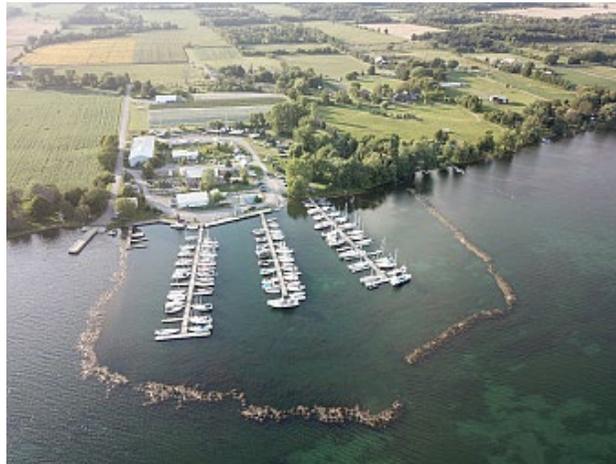
- Waupoos Marina is protected with an old floating tire breakwater which contributes rubber pollution to the lake.

- **Protect:** Investigate traditional shoreline protection structure for Cressy Lakeside Rd. and compare to “re-align” cost. Replace floating tire breakwater at Waupoos Marina with modern, environmentally friendly floating breakwater. Shore protection from Waupoos to Cressy should be carefully designed for bedrock shoreline by a professional engineer. Hybrid grey/green shore protection should be considered for shorelines in sheltered areas behind Waupoos Island (refer to Section 7.3). Monitor and maintain existing shoreline protection structures.

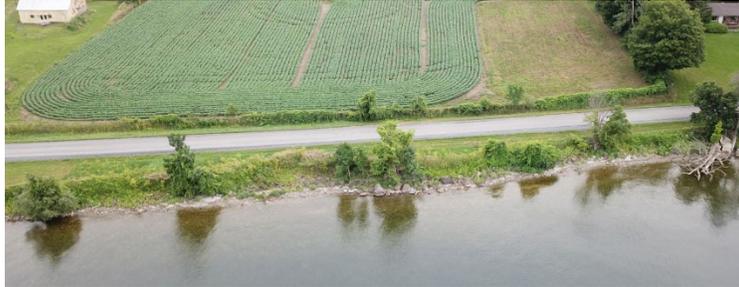
- Coastal hazards in Reach 8 are relatively low, especially compared to the exposed southwest shoreline of Prince Edward County.
- Cressy Bayside Rd. runs along the top of bank for approximately 2 km and may be affected by flooding and erosion during major storms coupled with high water levels.

- **Protect:** monitor bank erosion and flooding of Cressy Bayside Rd. and mitigate as required with shoreline protection (refer to Section 7.3 of the SMP). Monitor and maintain existing shoreline infrastructure in Glenora. Hybrid grey/green erosion and flood protection schemes are recommended. Vegetated rip rap toe protection is recommended for steep embankments where shoreline erosion may lead to slope instabilities.

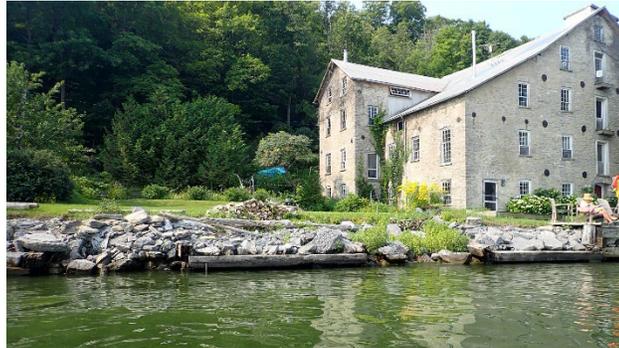
- Aging ad-hoc shore protection structures are prevalent in and around Glenora.

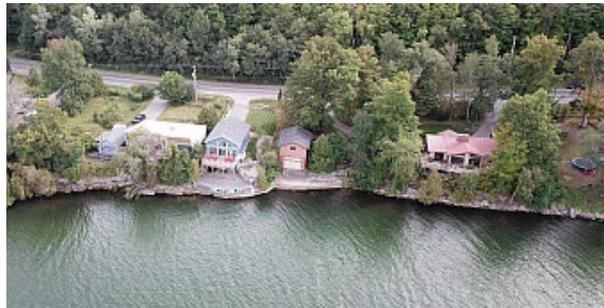
- Many properties west of Glenora feature buildings close to the shoreline that require shore protection or upgrades to existing, aging shoreline protection.

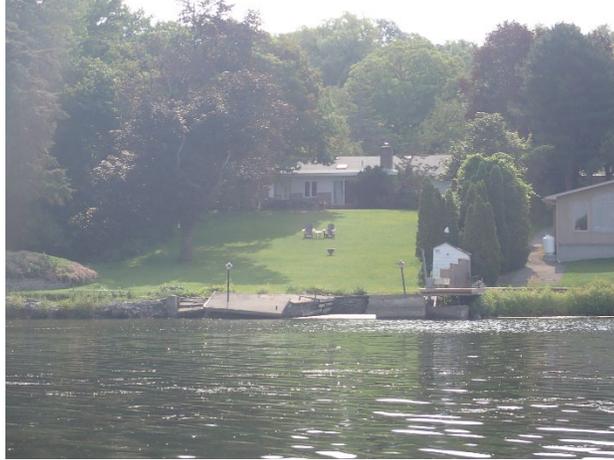
- The challenges and risks associated with natural hazards are low in Reach 9.
- Some aging shore protection requires repairs or replacement. All shoreline infrastructure requires monitoring and regular maintenance.

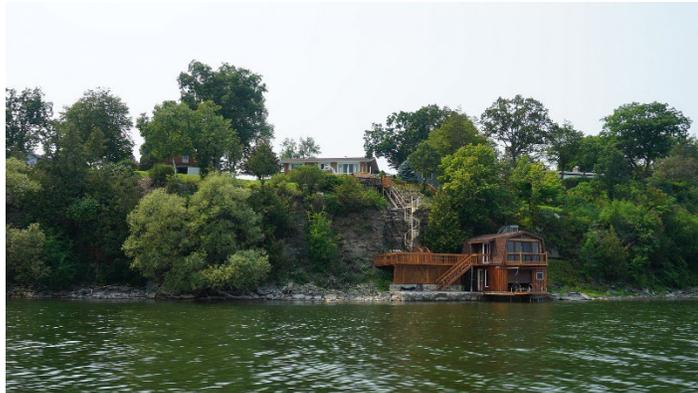
- Boat houses and fixed elevation docks may be vulnerable to high lake levels.

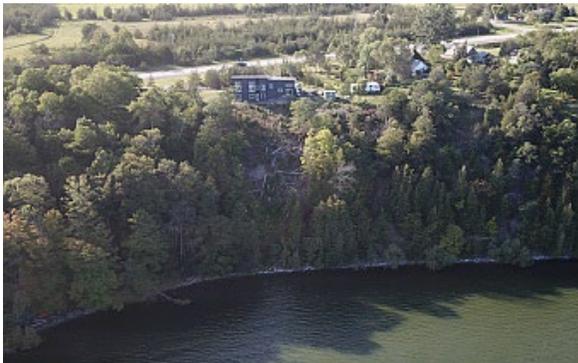
Bedrock Bluff with New Development and Tree Clearing on Slope

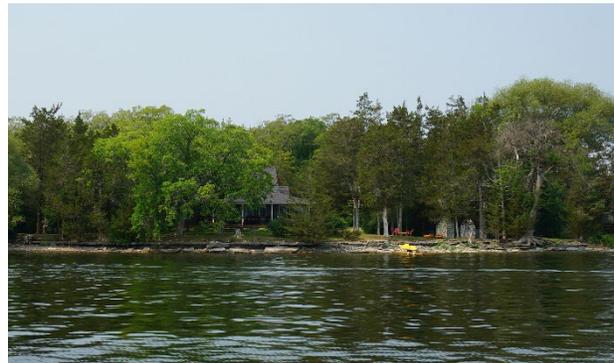
Low Plain Bedrock Shoreline near Green Point Lane

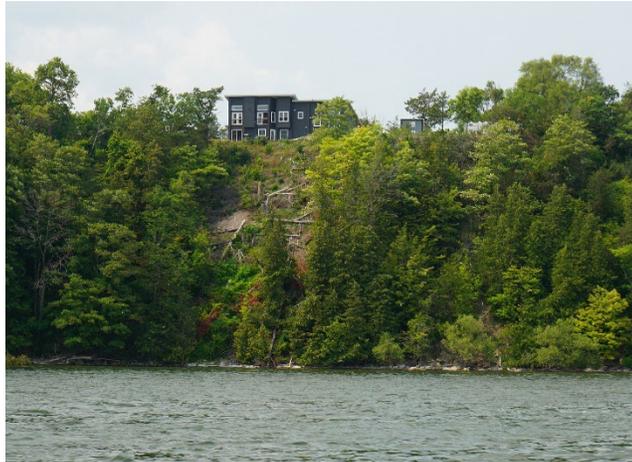
- Given the limited fetch in Reach 10, wave heights are small relative to the Lake Ontario shoreline. Consequently, exposure to erosion and flooding hazards is also small compared to Reaches 2 to 7. Boat wakes are of similar concern to wind-generated waves.
- Wave uprush is unusually high for such a small wave climate due to the deep nearshore and steep slopes at the waterline throughout much of the reach.
- Tree removal on the bedrock bluffs may destabilize the slope and accelerate erosion.

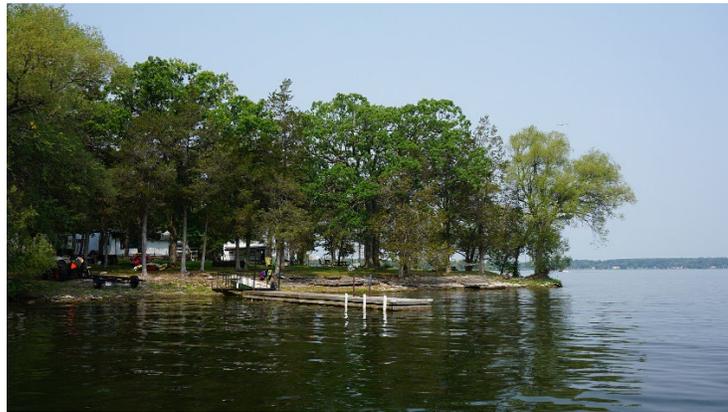
- At the north boundary of Reach 10, several lots are low-lying and vulnerable to flooding.

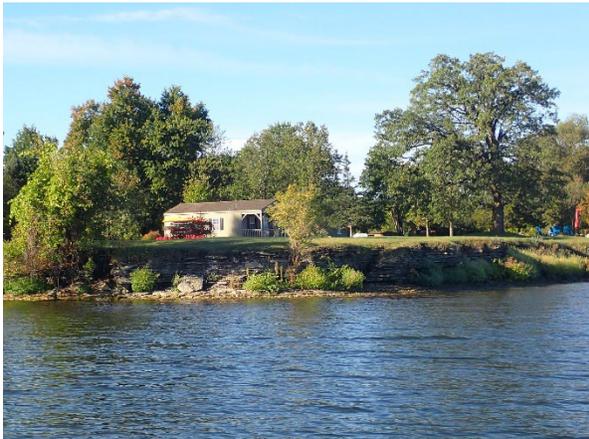
Low bank bedrock shoreline

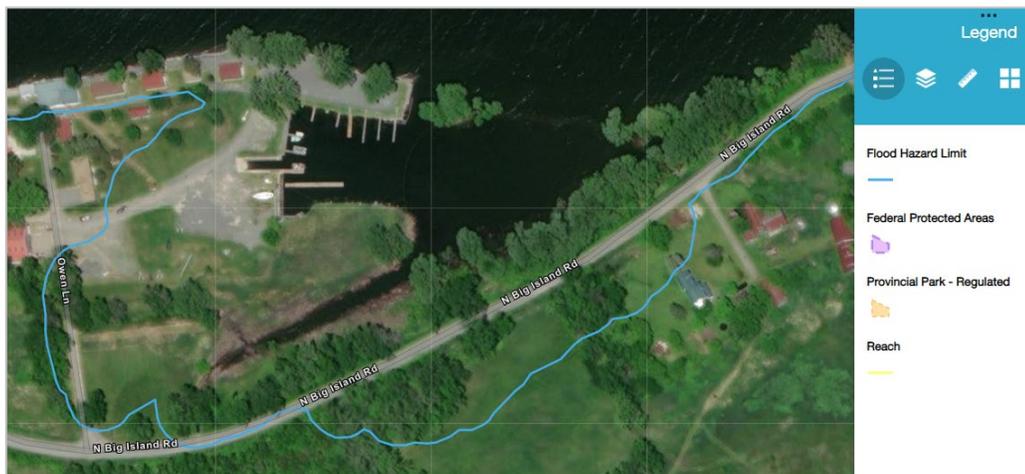
- Sections of Big Island (north side) are located within the Flood Hazard Limit, along with infrastructure (e.g., marina basin). This is a challenge in Robinson Cove as well.

- **Accommodate:** site specific investigations are required for communities with safe access challenges, as identified through the hazard mapping. Floodproof buildings, raise foundations, and upgrade septic systems on flood prone lands. Emergency planning and preparedness for a major flooding event.

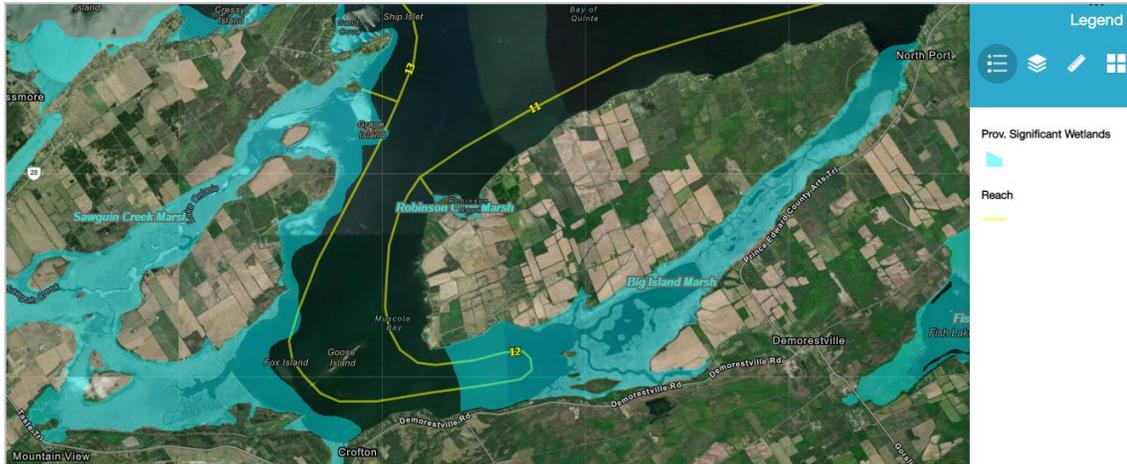
- Provincially Significant wetlands make up the majority of the shoreline in Reach 12, as seen in the map below.
