Quinte Conservation Shoreline Management Plan

Quinte Conservation

June 21, 2022

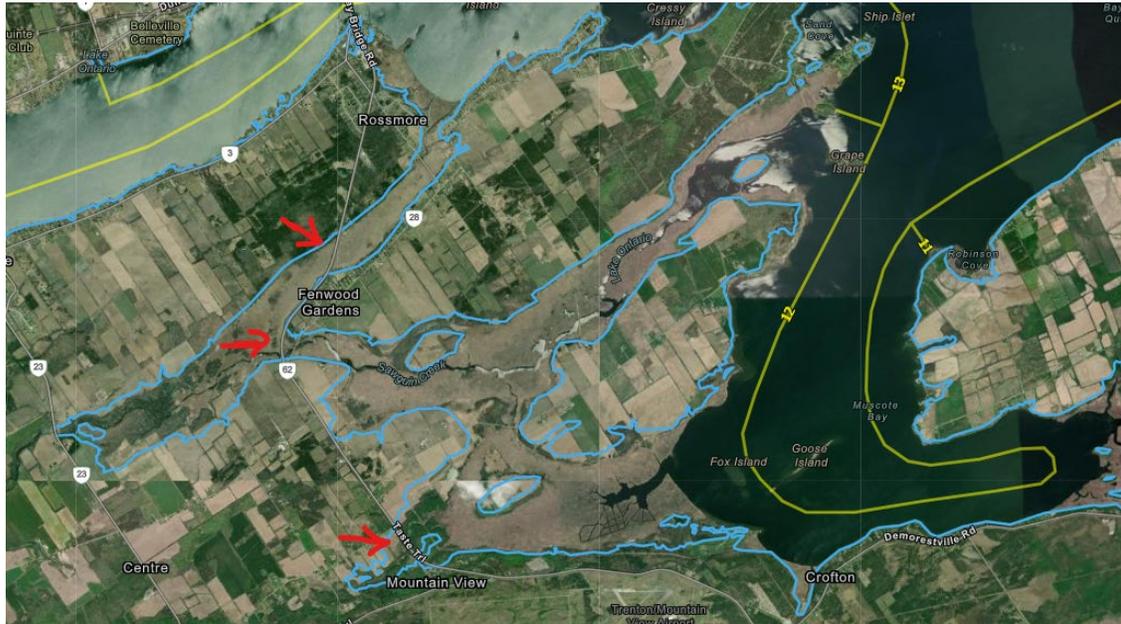
- With the high percentage of natural shoreline in Reach 12, challenges related to natural hazards are relatively low, especially compared to the exposed lake shoreline.
- Three locations along Highway 62 that cross the Sawquin Creek Marshes west of the shoreline in Reach 12 are within the Flood Hazard Limit (see red arrows and blue Flood Hazard Limit line below). These areas require further local studies.

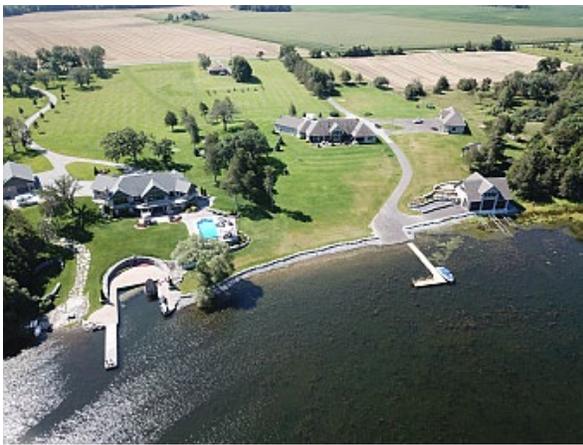
Developed Shoreline with Hardened Edge and Docks

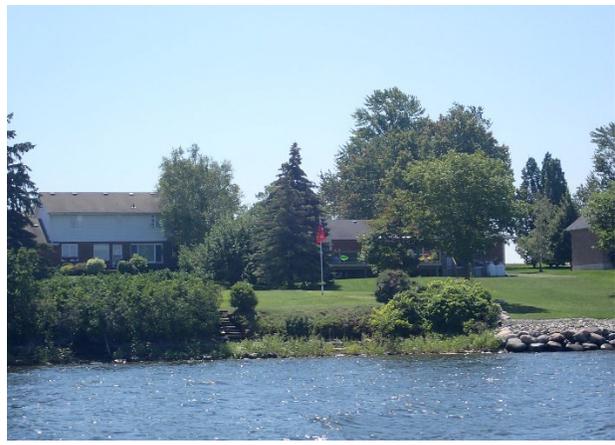
Natural Shoreline Adjacent to Hardened Shoreline (right)

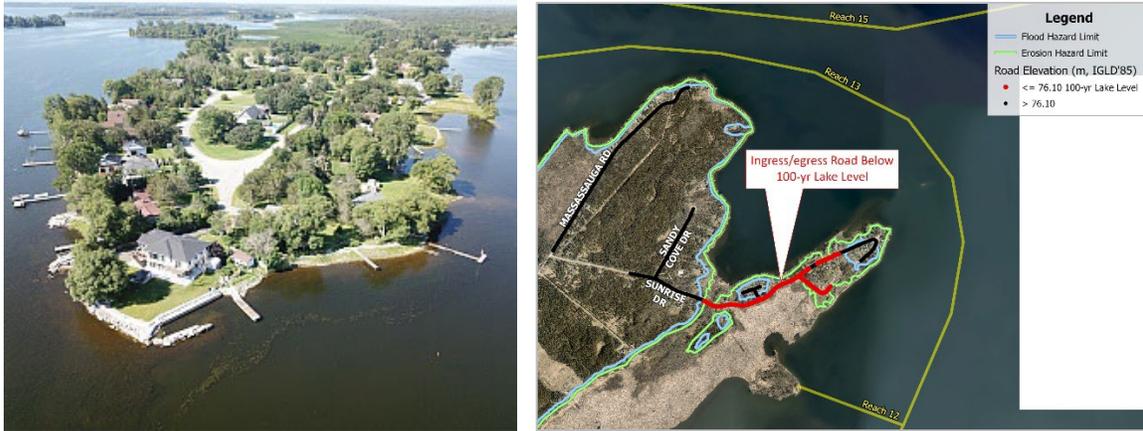
- Horse Point is accessible from Sunrise Drive. The majority of the road is below the 100-year flood level and the peninsula is within the Flood Hazard Limit (some of the homes are elevated above the 100-year flood level). Refer to the picture and map below.

- **Accommodate:** site specific investigations are required for communities with safe access challenges, as identified through the hazard mapping. Floodproof buildings, raise foundations, and upgrade septic systems on flood prone lands. Emergency planning and preparedness for a major flooding event.

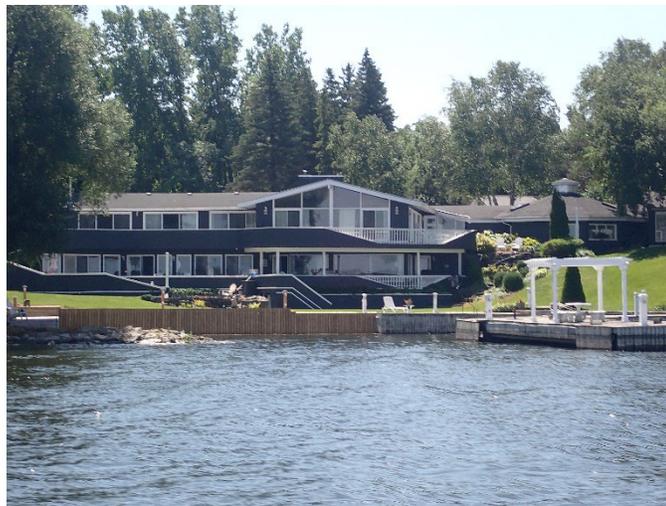
- Fixed level docks are vulnerable to flooding and wave overtopping during periods of high lake levels.

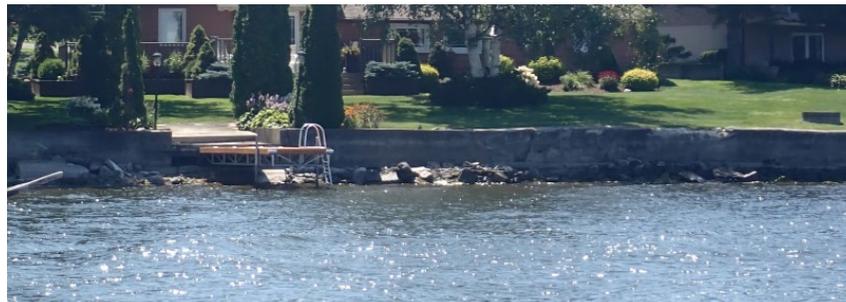
- A significant amount of aging shoreline protection structures are present in Reach 13, including several examples of concrete seawalls that are close to or beyond the end of their serviceable design life.

- **Protect:** Nature-based or hybrid grey/green erosion and flood protection schemes are recommended, as discussed in Section 7.3.2 of the SMP. All existing shoreline protection should be monitored and maintained regularly. Existing infrastructure can be improved with nature-based components such as cobble toe protection or vegetated buffers. Failing concrete, steel and gabion basket structures should be replaced with hybrid grey/green structures before outright failure.

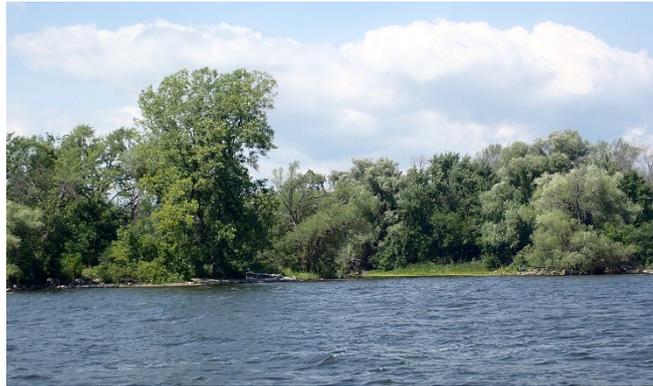
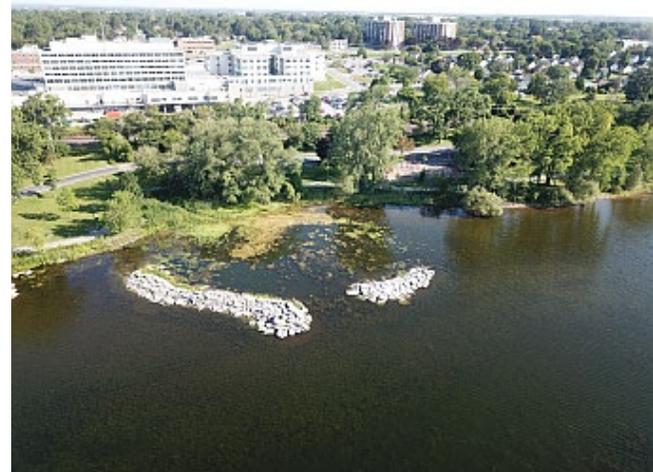
Shoreline Type - Reach 14

- The western portions of Reach 14 alternate between developed shoreline and natural conditions (top image).
- The majority of the Belleville waterfront is armoured with a variety of sloping rock structures and vertical walls (armour stone, concrete, or steel sheet pile).

- East of the Belleville waterfront more natural shoreline conditions return, and some nearshore habitat enhancements were observed (e.g., rock islands fronting hospital lands, bottom image).

- Reach 14 shoreline approximately 50% natural and 50% armoured, making it the most armoured shoreline in the entire project geography.
- Of the armoured portion of the shoreline, 36% is ad-hoc field stone or quarry stone bank protection, 31% engineered revetment, 14% concrete seawall, and 7% is steel sheet pile.

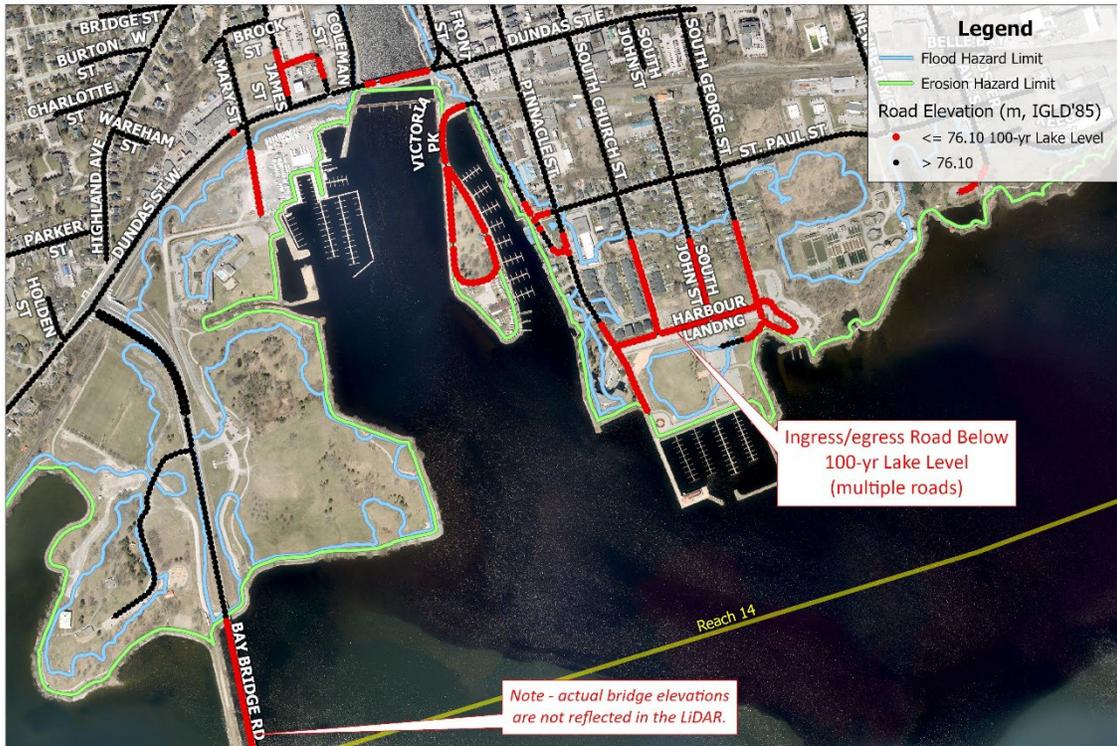
- A significant area of Belleville on the east banks of the Moira River are within the Flood Hazard Limit. Refer to the map below illustrating municipal roads below the 100-year flood level (in red). Victoria Park and the lands north of Jane Forrester Park (Church, John, and George Streets) are all below the 100-year flood level, indicating that they would be flooded during non-storm conditions when lake levels are very high (e.g., 2019).
- Similar challenges exist for the Crate Marina on the west banks of the river.

- **Accommodate:** site specific investigations are required for areas within Belleville where safe access is impeded during major flooding events, as identified through the hazard mapping. Site specific investigations should look for solutions to access issues in all existing communities based on the flooding hazard mapping and accounting for likely future impacts of climate change. Floodproof buildings, raise foundations, and upgrade septic systems on flood prone lands. Emergency planning and preparedness for a major flooding event.

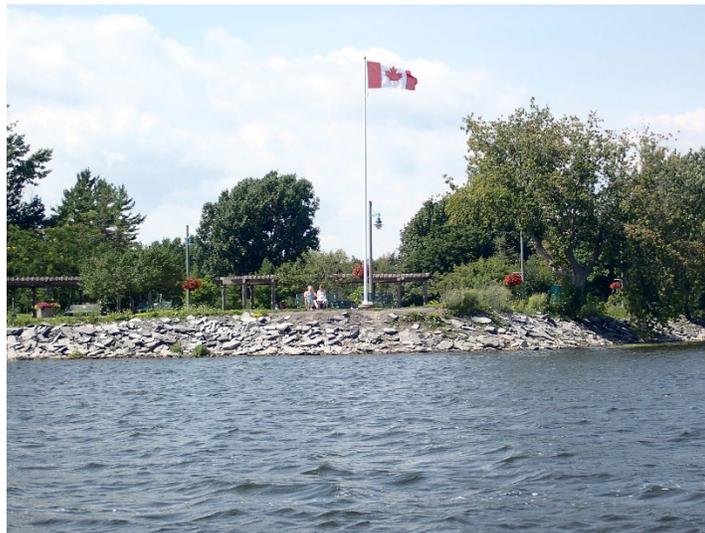
- High lake levels and erosion have damaged the existing shore protection in places, including at East Zwick's Centennial Park (pictured below).

- **Protect:** Nature-based or hybrid grey/green erosion and flood protection schemes are recommended, where feasible, as discussed in Section 7.3.2 of the SMP. All existing shoreline protection should be monitored and maintained regularly.

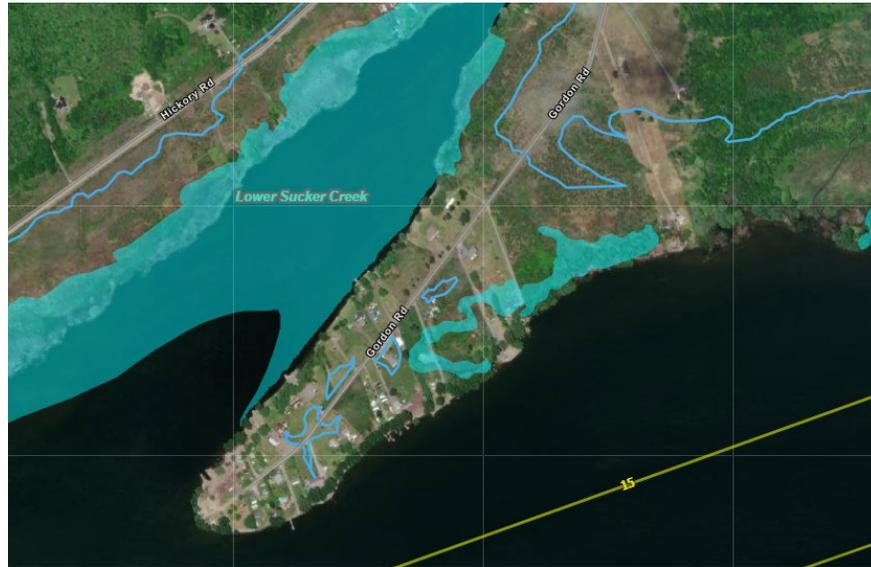
- The biggest challenge with natural hazards in Reach 15 is flooding.
- Several developments located on peninsulas along the lake, such as Gordon Road (pictured below), are within the Flood Hazard Limit and safe access on the road may not be possible during the 100-year flood level.

- **Accommodate:** site specific investigations are required for communities with safe access challenges, as identified through the hazard mapping. Floodproof buildings, raise foundations, and upgrade septic systems on flood prone lands. Emergency planning and preparedness for a major flooding event.

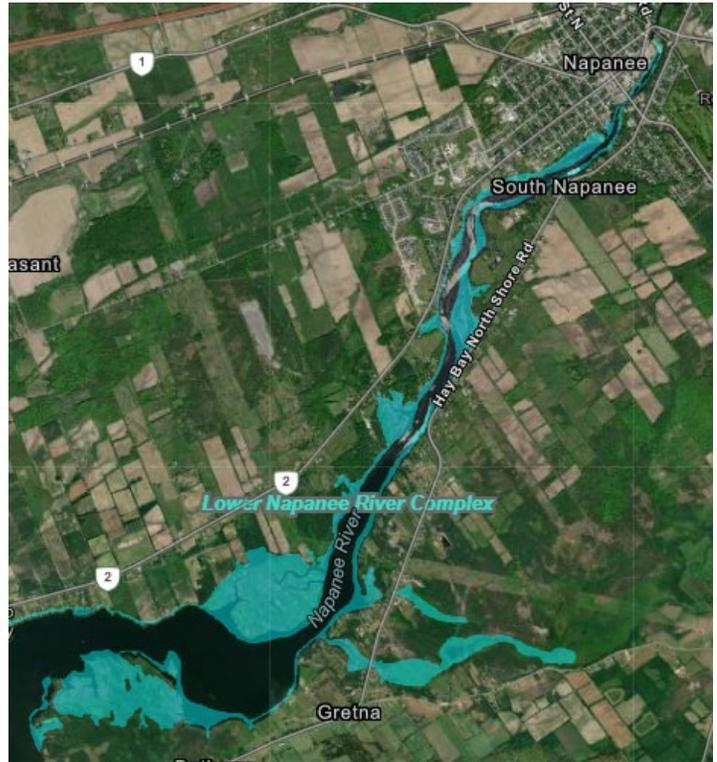
Shoreline Type - Reach 16

- From the falls to Centre Street, the riverbanks are partially armoured and confined to the bedrock channel.
- Below Centre Street, the riverbanks are generally in a natural state and the floodplain spills the banks in some locations.
- A significant portion of Reach 16 features provincially significant wetlands known as the Lower Napanee River Complex.
- The Reach 16 shoreline is approximately 94% natural and only 6% armoured, based on the entire shoreline length including coastal wetland areas.
- Of the armoured portion of the shoreline, 37% is ad-hoc field stone or quarry stone bank protection, 23% is wood or timber structures, 9% is armour stone seawall, 3% is cast-in-place concrete seawall, 3% is composite revetment-seawall, and 22% is steel sheet pile.
- Tolerance for additional shoreline hardening is low.

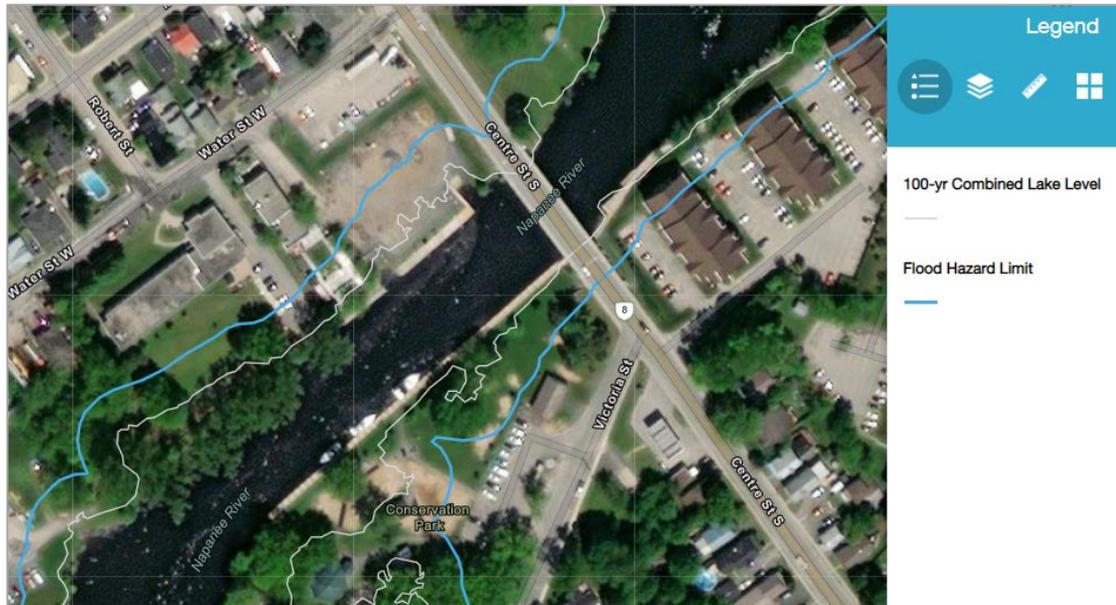
- For the lower portion of Reach 16 including the rivermouth there are no natural hazards since wetlands define the riverbanks and they are resilient to lake level fluctuations and storm impacts.
- At Centre Street South, the 100-year flood level is higher than the riverbanks, suggesting a storm surge that propagates up the river could flood the banks and low-lying infrastructure, such as parking lots. See map below.
