**Quinte Source Protection Region
Updated Conditions Report**

**Submitted to the Source Protection Committee
as part of the
Updated Assessment Report**

April 25, 2019

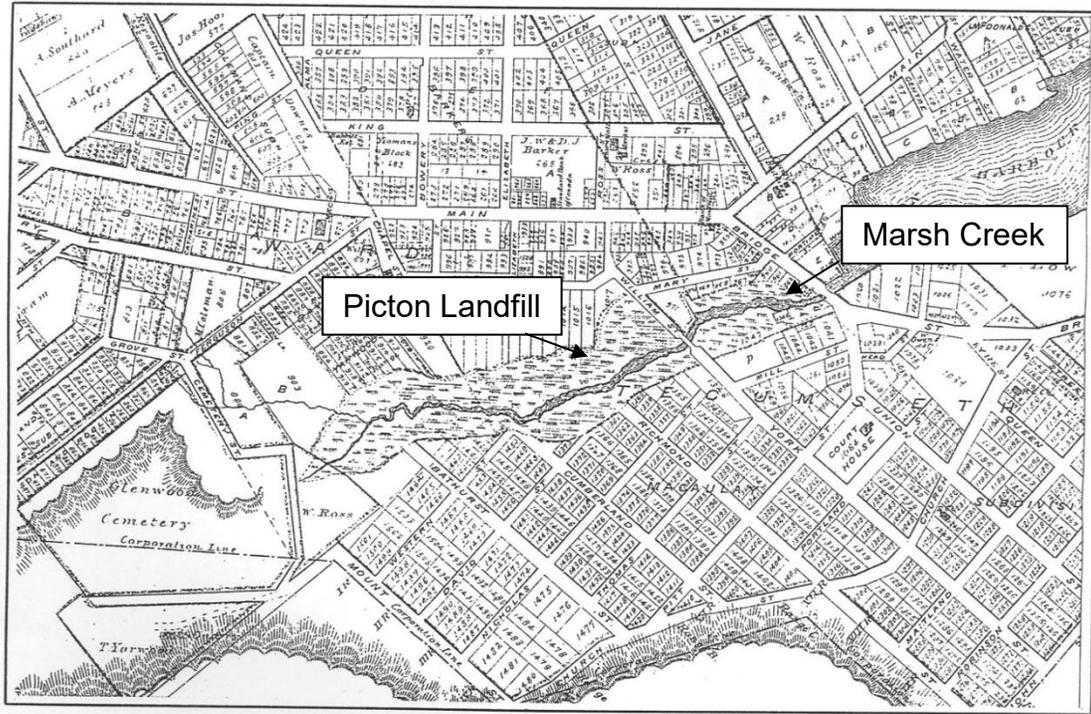
Map 1

From this compilation, two sampling sites were noted in the general area of the Picton intakes as illustrated by Map 1. One station (labeled as EHD-6) is located near the mouth of Marsh Creek where it discharges to Picton Bay, downstream of the landfill site and the sewage treatment plant outfall. This site was part of an Environment Canada study when samples were collected between July and November of 2003. During this study surface sediment samples were taken to a depth of 1-2 cm and analysed for trace metals, PCBS, as well as PAHs.

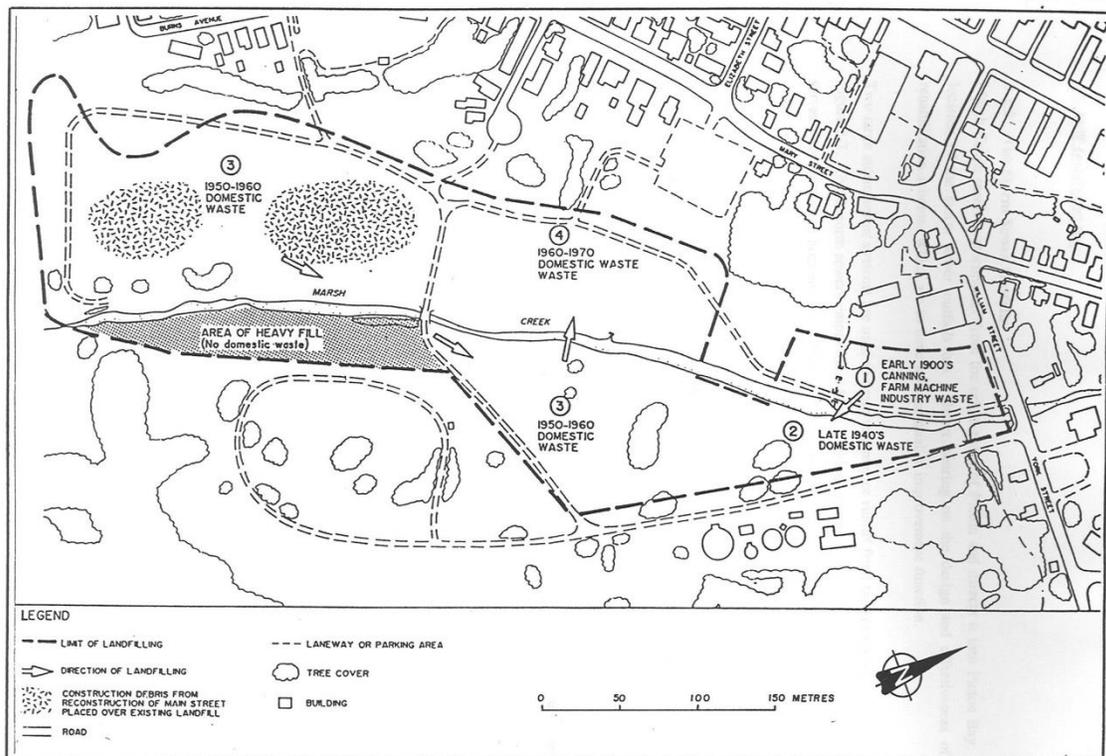
Figure 1: Town of Picton Landfill Site

It was reported that landfill operations was recommended to maintain a 30 metre separation from Marsh Creek. However this recommendation did not appear to be followed (Water & Earth Science Associates, 1989). Water quality monitoring of the creek by the Ministry of the Environment in 1971 and 1979 found the landfill to be impacting on the creek with some parameters identified at higher levels in 1977 than in 1971.

MARSH CREEK AND SURROUNDING WETLAND - 1878

LANDFILL DESCRIPTION

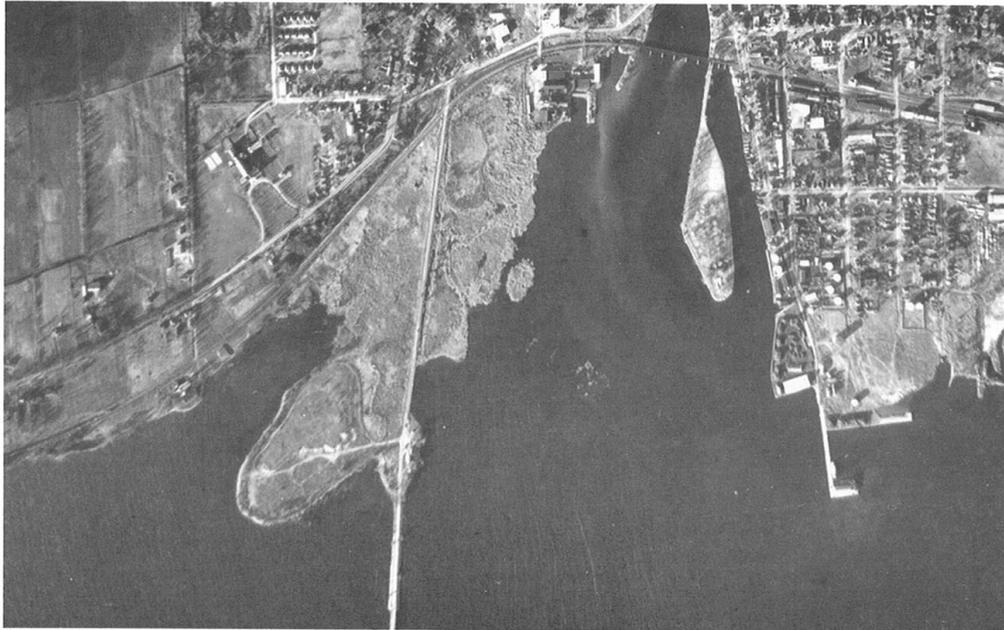
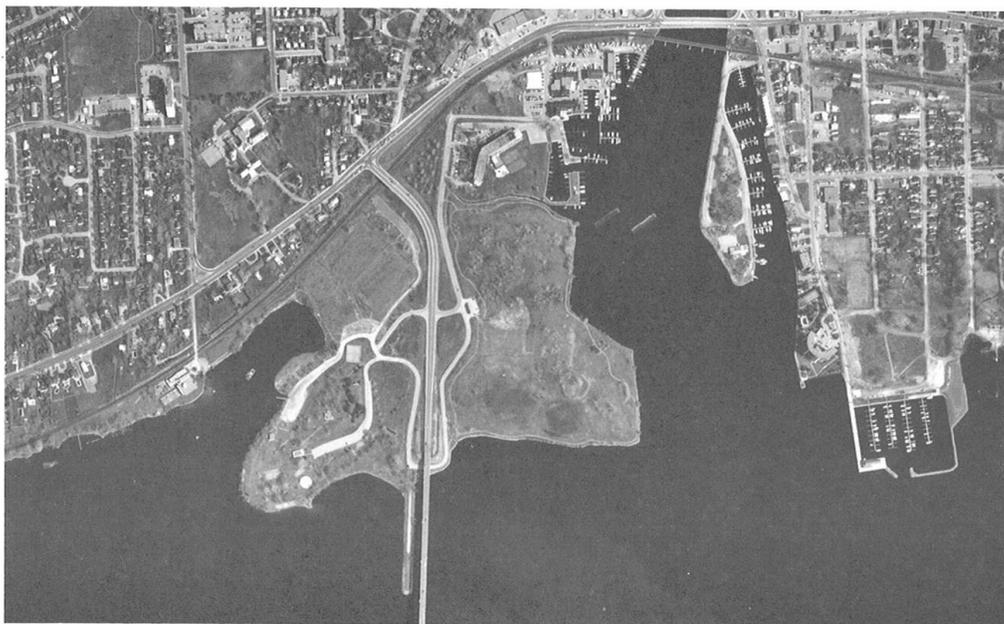
Figure 2: Zwicks Island Landfill Before & After Filling

Aerial Photograph 1 (Roll No. A11795-73) Zwick's Island, Belleville, December 3, 1948

Aerial Photograph 2 (Roll No. 92032-10-132) Zwick's Island, Belleville, May 6, 1992
