East Lake State of the Lake

2012 / 2013

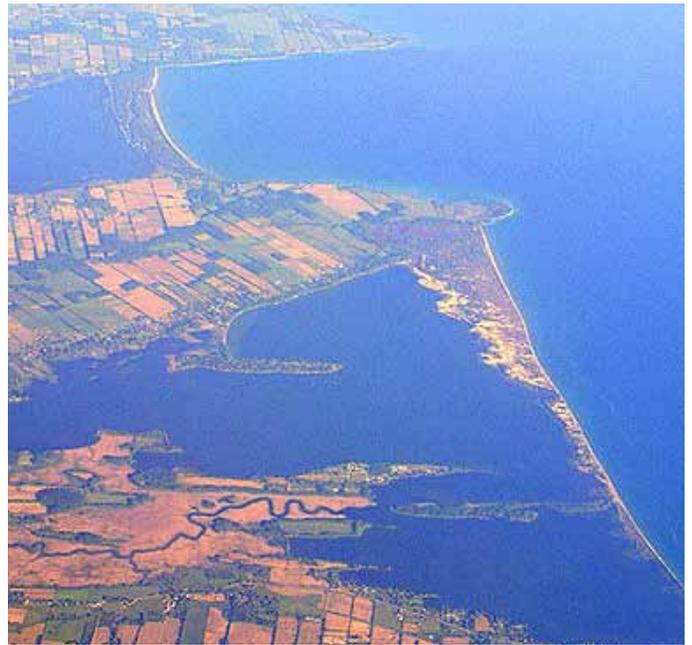
Above: West Lake and East Lake Sandbars

East Lake was initially created following the retreat of the last glaciers; about 12,000 years ago. Wave and wind action along the early Lake Ontario shoreline caused sand to accumulate and create baymouth sandbars that separated both East and West Lakes from Lake Ontario. East Lake is connected to Lake Ontario via the Outlet River. Under normal conditions, the Outlet River is open to Lake Ontario during the summer months and the water level in East Lake corresponds very closely to that of Lake Ontario. However, at certain times of the year the outlet of the river becomes plugged.

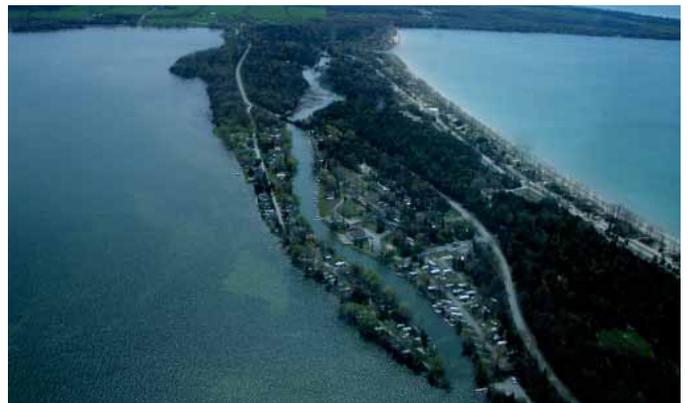
Above: Outlet River on East Lake Sandbar

The Outlet River formed between East Lake and Lake Ontario to drain water out of East Lake when East Lake levels were higher than Lake Ontario. When the water levels of Lake Ontario and East Lake are the same the Outlet River can naturally close off as the water flow from East Lake is significantly reduced, causing the longshore transport of sediment along Lake Ontario to fill in the outlet of the river. It is also possible that some back flushing may occur when Lake Ontario is at the same level, or higher, than East Lake.

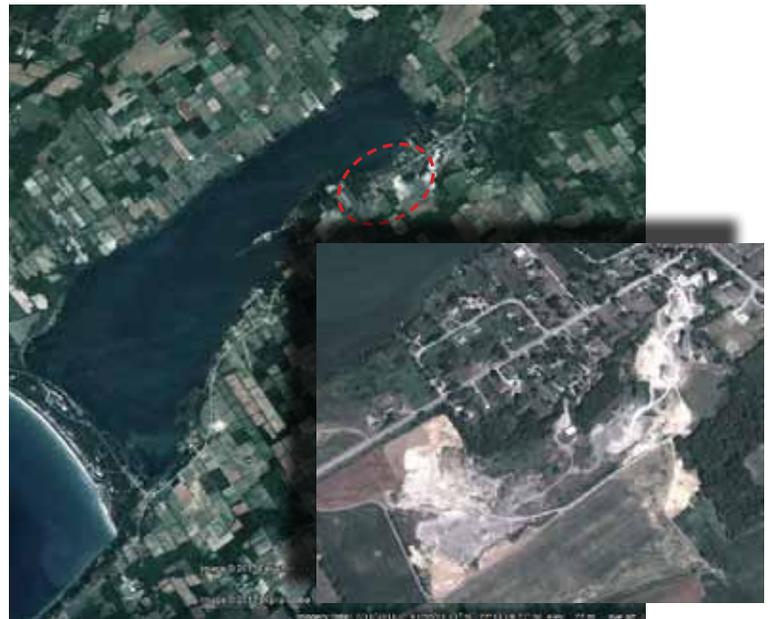
Above: The Cherry Valley Esker, where today a gravel pit exists.

The Cherry Valley Esker formed on the southeast side of the Lake, part of which can be seen in the aerial photograph to the right. An esker is a long, narrow, winding ridge composed of stratified sand and gravel. It is formed by glacial meltwater that formed rivers that flowed within and under the ice. Eskers are often quarried for sand and gravel as the material is readily accessible. The photo to the right shows the sand and gravel from the Cherry Valley Esker that is being quarried today (Water & Earth Science Associates Ltd. 1985).

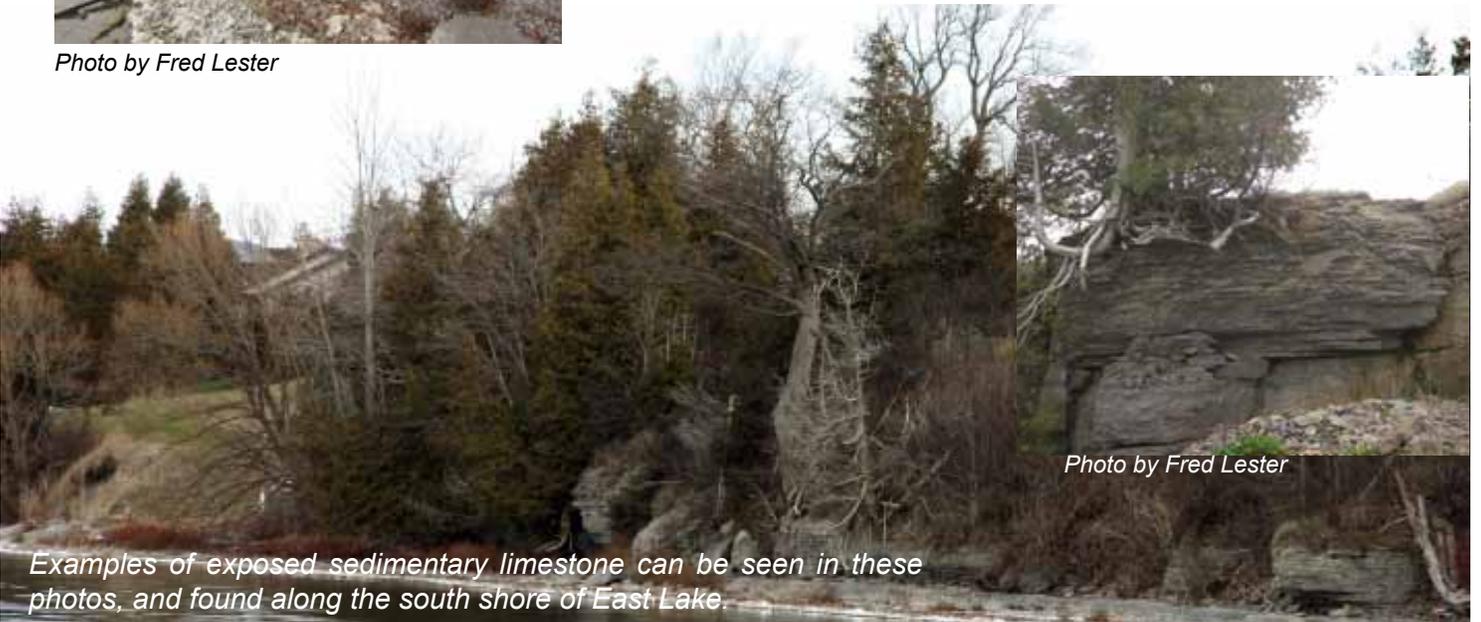
Examples of exposed sedimentary limestone can be seen in these photos, and found along the south shore of East Lake.

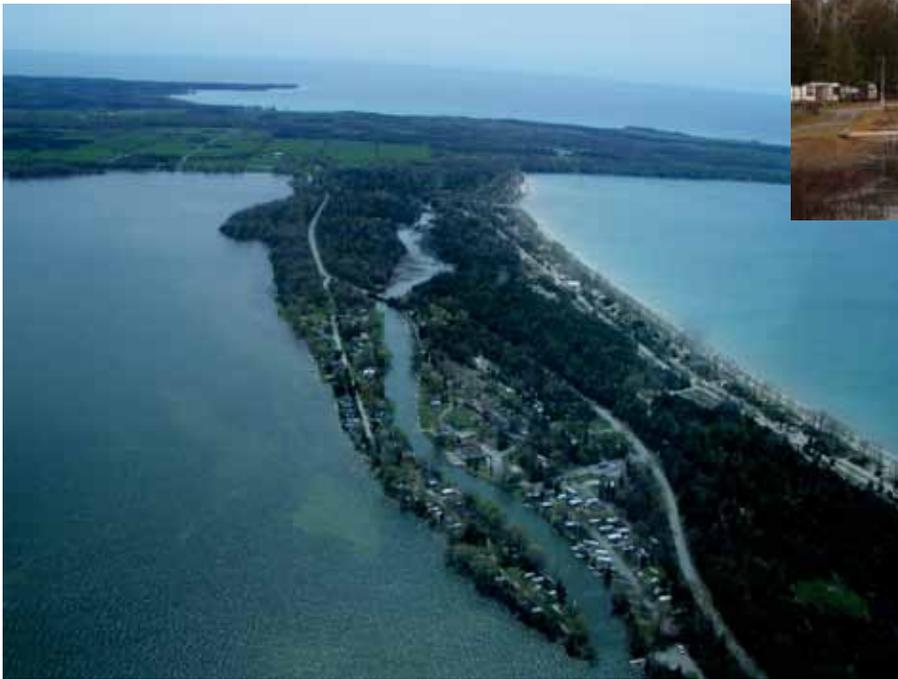
Above: View looking northwest of the Outlet River in January 2013

Under normal conditions, the Outlet River is open to Lake Ontario during the summer months and the water level in East Lake corresponds very closely to that of Lake Ontario. During the late summer and early fall the flow of water in the river decreases and the water level of Lake Ontario also drops; exposing a larger expanse of sand beach. Currents along the shoreline of Lake Ontario, also known as littoral drift, with wind and wave action gradually redistributes the sand along the shore and this action can block the mouth of Outlet River. When the river is blocked, water levels on East Lake have risen by as much as 0.6 metres during the late fall and winter. With the spring melt and additional runoff into East Lake, the sand plug at the river mouth breaches and a channel is scoured through the sand beach returning the East Lake water level to the same as that of Lake Ontario.

During the summer months, it is noted that virtually no flushing of the lake occurs; water which is lost by evaporation is balanced with surface runoff or precipitation falling directly on the lake. Discharge at the mouth of the Outlet River is noted to peak during the spring thaw, mid-March to mid-April, when snow and ice are melting at approximately 24.5 cubic metres per second.

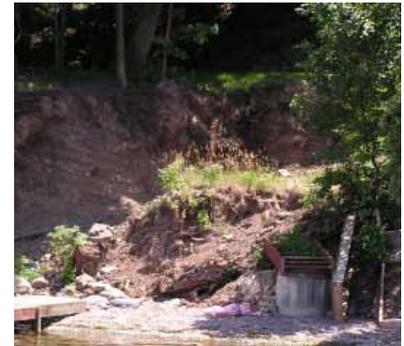
Above: Eroded Shoreline

In 1986 when water levels on Lake Ontario were at record highs abnormally high levels on East Lake lead to significant erosion damage during the late fall of the year. The former Prince Edward Region Conservation Authority (now Quinte Conservation) subsequently assisted landowners in protecting their shorelines through the planting of trees and shrubs, the installation of livestock fencing along the north shoreline, and installation of rubble rip rap or gabion baskets along the southern shore (J. D. Paine Engineering, 1989).

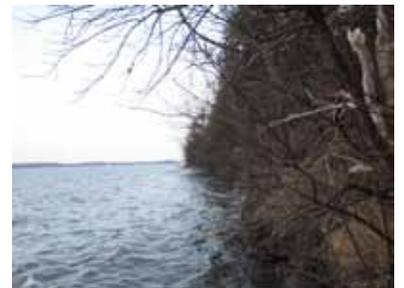
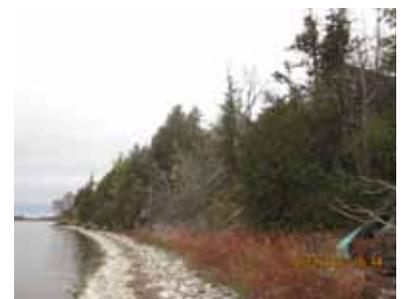
Above: High water and low water both shown in 2012

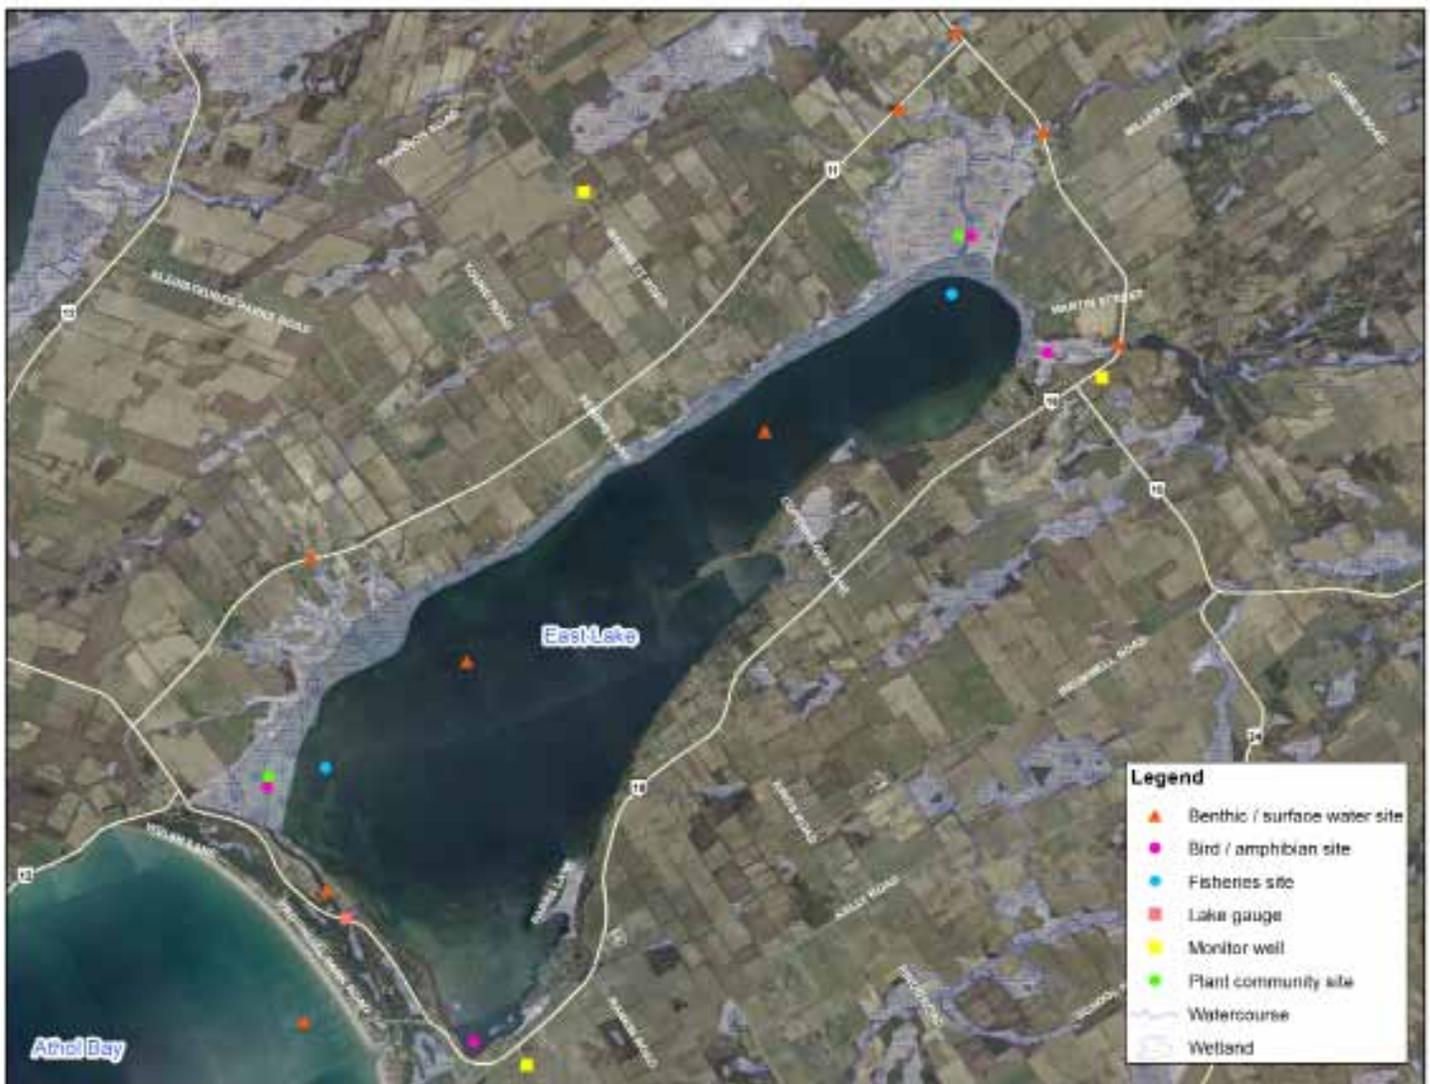
Summary of 2013 Sampling Results by Quinte Conservation

Species abundance for wetland plants, marsh indicator amphibians, fish and birds were all very good. There were some slight exceedences in surface sampling for a few parameters but nothing of concern to Quinte Conservation staff. Exceedences tended to coincide with natural causes, ie. pH due to limestone weathering, manganese and iron from soil leaching and dissolved organic carbon from the wetlands.

The benthic sampling was as expected for the watercourse conditions. Many of the tributaries in the summer months are low flow and historic sedimentation makes for difficult living conditions for benthics.

Ground water monitoring showed water table fluctuations of up to 3 metres over a relatively short monitoring period. in the shallow wells water fluctuations were in direct response to precipitation. A deep well in Cherry Valley did not fluctuate in response to precipitation. Lake levels were noted to fluctuate (approximately 0.3 metres) in response to precipitation and exhibited similar patterns to groundwater levels.

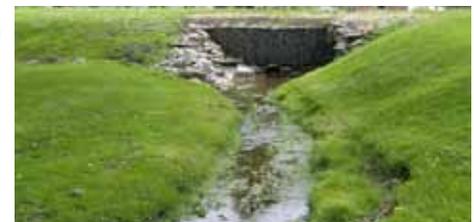
Above: A stream sampled in 2007

Watercourses draining into East Lake were sampled by Quinte Conservation staff in 2007 for various parameters, including phosphorus. The samples indicated that total phosphorous concentrations were found to occasionally be greater than the Provincial Water Quality Objectives (PWQO) downstream from Beaver Meadows watercourse station, and in every sample taken from the Cherry Valley watercourse station. The increased nutrient levels could be from adjacent land uses, such as agricultural lands at the Beaver Meadow site and stormwater and sewage effluent from the Cherry Valley site. Phosphorus results from the 2013 sampling were highly variable with minor exceedences. Additional stream studies will help in understanding the ongoing trends.

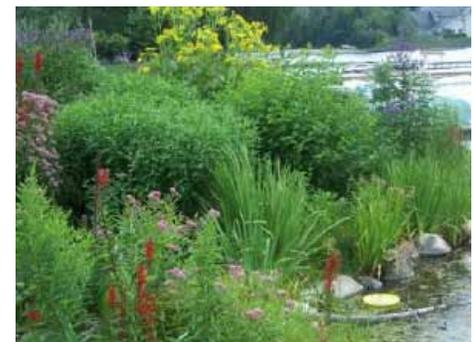
Above: A cottage shoreline planted with native flowering plants and shrubs aids in; shoreline stabilization, limiting soil erosion, purifying land runoff before it enters the lake water, and creating a beautiful shoreline that attract birds, butterflies, dragonflies and small animals by providing food and shelter.
