QUINTE CONSERVATION

Consecon Lake and Creek Flood and
Erosion Hazard Mapping

Floodplain Mapping Report

23-4192-001

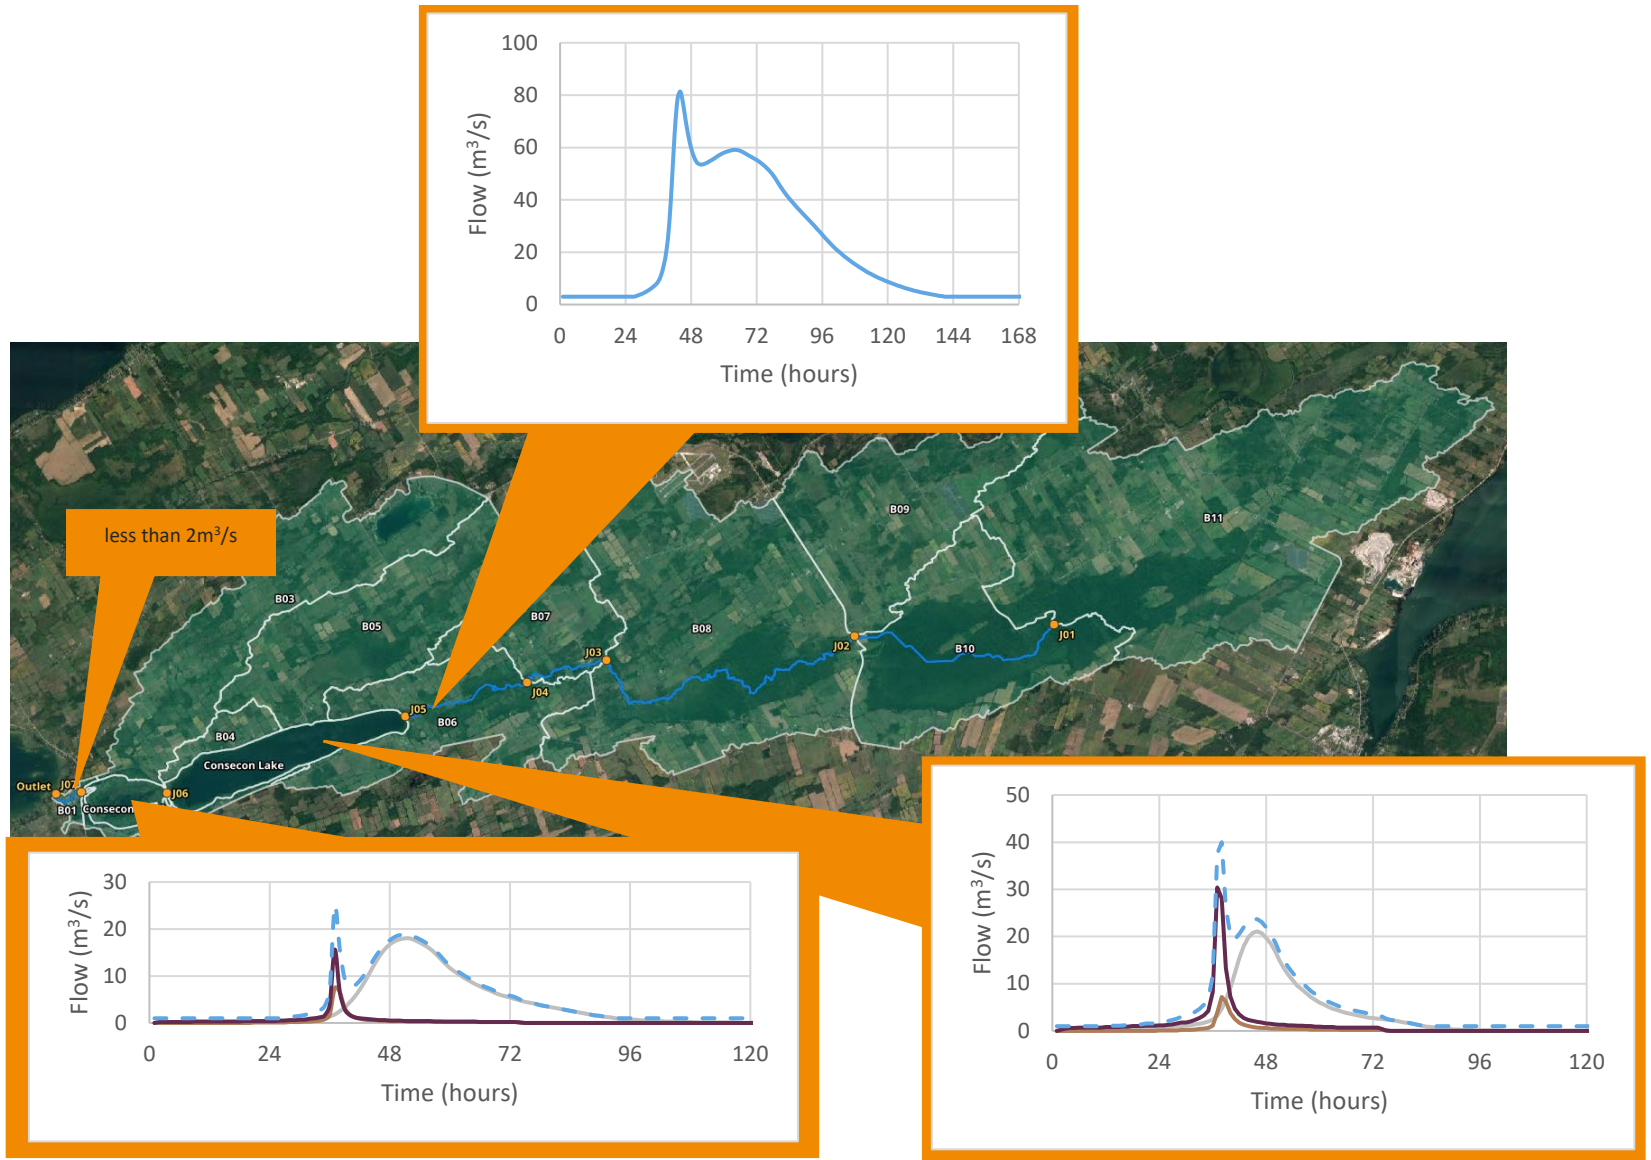
FIGURE 2-2: HYDROLOGIC INFLOWS 100-YEAR (1% AEP) FLOOD

The input flows for the hydraulic analysis were the results obtained with the hydrologic model described in KGS Group (2024a). Figure 2-2 shows the values that correspond to the 100-year (1% AEP) flood, which was adopted as the Regulatory Flood. These include:

- Consecon Creek flow hydrographs upstream of Consecon Lake. The peak flow value for 100-year (1% AEP) flood was 81 m³/s (time 43 hours), with a second peak flow of 60 m³/s (time 64 hours).

- Hydrograph for local inflows to Upper Consecon Lake. This hydrograph combines the outflows obtained with HEC-HMS for two sub-catchments adjacent to the lake plus those from the sub-catchment used to represent direct precipitation on Upper Consecon Lake. The peak flow value for the 100-year (1% AEP) flood was 40 m³/s (time 38 hours) and there is a second peak of 23 m³/s (time 47 hours).

- Hydrograph for local inflows to Lower Consecon Lake. This hydrograph combines the outflows obtained with HEC-HMS for two adjacent sub-catchments plus those representing direct precipitation on Lower Consecon Lake. The peak flow value for the 100-year (1% AEP) flood was 25 m³/s (time 37 hours) and there is a second peak of 19 m³/s (time 52 hours).

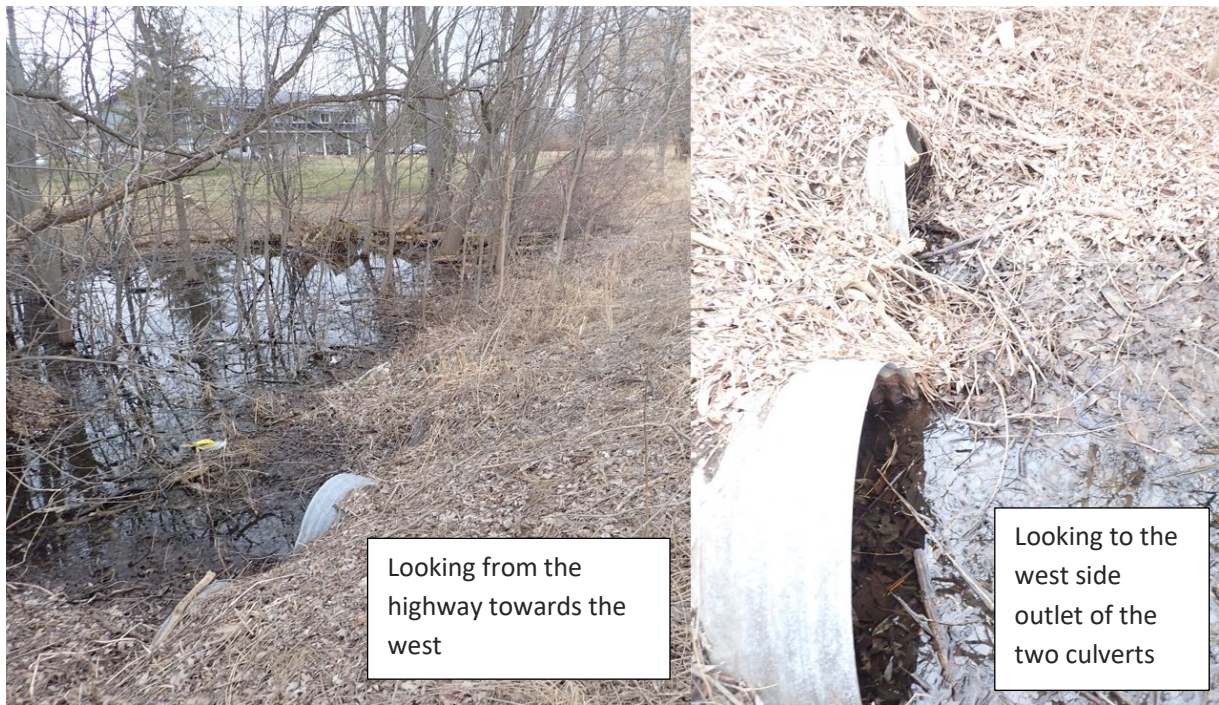
FIGURE 3-1: CULVERTS ALONG HWY 33-WEST SIDE OF THE ROAD

After those simulations had been completed, a visual inspection was conducted by KGS Group. Figure 3-1 shows the culverts along Hwy 33 as inspected at the site. In the low area, where flows from the lake pass to the west of Hwy 33, there are two CSP culverts with a diameter of 0.95 m. The cross-sectional area of the two CSP pipes found on the site is 1.42 m², while the equivalent area of the three CSP pipes included in the initial model is 1.37 m². While the model was adjusted, to provide a corrected model to QC, the difference between the initial assumption and the conditions found on site are so small that they would not change the results obtained with the initial simulations. Furthermore, the adjustment to the model does not affect the floodline definition because, to comply with Provincial guidance, the floodline was prepared based on the conditions in which the embankment of Hwy 33 was removed (i.e. as if the embankment in the low area was washed out).

The culverts across Hwy 33 were included in the model based on the initial information available (three CSP culverts with a diameter of 30") in the low terrain approximately 180 m south of the bridge. The model was run with this configuration. A separate simulation was carried out in which the model was run as if the highway embankment was washed out in that area of low terrain, allowing direct connection to the high lake levels. This simulation was important because as per Ontario policies and guidelines, embankments are not considered permanent solutions and the areas protected by them are still considered part of the floodplain.

It must be noted that there are more culverts across Hwy 33, nearby (there is a set of culverts, one 0.95 m CSP and one 0.76 m CSP, closer to the bridge over Consecon Creek) but those would not act as a connection from the lake to the ditch during the simulated events.

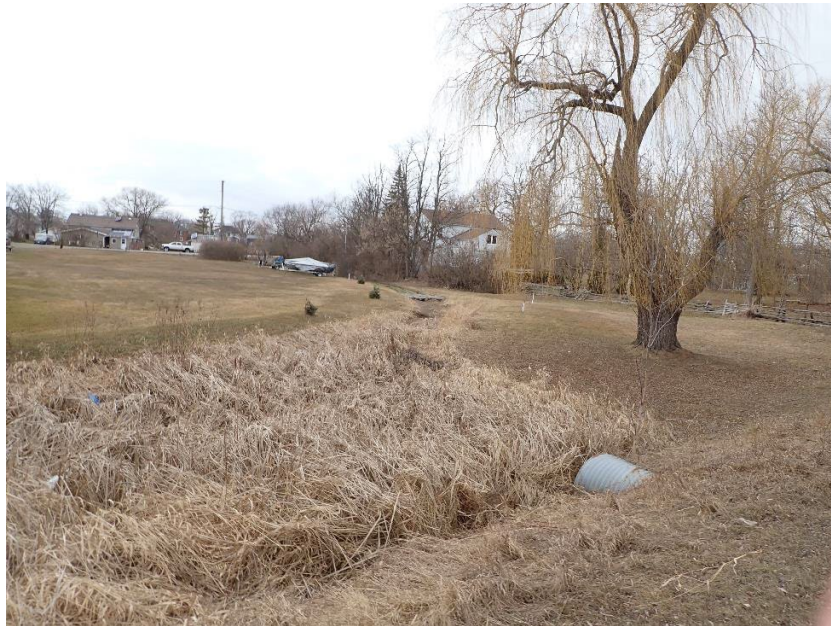
FIGURE 3-2: DITCH WEST OF HWY 33

It is important to note, however, that the ditch in that area west of Hwy 33 was found to be overgrown. For it to properly operate, it needs to be cleaned of vegetation and obstacles and properly maintained. Figure 3-2 shows the ditch looking from Hwy 33 in the downstream direction. There is a crossing on the ditch that has only a small pipe, not properly installed and currently blocked. This crossing, shown more closely in Figure 3-3, is effectively a blockage for flow along the ditch. It needs to be removed. Further downstream along the ditch, Figure 3-4 and Figure 3-5 show the conditions at the driveway crossing, adjacent to Consecon Main Street. This crossing is in poor condition, and the ditch is overgrown with vegetation both upstream and downstream of the crossing.

It must be noted that for estimation of the floodplain, the ditch was assumed to be maintained and free of those obstacles. Otherwise, the maps would represent a preventable condition, caused by poor maintenance.

A critical recommendation is to maintain the ditch west of Hwy 33, that drains into Consecon Creek upstream of Consecon Main St, clean of obstacles (such as the blocked crossing shown in Figure 3-3) and overgrown vegetation. An initial cleaning of the ditch could cost approximately \$10,000 to \$15,000. After that, routine

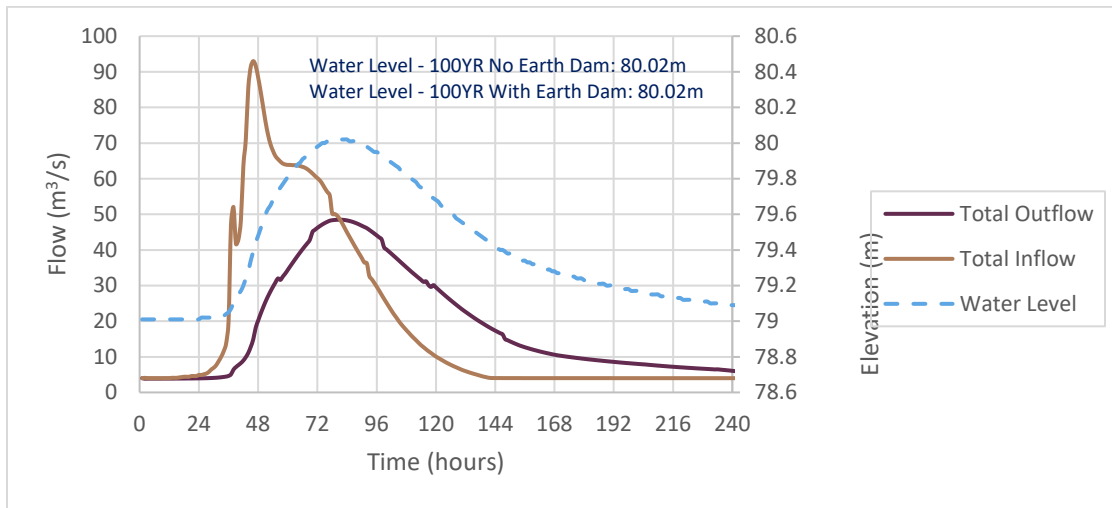
FIGURE 3-6: ROUTING OF THE REGULATORY FLOOD THROUGH UPPER CONSECON LAKE-EXISTING CONDITIONS (WHITNEY DAM EMBANKMENT REMOVED)

- Figure 3-6 shows the total inflows going into upper Consecon Lake and the total outflows and water levels obtained with the HEC-RAS model for the 100-year (1% AEP) Flood.

The water levels in these figures were obtained from the simulation assuming existing conditions of the Whitney Memorial Dam (the embankment that does not exist anymore was not included in the model). The figures were annotated to add the corresponding values with the removed embankment.

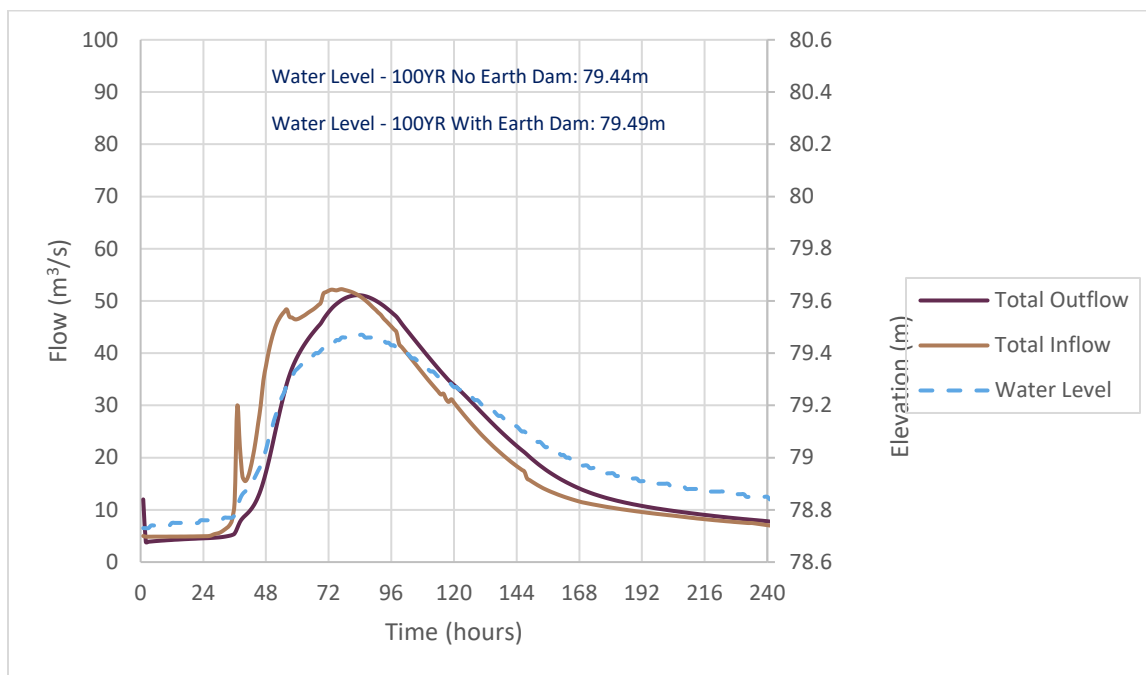
FIGURE 3-7: ROUTING OF THE REGULATORY FLOOD THROUGH LOWER CONSECON LAKE-EXISTING CONDITIONS (WHITNEY DAM EMBANKMENT REMOVED)

- Figure 3-7 shows the total inflows (hydrologic inputs from the hydrologic model plus routed outflows on upper Consecon Lake), and the outflows and water levels for lower Consecon Lake obtained with the HEC-RAS model for the 100-year (1% AEP) Flood.

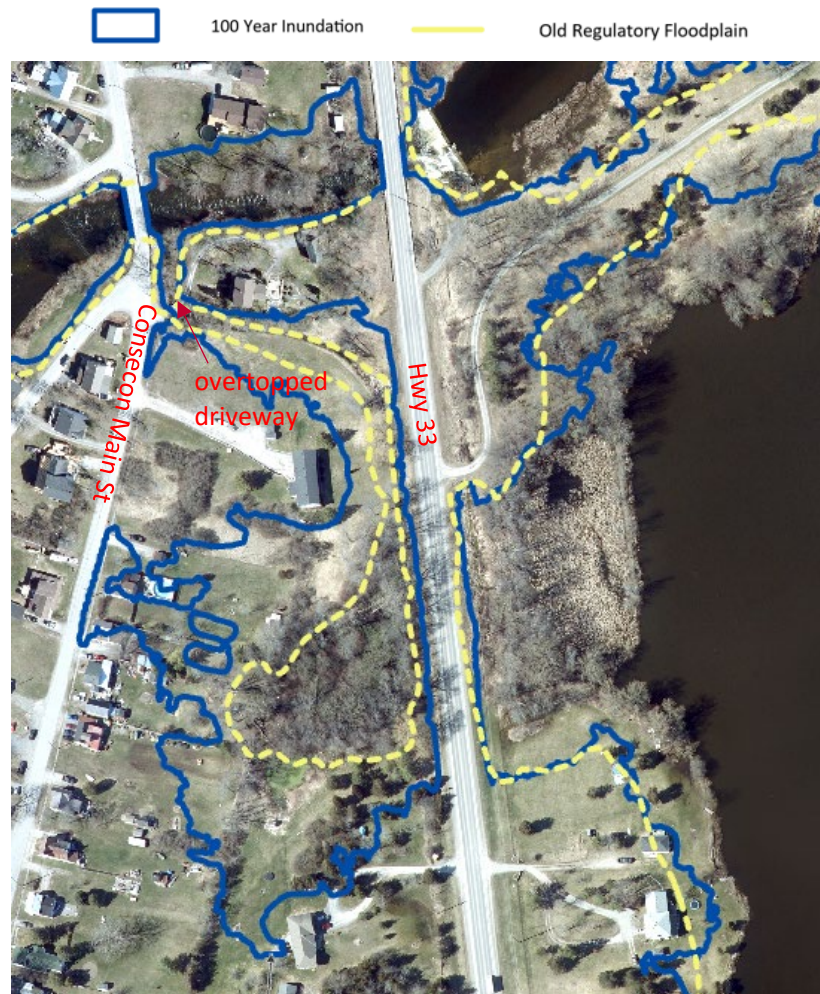
FIGURE 4-1: AREAS WEST OF HWY 33 FLOODED BY THE REGULATORY FLOOD

The water levels obtained at the lower Consecon Lake did not overtop Hwy 33. However, the flow that passed through culverts towards the west side of the highway was found to fill the low areas west of the highway. In this area, the water level obtained with the HEC-RAS model (Table 3-2 for condition without the removed embankment at Whitney Dam) was El. 79.33 m, while the water level for lower Consecon Lake was El. 79.46 m.

With either level (79.33 m or 79.46 m) the extent of the flooding would reach the backyards of some properties along Consecon Main Street and even one existing house. The water levels did not overtop Consecon Main Street.

For definition of the floodplain, and following provincial policy, the adopted floodline for the area between Main Street and Hwy 33 is based on the level of lower Consecon Lake, to acknowledge that the embankment of Hwy 33 is not considered a permanent flood protection. This area is shown in Figure 4-1. It must be noted that the previous floodplain map did show flooding reaching the buildings in this area. Based on the new results, two buildings in this area are within the new floodplain line, and a small crossing of a driveway is shown as flooded.

There were approximately four buildings that were found to be adjacent to or within the floodplain within the study domain. These are shown in Figure 4-1, Figure 4-2, Figure 4-3 and Figure 4-4. There were no

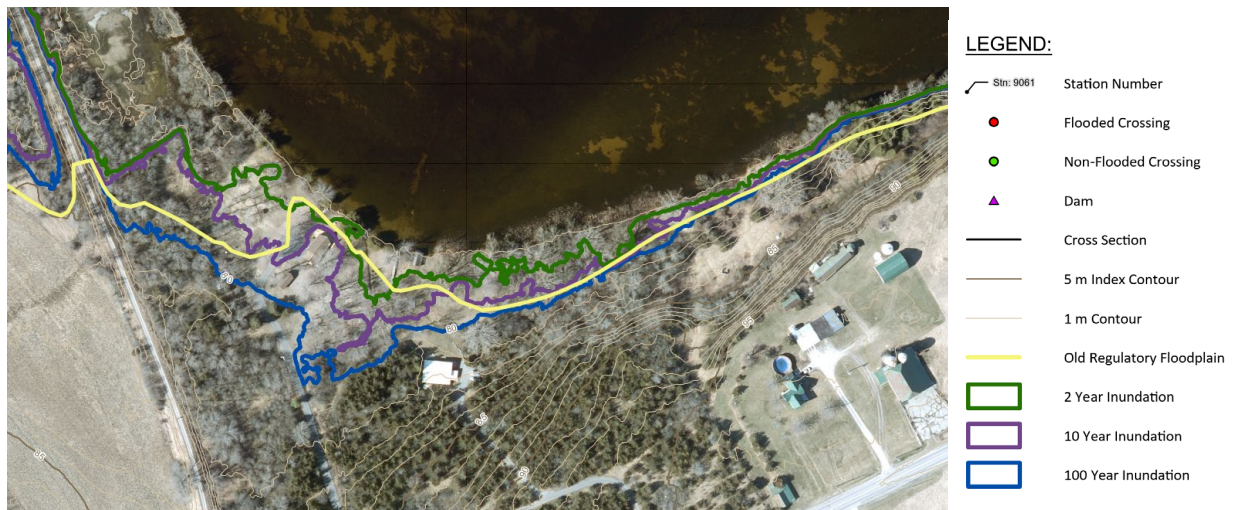
FIGURE 4-3: UPPER CONSECON LAKE UPSTREAM OF THE CAUSEWAY

The results obtained in this study are consistent with the previous floodline in the areas around Consecon Lake. However, there is an area on the south side of upper Consecon Lake, just east of the causeway, in which the floodline obtained in this study extends farther inland than the previous one, and in doing so it would include one building in the floodplain. Since the lines are consistent elsewhere around the lake (and in some cases even reflect higher levels for the previous floodplain than with these new results) it seems that this is due to differences in the terrain model used for the two studies. This area is shown in Figure 4-3.

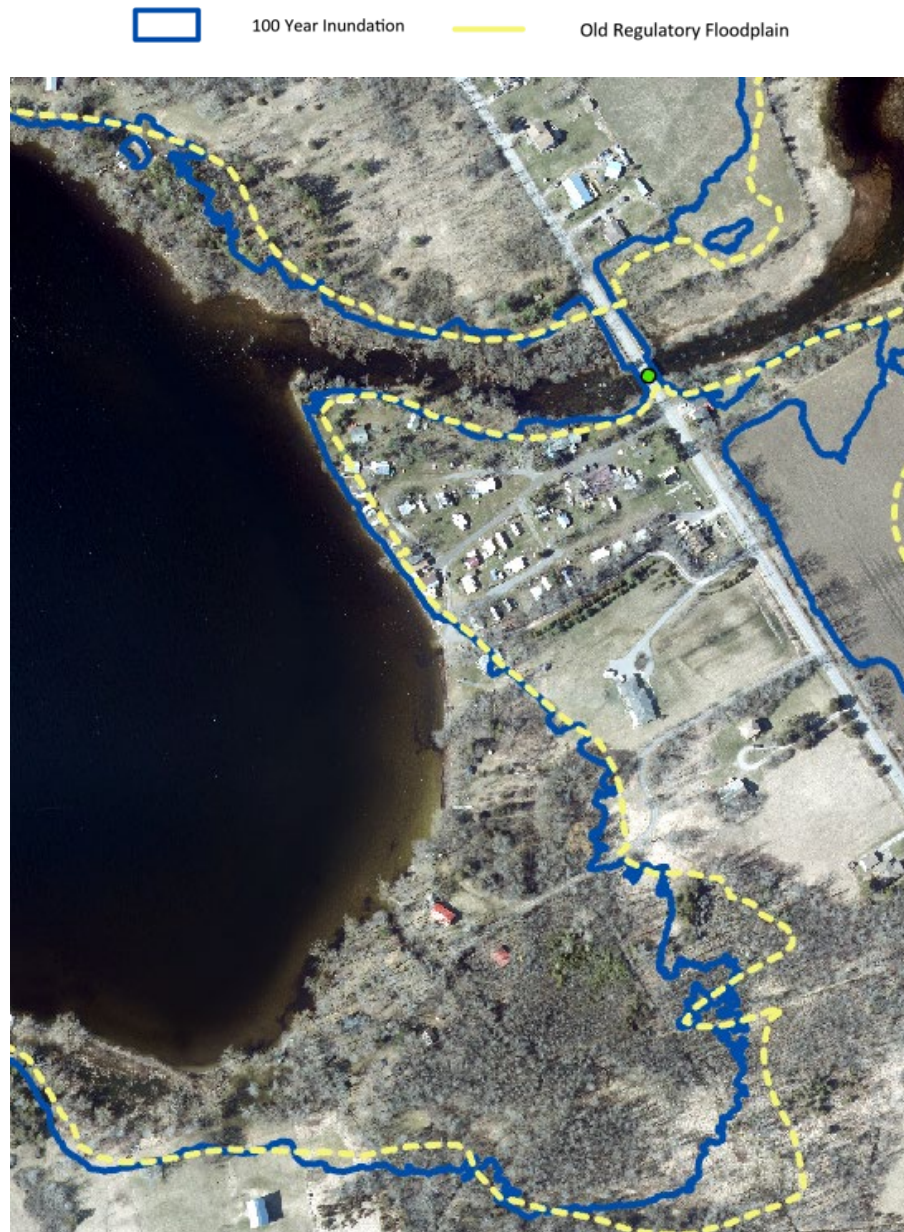
FIGURE 4-4: UPSTREAM END OF CONSECON LAKE

At the upstream end of Consecon Lake, some buildings are close to or within the floodplain (both previous and new floodplain limits). This area is shown in Figure 4-4.

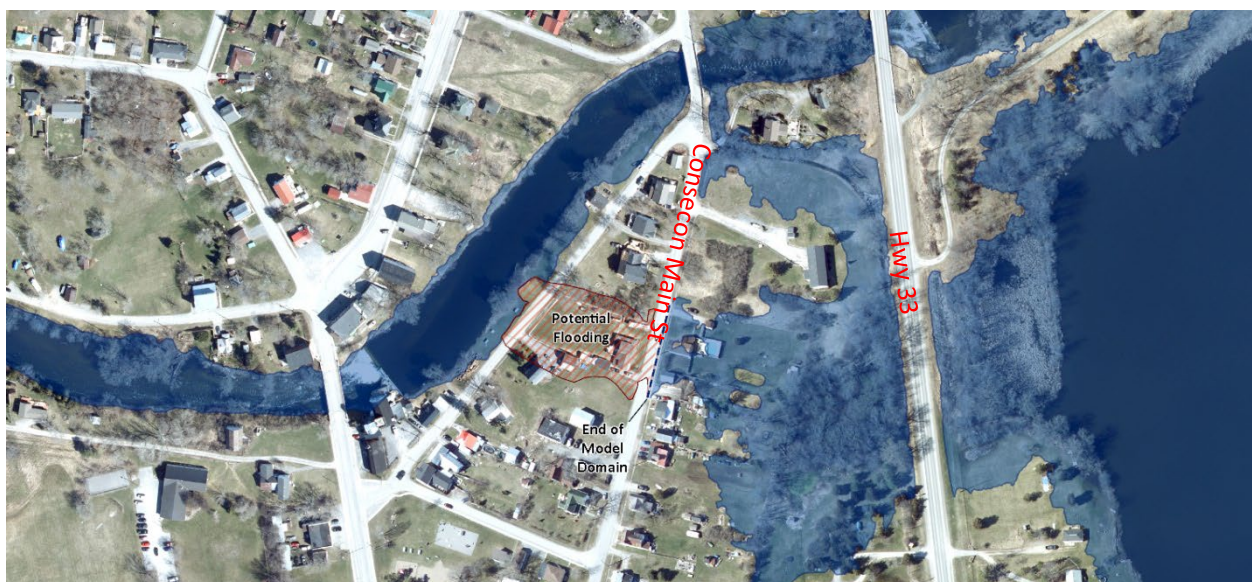
FIGURE 4-5: FLOODING WEST OF HWY 33 FOR THE 200-YEAR (0.5 % AEP) FLOOD EVENT

It must be noted that the levels of Consecon Lake would not reach the top of Hwy 33, so that it is not likely that the highway embankment would be washed out; but the analysis was done assuming that it would for consistency with the Provincial guidance. The conditions with the embankment in place and flow only through the culverts under the highway were also simulated, and the results showed that, in that case, Consecon Main St. would not be overtopped.

The simulation of the 500-year (0.2 % AEP) Flood showed that even for that event Hwy 33 would not be overtopped, so that the conditions would be similar to those obtained for the 200-year Flood, with higher water levels.

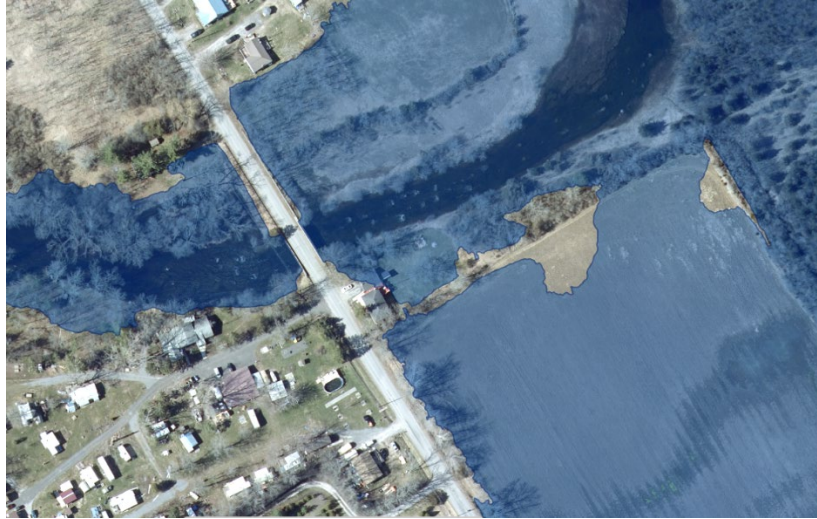
FIGURE 4-6: FLOODING UPSTREAM OF MELVILLE RD FOR THE 200-YEAR (0.5 % AEP) FLOOD EVENT

Another area in which a building would be affected by the 200-year (0.5 % AEP) Flood scenario is upstream of Melville Rd, as shown in Figure 4-6.
