Final Report

Bellrock Dam

Napanee Watershed

April 2004

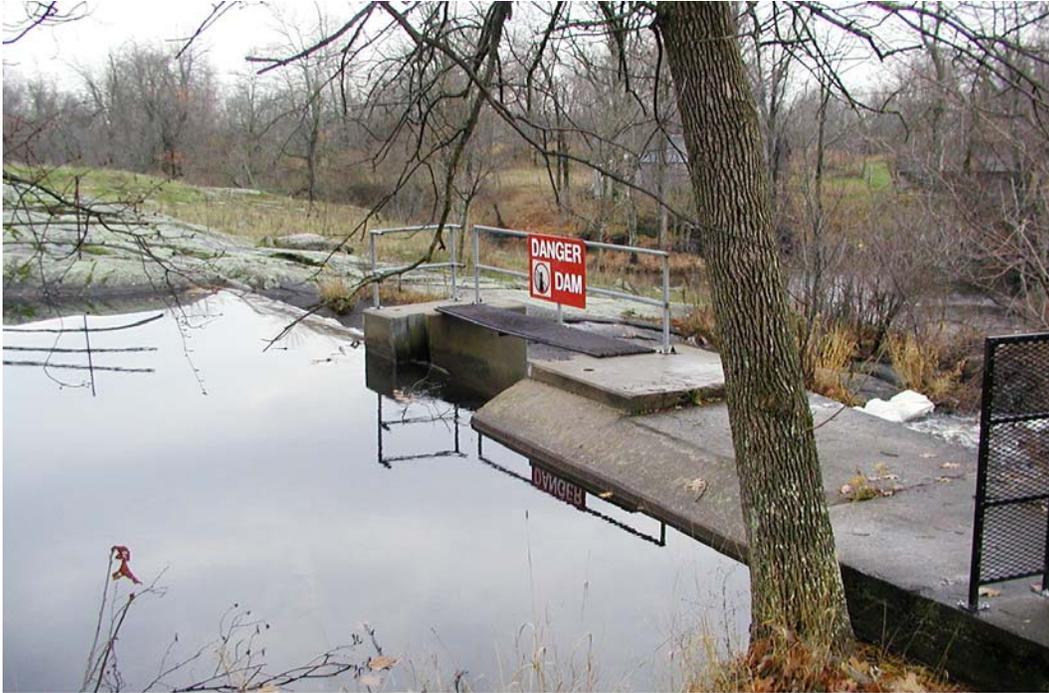
Photo 1 - November 6, 2003
Bellrock Dam
Bellrock Dam - Upstream View

The rock at the left abutment of the Bellrock Dam was exposed (Photos 1 and 2), and water was spilling above the overflow weir portion of the dam during the site inspection (Photo 3).

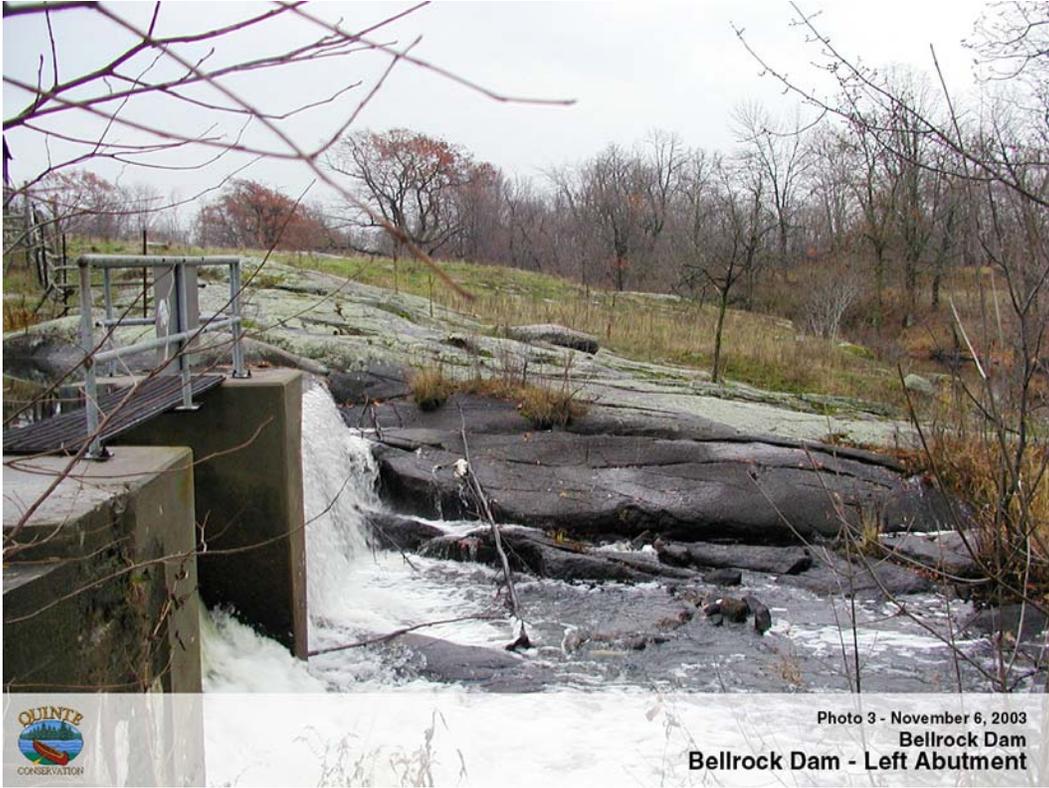
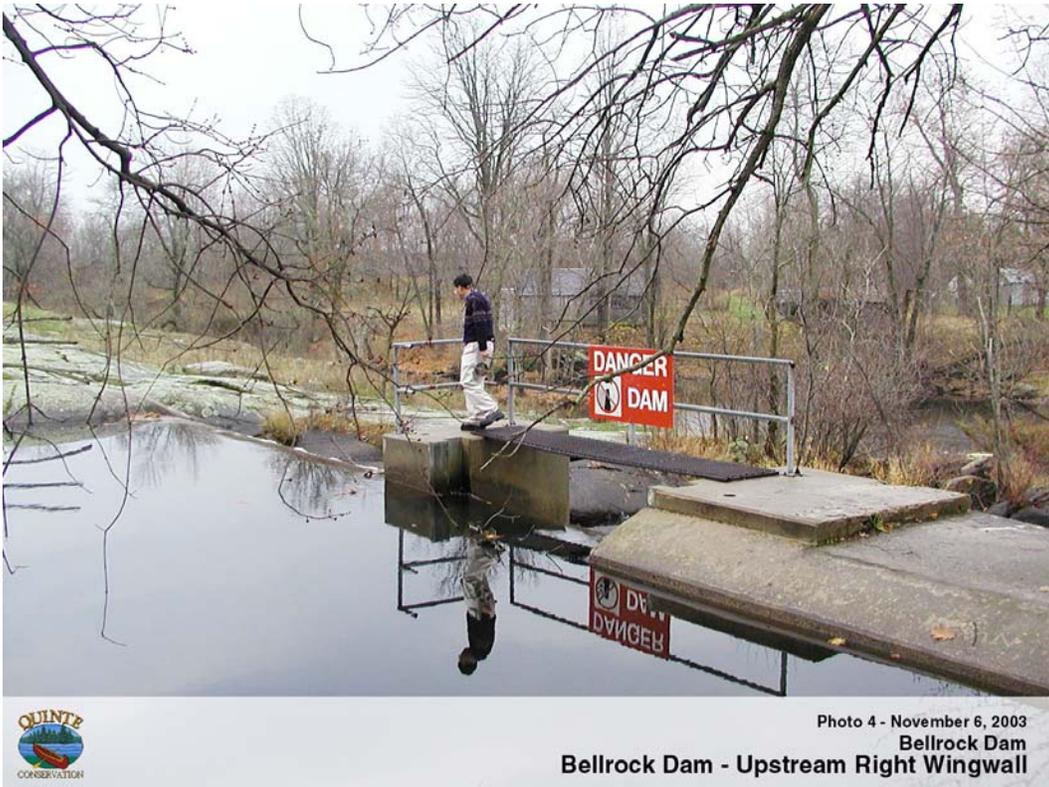
Some map cracking was noticed on the crest of the wall, and light spalling was observed at the junction wall/pier with no sign of erosion at the waterline (Photo 4). No sign of wall movement was observed. A major concrete deterioration was observed at the downstream face of the wall with its junction with the right pier (Photo 5). Also, seepage through the concrete joints was noticed. Stability of this structure could be an area of concern. If problems are identified, repair works may include crack treatment.

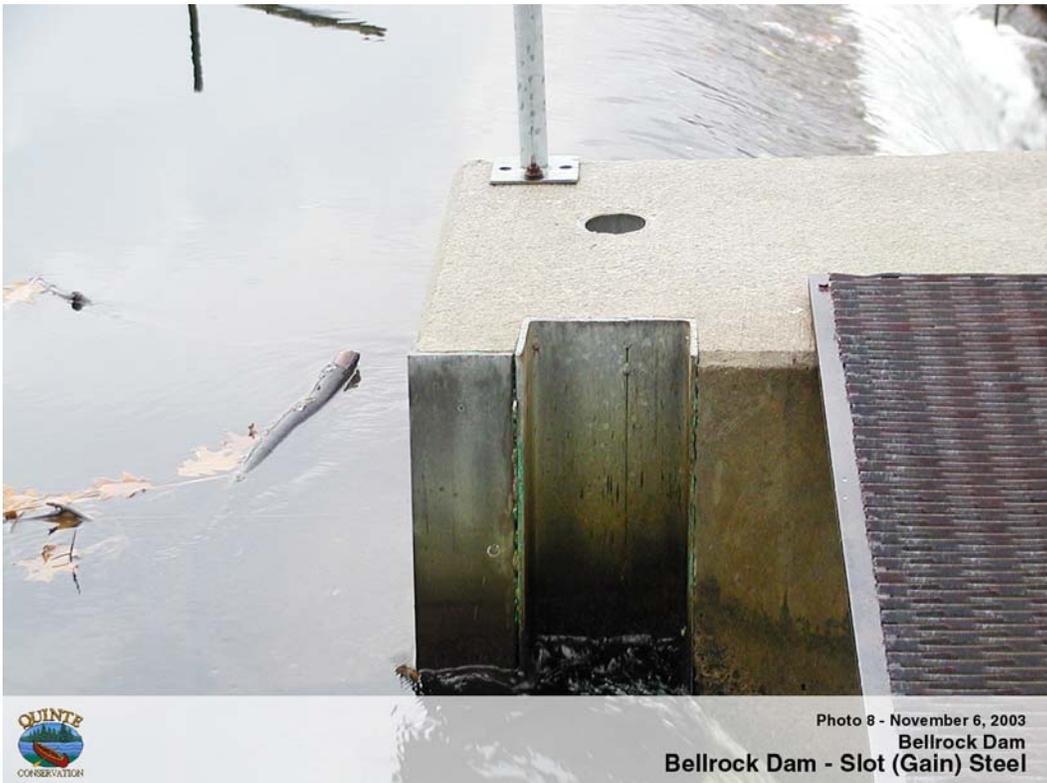
Photo 8 - November 6, 2003
Bellrock Dam
Bellrock Dam - Slot (Gain) Steel

Rough concrete surfaces were noticed at the waterline inside the piers. Deck, allowing crossing from the right wingwall to the stop log guides, is of steel grating (Photo 6). Guards are fabricated of steel pipe. Slot (gain) steel was not severely rusted above the waterline. The steel deck was in good condition and well fixed to the concrete piers. The steel deck components need some painting. The topside of the concrete piers was showing some map cracking with spalling observed near the stop log gains (Photos 7 and 8). Hoist equipment was not available during the site inspection. There were no stop logs on the deck. The number of stop logs

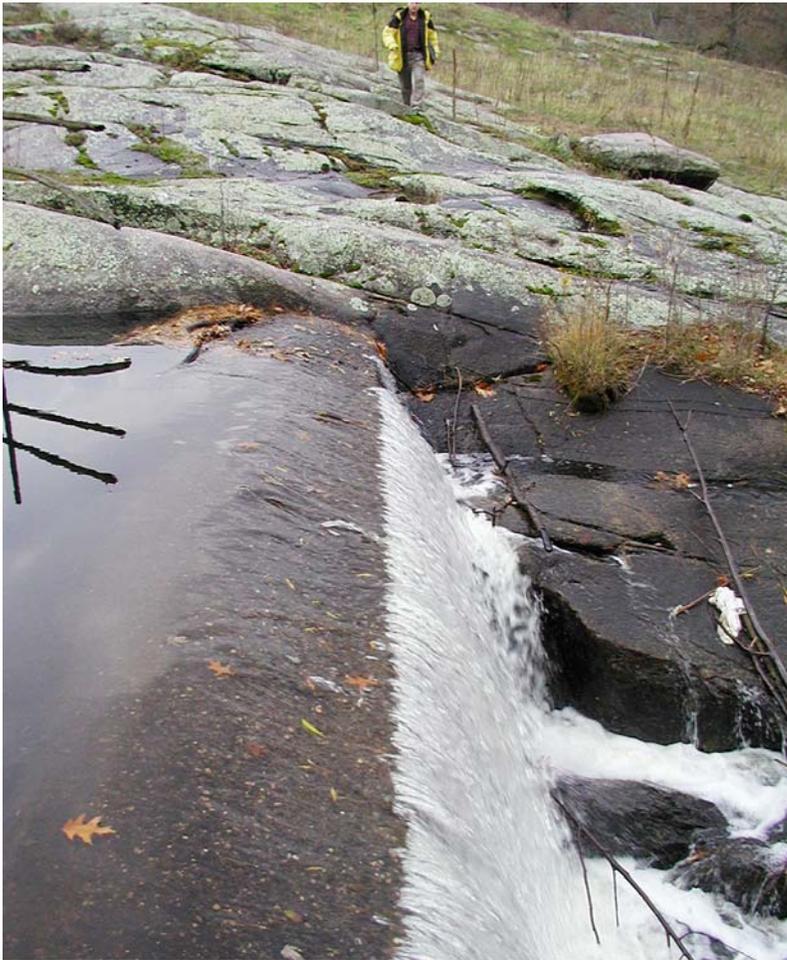
Photo 9 - November 6, 2003
Bellrock Dam
Bellrock Dam - Overflow Weir

The weir was not inspected due to spillage at the time of inspection (Photo 9). Stability against overturning and sliding of this structure could be an area of concern.

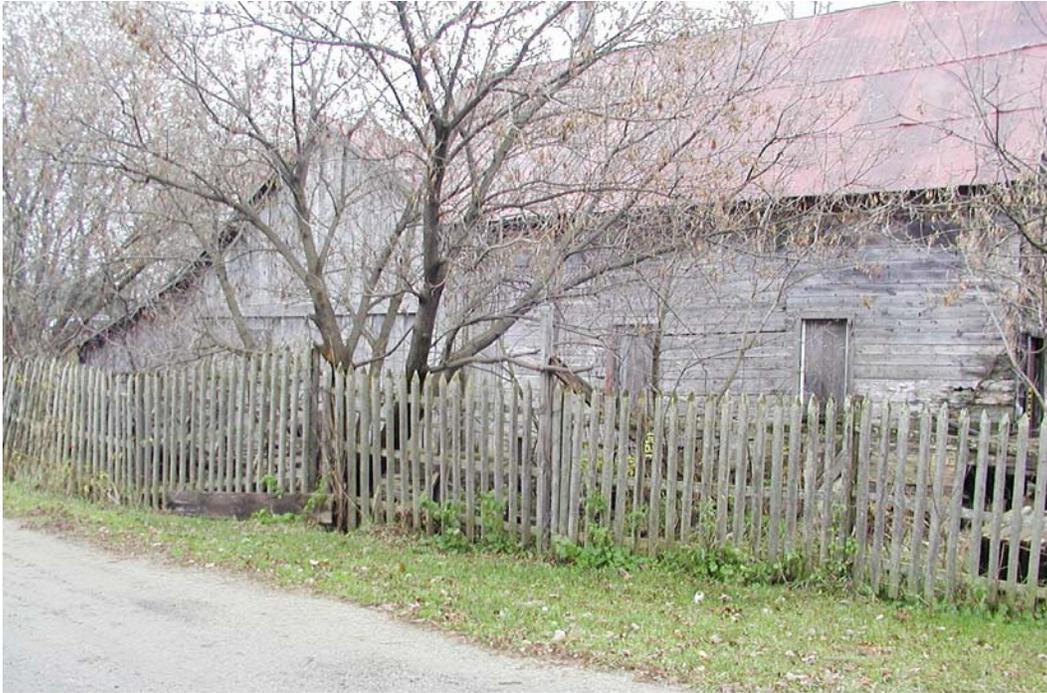
Photo 11 - November 6, 2003
Bellrock Dam
Mill Dam - Adjacent Mill

The Mill dam is a retaining wall 32 m long (Photo 10) with a sluiceway that formerly provided water to an adjacent mill that is no longer in operation (Photo 11). The concrete was in good condition. A “Dam - Danger” sign was clearly visible on the sluiceway guard. The sign was generally in good condition (Photo 12).

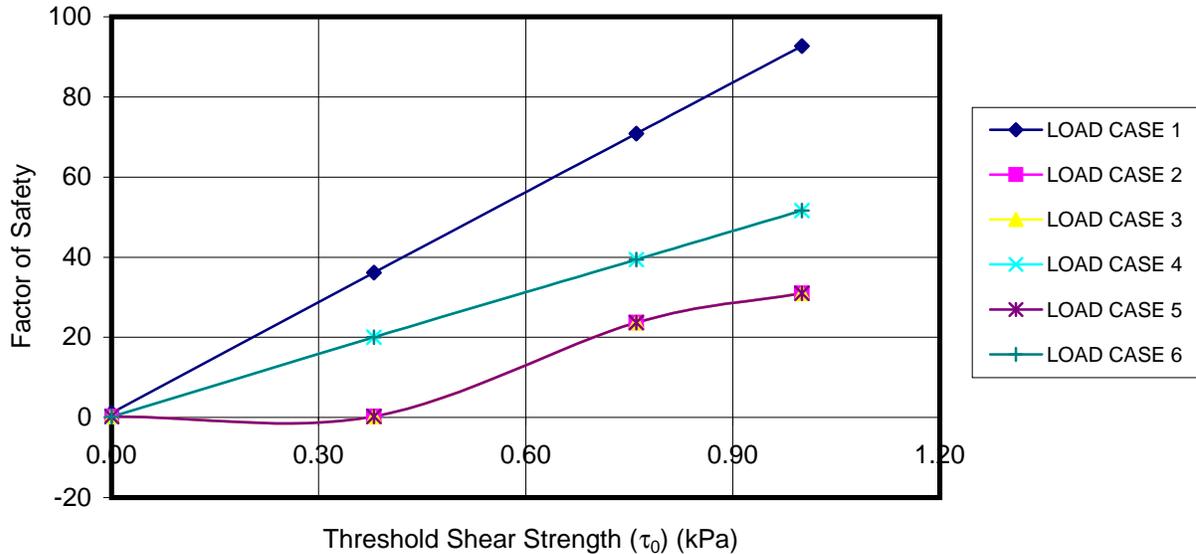
Sliding Factors of Safety for Specified Angle of Sliding Friction (ϕ_3) = 43°

Minimum Sliding Angle of Friction to Achieve Required Factor of Safety and % Bonding Results

The results indicate that the gravity section satisfied the summer normal loading conditions. The sluiceway and overflow sections developed cracks at the concrete-rock interface as well as substandard factors of safety versus sliding. This means these two sections do not meet the ODSG requirements under summer normal conditions.

All sections developed unstable cracks under winter ice load conditions and failed to meet the ODSG requirements.
