# Storm Outfall Monitoring

Bay of Quinte  
Remedial Action Plan

## Storm Outfall Site Inspection Form

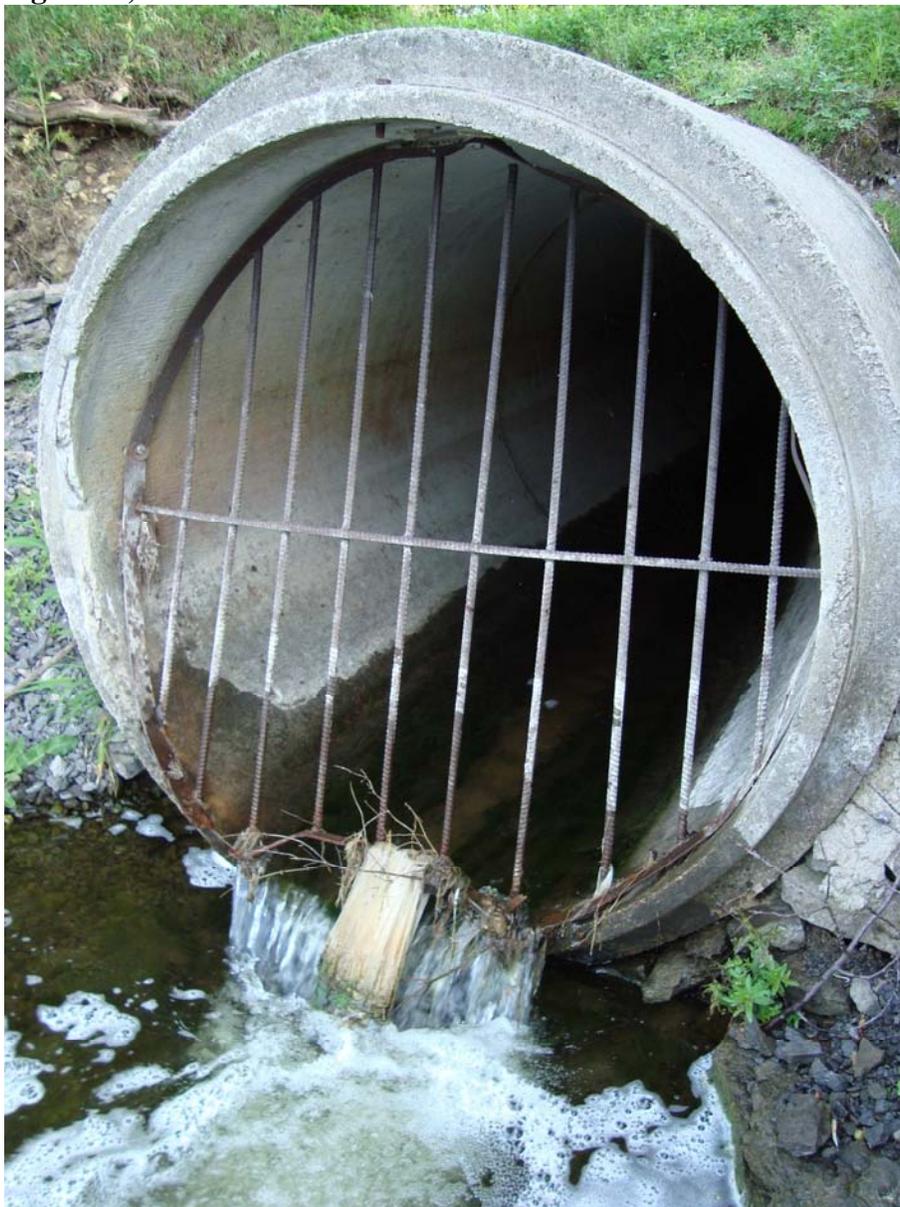
BE10 – August 22, 2008

Is there discharge from the outfall pipe? If yes, then please estimate flow depth in outfall pipe, or approximate % of pipe that is full	Approx. 15cm
Is the flow clear or cloudy or muddy?	Clear
Is there sediment or debris accumulation in the outfall pipe? If yes, then what approximate depth of pipe is filled by sediment or debris?	No
Is there any indication of oil and grease in the flow (for example, surface sheen)?	No
Is there any odour? If yes, please describe. No	
Is there any evidence of sewage contamination? If yes, please describe. No	
Other observations or notes:

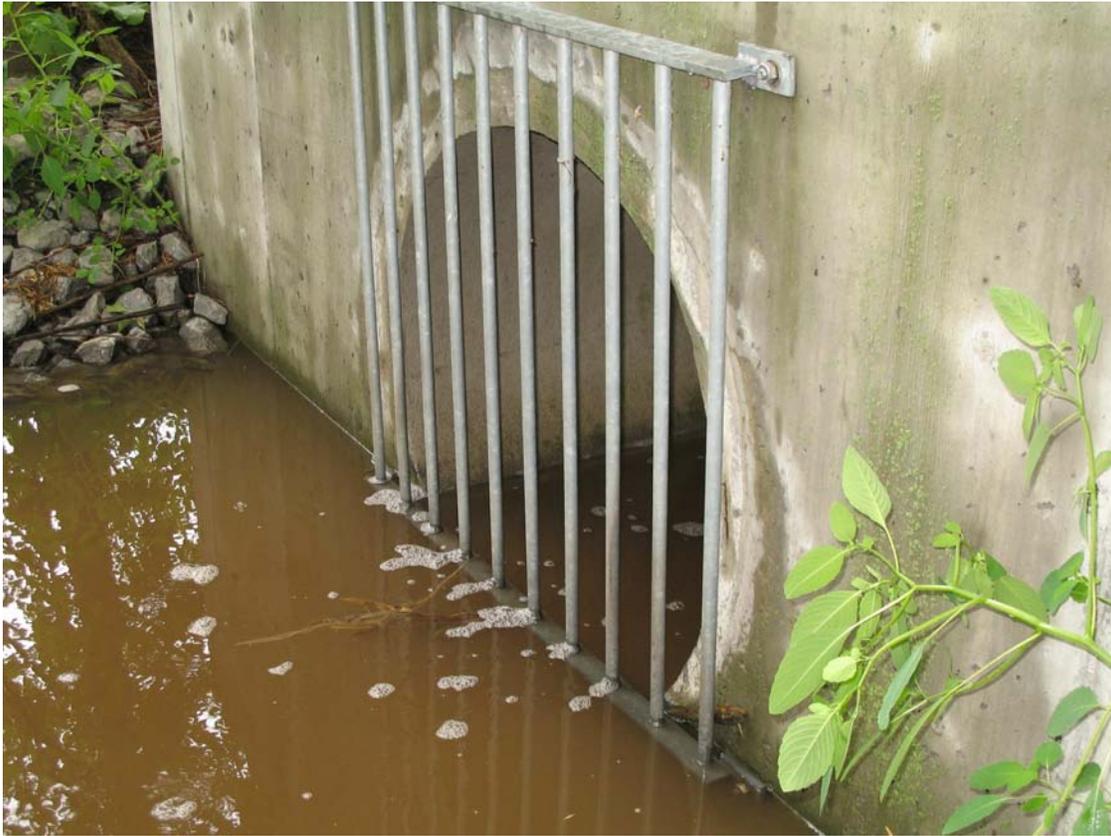
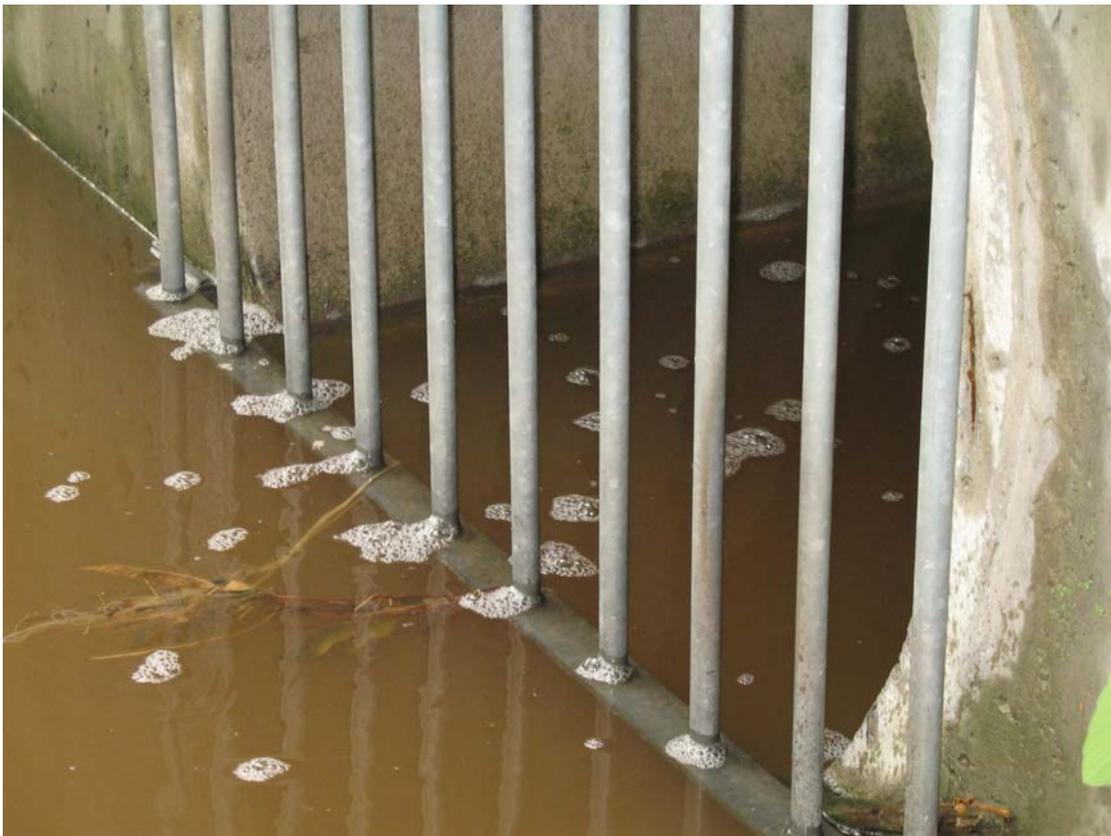
BQ30 – July 24, 2008

Is there discharge from the outfall pipe? If yes, then please estimate flow depth in outfall pipe, or approximate % of pipe that is full	Approx. 1/8 full
Is the flow clear or cloudy or muddy?	Muddy and Rusty-brown colour
Is there sediment or debris accumulation in the outfall pipe? If yes, then what approximate depth of pipe is filled by sediment or debris?	No
Is there any indication of oil and grease in the flow (for example, surface sheen)?	No
Is there any odour? If yes, please describe. No	
Is there any evidence of sewage contamination? If yes, please describe. No	
Other observations or notes:  Water is a rusty-brown colour
