West Lake

Aquatic Vegetation Report, 2021

Quinte
CONSERVATION

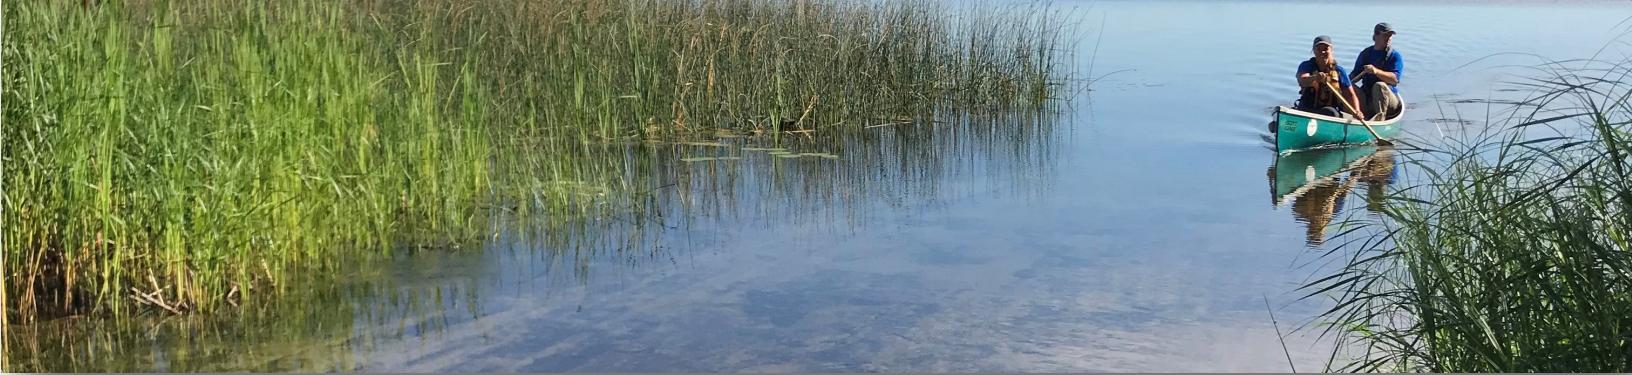
Map 1: West Lake 2021 Vegetation Survey Locations

Submerged Aquatic Vegetation (SAV) surveys took place in the summer of 2021. Separate zones were surveyed across West Lake and within each zone, 60 randomized sampling locations were surveyed for vegetation species and percent coverage. *See Map 1 for survey locations.*

The surveys of submerged aquatic vegetation (SAV) used a random point method, within predetermined areas with SAV (i.e. Wetlands). Random points were generated before sampling. Sites were then surveyed for an inventory of SAV and their aerial coverages within 1x1 meter quadrats.

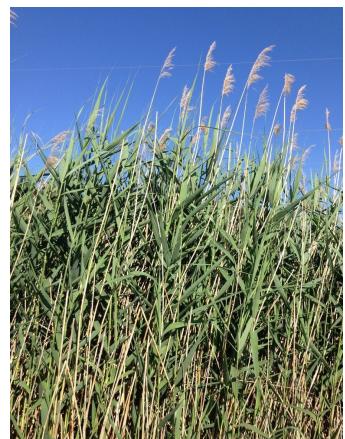
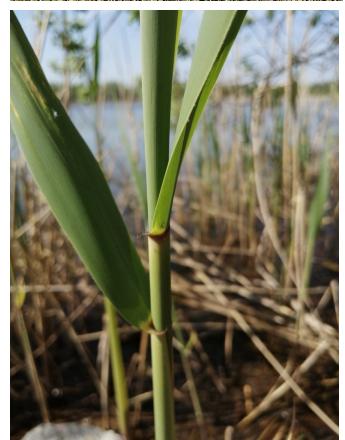
Distinguishing between the two can sometimes be difficult, since characteristics may overlap, and hybrids complicate it further.

The red stem segments on the native phragmites (right) is a fairly good way for a non-expert to distinguish it from invasive phragmites (above).

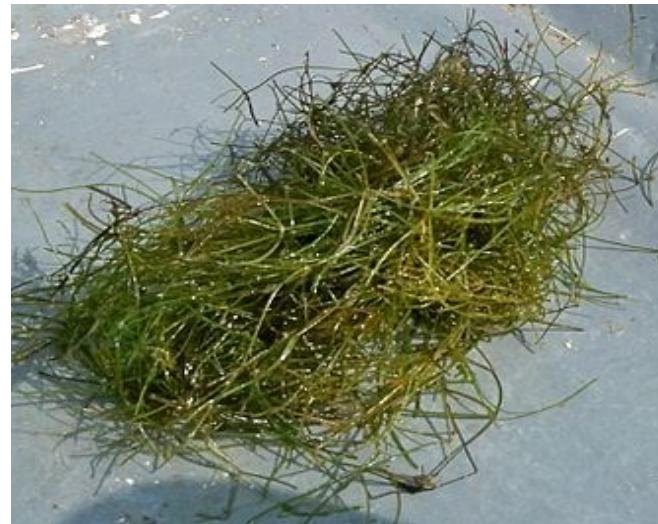
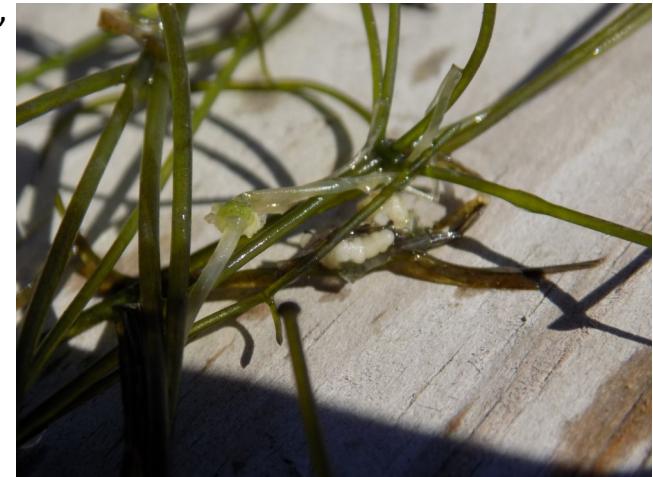
IDENTIFICATION: Starry stonewort is a plant-like form of algae. This plant reaches 30cm to 10m in the water column and has white, star shaped bulbils on the main axes. The stem is smooth green, and the branchlets are in whorls of 4 to 6 (Invasive Species Centre, n.d.)

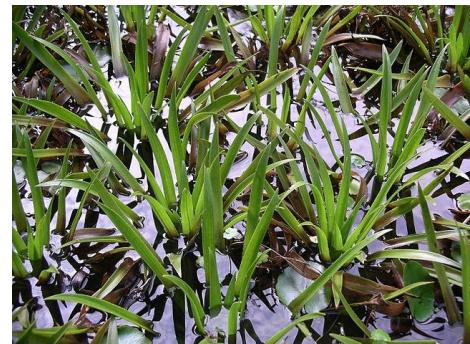
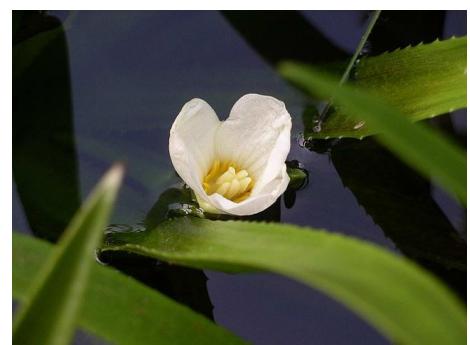
IDENTIFICATION: This species is similar in appearance to an aloe plant, and has broad, serrated leaves, and floats in open shallow water. There are a few potential native look-alikes in Ontario, but none of them have the sharp serrated leaves of the Water soldier, so this is a good identifying feature. The Water soldier may produce flowers, but in Ontario it seems to only reproduce vegetatively.

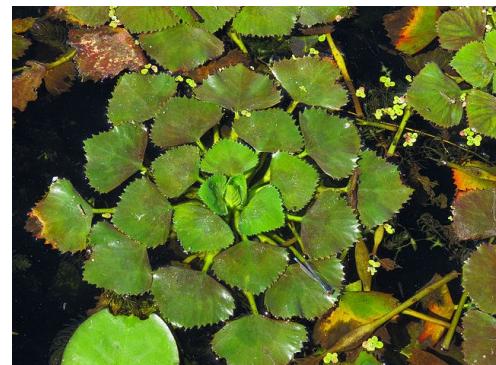
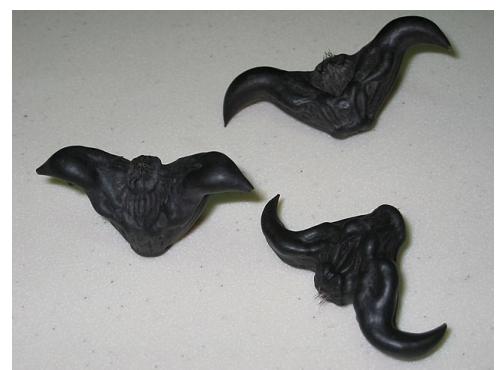
IDENTIFICATION: This species is distinct amongst wetland plants in Ontario, and does not have any close look-alikes. It floats on the water's surface and have spade shaped serrated leaves. The leaves are on long stems and fan out from a "rosette". The "nuts" are dark, woody and have two hooks.
